Contract #: 04-0120F4Cty: SF/ALA Rte: 80 PM: 13.2/13.9File #: 69.25B**QUALITY ASSURANCE -- NON-CONFORMANCE REPORT****Location:** Changxing Island, Shanghai, PRC**Report No:** NCR-000203**Prime Contractor:** American Bridge/Fluor Enterprises, a JV**Date:** 13-Oct-2008**Submitting Contractor:** Zhenhua Port Machinery Company, Ltd (ZPMC), Changxing Island**NCR #:** ZPMC-0181**Type of problem:**

Job Name: SAS Superstructure

Subject: NCR No. ZPMC-0181

Reference Description: Inaccessability of "E3" stiffener Welding

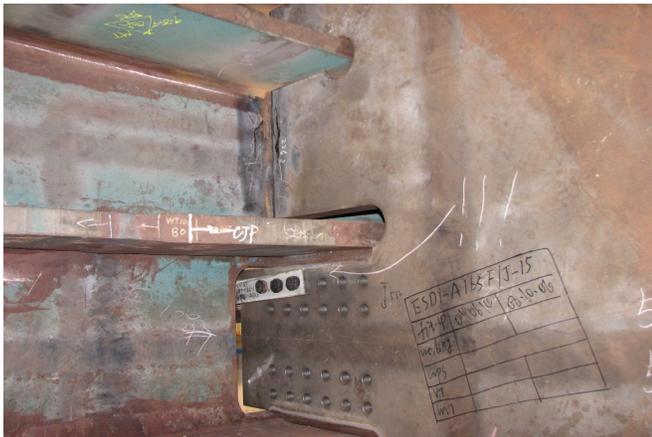
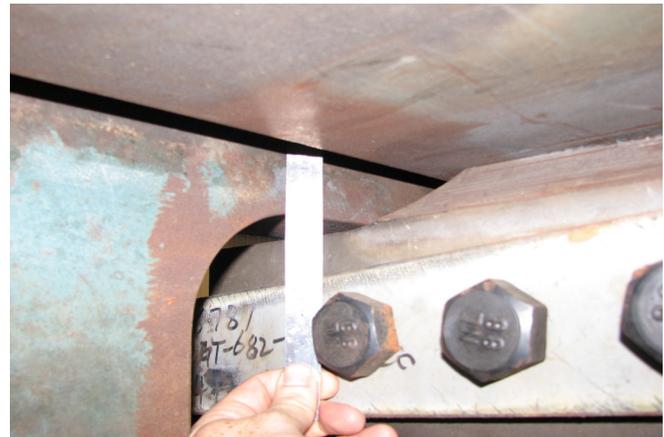
ZPMC did not follow the approved fabrication plan for welding stiffeners to skin when welding stiffener E3, to Skin E of the East shaft. p708 of stiffener E3 was not welded when the other stiffeners were welded to Skin E. The approved fabrication plan shows that all stiffener to skin welds will be complete with welding and NDT before fit-up of the Skin E to Skin A.

1. Remove Part p708 from Skin E, by removing the Longitudinal Stiffener butt weld and its tack welds to skin.
2. Butter bevel and re-groove 1210mm of length for a single-sided CJP as depicted on the diagram below, which will be welded in 1-G position.
3. Introduce R75 weld access hole on the longitudinal stiffener at the intersection of longitudinal stiffener butt weld and to skin weld.
4. Fit and tack Part p708 to Skin E and Longitudinal Stiffener E3.
5. Weld the longitudinal stiffener butt splice and to skin single-side CJP joint.
