Contract #: 04-0120F4Cty: SF/ALA Rte: 80 PM: 13.2/13.9File #: 69.25B**QUALITY ASSURANCE -- NON-CONFORMANCE REPORT****Location:** Changxing Island, Shanghai, PRC**Report No:** NCR-000205**Prime Contractor:** American Bridge/Fluor Enterprises, a JV**Date:** 16-Oct-2008**Submitting Contractor:** Zhenhua Port Machinery Company, Ltd (ZPMC), Changxing Island**NCR #:** ZPMC-0183**Type of problem:**

Reference Description: PJP Non uniform groove face**Description of Non-Conformance:**

Job Name: SAS Superstructure

PROJECT: SAN FRANCISCO OAKLAND BAY BRIDGE

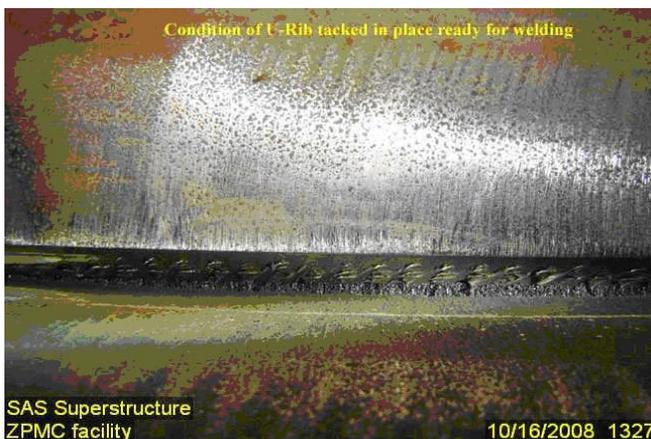
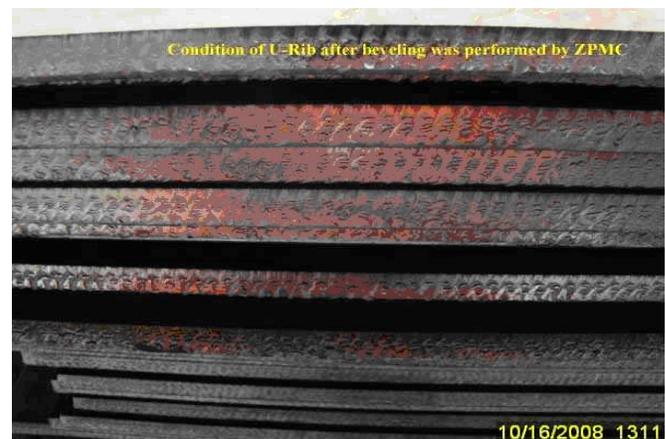
Surfaces to be welded do not conform to workmanship requirements for preparation of base metal. Groove faces of closed ribs welded to deck panels were not smooth or uniform. This is typical on all U-Ribs that have been manufactured to date. Please reference NCR-ZPMC-0070 dated Feb. 15, 2008. The Contractor has indicated (via ABF-CAL-LTR-000626, dated 14 August) that the nibbler teeth would be replaced on a more frequent basis, and that surfaces would be repaired via grinding before welding. This remain, however, an ongoing issues. Included below are digital pictures of the closed rib PJP groove face discrepancy.

AWS D1.5, Section 3.2.1: "Surfaces and edges to be welded shall be smooth, uniform, and free from fins, tears, cracks, and other discontinuities which would adversely affect the quality or strength of the weld. Surfaces to be welded and surfaces adjacent to a weld shall also be free from loose or thick scale, slag, rust, moisture, grease, and other foreign material that would prevent proper welding or produce objectionable fumes."

With this letter of response, ZPMC requests closure for Caltrans NCR-000205 (ZPMC-0183). We have instructed the work staff that he must assure the groove surface reached smooth quality before going ahead to the next step. But if some areas were not uniform to the specification, he can repair by free-hand grinding.

Groove faces of closed ribs welded to deck panels shall be smooth or uniform via grinding after machining.
