QUALITY ASSURANCE -- NON-CONFORMANCE REPORT

Report No: NCR-000215

NCR #: ZPMC-0191

Reference Description: Crack indication overlooked on weld # SP726A-001-030 located on the SP726A-001 side plate sub assembly.

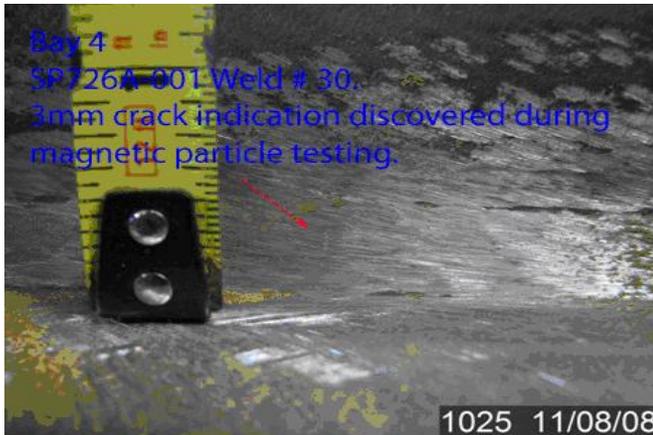
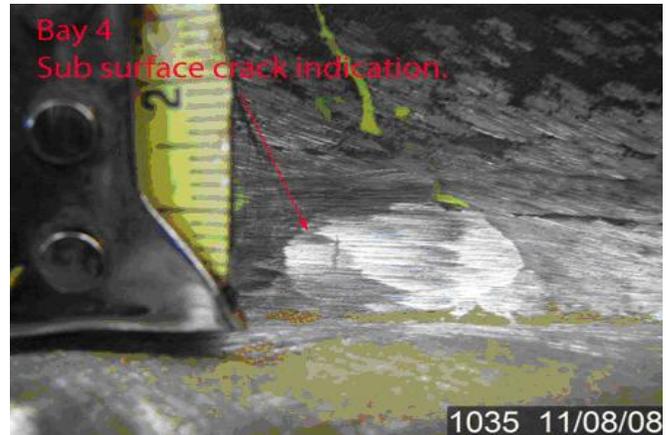
The Quality Assurance Inspector discovered a crack indication overlooked by Quality Control while performing magnetic particle verification on weld # SP726A-001-030 located on the SP726A-001 side plate sub assembly. The Quality Assurance Inspector informed American Bridge/Fluor Quality Assurance Inspector Hu Gui Hua about the crack indication overlooked by ZPMC Quality Control Inspectors. Mr. Hua agreed with the Quality Assurance Inspector and informed ZPMC Quality Control Inspector Gui Yang Wei about the overlooked crack indication. The Quality Assurance Inspector observed ZPMC personnel have removed 1mm of filler metal by grinding in an effort to confirm if the indication discovered by the Quality Assurance Inspector is a surface indication. The Quality Assurance Inspector observed ZPMC Quality Control personnel perform magnetic particle testing on the ground area, revealing the crack indication is a sub surface indication. Mr. Hua informed the Quality Assurance Inspector a critical weld repair will be issued prior to welding the repair.

AWSD1.5 2002 Section 6.26.2, "Welds that are subject to RT and MT in addition to visual inspection shall have no cracks and shall be unacceptable if the RT or MT shows any types of discontinuities described in 6.26.2.1..." 6.26.2.1, figure 6.8

Please propose a resolution for Quality Control Inspector overlooking crack indication. Critical weld repair for the sub surface indication has been submitted.

The proposed resolution is acceptable. An internal NCR was written, and the MT technicians received additional training. Also, the welds in question have been accepted by VT and MT as shown in the attached documents. The Department concurs that Non-Conformance ZPMC-0191 is closed.
