QUALITY ASSURANCE -- NON-CONFORMANCE REPORT

Report No: NCR-000216

Reference Description: Crack indication (2 to 3mm) overlooked on weld # FB011-017-003 located on the FB011-017 floor beam sub assembly.

Job Name: SAS Superstructure

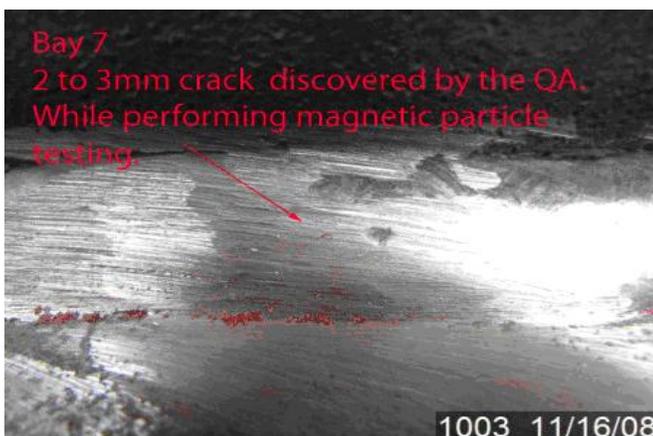
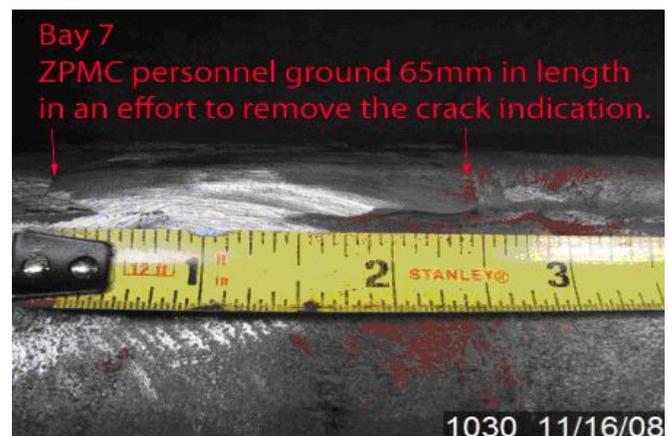
The Quality Assurance Inspector discovered a 2 to 3mm in length crack indication overlooked by ZPMC Quality Control Inspectors. The crack indication was discovered while the QA was performing magnetic particle verification on weld # FB011-017-003 located on the FB011-017 floor beam sub assembly. The Quality Assurance Inspector informed American Bridge/Fluor Quality Assurance Inspector Um Bin about the crack indication overlooked by ZPMC Quality Control Inspectors. Mr. Bin and ZPMC Quality Control Inspector Wen Peng agreed with the Quality Assurance Inspector that the crack indication was overlooked by ZPMC Quality Control Inspectors. The Quality Assurance Inspector observed ZPMC personnel removed an area 8mm in depth and 65mm in length of filler metal by grinding in an effort to remove the indication discovered by the Quality Assurance Inspector. ZPMC Quality Control Inspector Wen Peng informed the Quality Assurance Inspector ZPMC personnel performed magnetic particle testing on the ground area, revealing the crack indication is a sub surface indication. Mr. Peng informed the Quality Assurance Inspector a critical weld repair will be issued prior to welding the repair.

Please propose a resolution for Quality Control Inspector overlooking crack indication. Critical weld repair for the sub surface indication has been submitted.

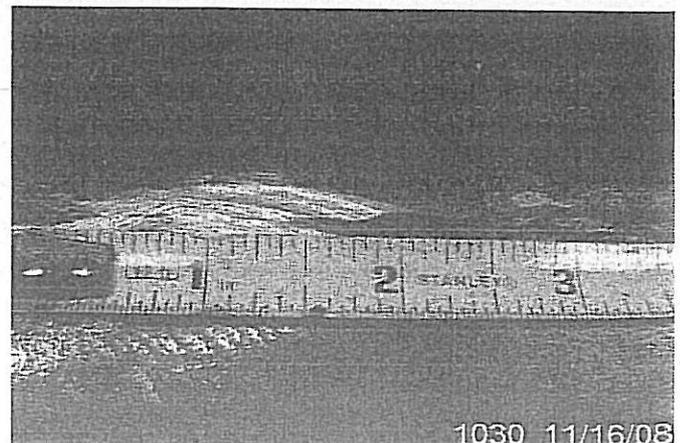
The Quality Assurance Inspector discovered a 2 to 3mm in length crack indication overlooked by ZPMC Quality Control Inspectors. The crack indication was discovered while the QA was performing magnetic particle verification on weld # FB011-017-003 located on the FB011-017 floor beam sub assembly. The Quality Assurance Inspector informed American Bridge/Fluor Quality Assurance Inspector Um Bin about the crack indication overlooked by ZPMC Quality Control Inspectors. Mr. Bin and ZPMC Quality Control Inspector Wen Peng agreed with the Quality Assurance Inspector that the crack indication was overlooked by ZPMC Quality Control Inspectors. The Quality Assurance Inspector observed ZPMC personnel removed an area 8mm in depth and 65mm in length of filler metal by grinding in an effort to remove the indication discovered by the Quality Assurance Inspector. ZPMC Quality Control Inspector Wen Peng informed the Quality Assurance Inspector ZPMC personnel performed magnetic particle testing on the ground area, revealing the crack indication is a sub surface indication. Mr. Peng informed the Quality Assurance Inspector a critical weld repair will be issued prior to welding the repair.

ZPMC welders performed weld repairs. The MT and VT result shows that the weld is acceptable. The MT technicians who failed to detect the indications also received additional training.
