Contract #: 04-0120F4Cty: SF/ALA Rte: 80 PM: 13.2/13.9File #: 69.25B**QUALITY ASSURANCE -- NON-CONFORMANCE REPORT****Location:** Changxing Island, Shanghai, PRC**Report No:** NCR-000221**Prime Contractor:** American Bridge/Fluor Enterprises, a JV**Date:** 02-Dec-2008**Submitting Contractor:** Zhenhua Port Machinery Company, Ltd (ZPMC), Changxing Island**NCR #:** ZPMC-0197**Type of problem:**

**Reference Description:** DP-598-001 and DP-612-001**Description of Non-Conformance:**

**Job Name:** SAS Superstructure

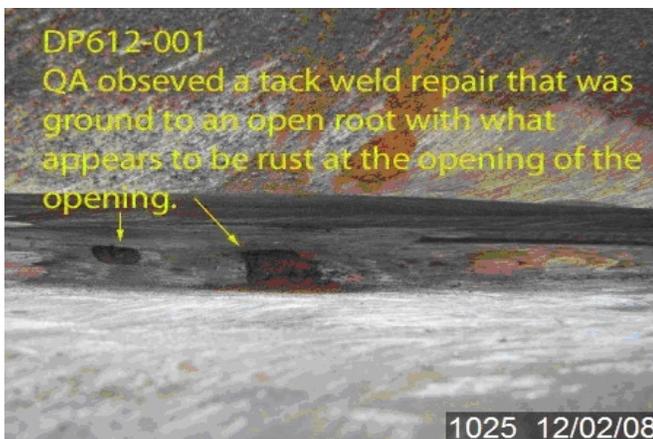
The Quality Assurance Inspector observed rust at the location of a closed rib open-root repair (indicating that water had been present; 1st photo). Subsequently QA Inspector, observed ZPMC personnel remove sealant caulking (by grinding) on several, deck panel to u-rib diaphragm plates on deck panels DP598-001 and DP612-001. The caulking between u-rib diaphragm plates and deck panel was removed in an effort to relieve entrapped water located within the deck panel u-rib. The Quality Assurance Inspector observed water pour through the location where caulking was removed. The presence of water inside these deck panels is not in conformance with the State of California Department of Transportation Standard Specifications.

**Reference Resolution:** To ensure water is not present within the U-Rib, ZPMC will remove the caulking from one end of each U-Rib, lift by crane the opposite end to allow any water to flow out, then re-seal.

This response is not acceptable. The proposed resolution addresses how to remove water from deck panels. However, it does not address two other important issues: 1) verifying that water contamination has not caused corrosion to the interior of the closed ribs, and 2) storing panels in a manner that will protect them from the weather.

The water which poured from the inside of the closed ribs was rusty, which may indicate that corrosion has occurred inside the closed ribs. Propose a method to verify that the water has not caused corrosion damage to the interior of the closed ribs. Also, inform the Department in advance of performing this verification in order to facilitate our witnessing of the verification.

Section 55-1.04 of the Standard Specifications requires that material be stored in a way to properly drain and be protected from corrosion. Please inform the Department what measures will be taken to protect the existing and future panels that will be stored outside from corrosion.

ZPMC workers removed water inside the U-Rib deck panels. The caulking (sikaflex-221) have been applied at the gaps between the diaphragm plates and deck panels. This corrective action is acceptable to control further corrosion inside the U-rib deck panels.
