Contract #: 04-0120F4Cty: SF/ALA Rte: 80 PM: 13.2/13.9File #: 69.25B**QUALITY ASSURANCE -- NON-CONFORMANCE REPORT****Location:** Changxing Island, Shanghai, PRC**Report No:** NCR-000224**Prime Contractor:** American Bridge/Fluor Enterprises, a JV**Date:** 26-Dec-2008**Submitting Contractor:** Zhenhua Port Machinery Company, Ltd (ZPMC), Changxing Island**NCR #:** ZPMC-0199**Type of problem:**

Welding	Concrete	Other	
Welding	Curing	Procedural	Bridge No: 34-0006
Joint fit-up	Coating	Other	Component: East Tower, Lift 1
Procedural	Procedural	Description: 15mm Tower Fit Lug Welds

Job Name: SAS Superstructure

Subject: NCR No. ZPMC-0199

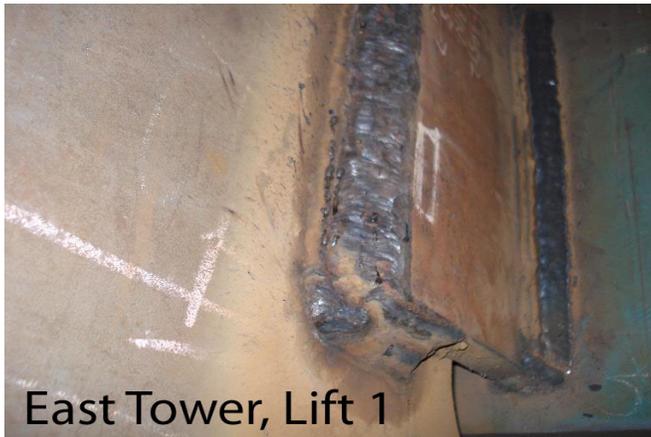
It was observed by QA that cascading of weld passes at termination was not being performed. The proposed 15mm fit lug weld detail notes "Cascade and grind terminations or cascade and fill craters complete (prior to ceasing the arc on each pass)." The following digital photographs depict the fit lug weld observed in East Tower-Lift 1 and the approved weld on the 89m mock-up.

ZPMC informed ABF that the welder performing this weld was not involved in the Mock-up, thus resulting in a weld not being completed per the pre-determined fabrication procedure. As the picture shows, the weld is not in a final condition and was subsequently ground to the proper contour and no defects detected. As a preventative measure, ABF/CT have instituted a training program for both welders and grinders. This specific case of fit lug welding and grinding is one of the training subjects.

Propose a resolution for the identified non-conformance with revised procedures to prevent future occurrences.

Perform weld repairs.

All affected fit lug welds in East Tower, Lift 1 have been repaired and green tagged.
