Contract #: 04-0120F4Cty: SF/ALA Rte: 80 PM: 13.2/13.9File #: 69.25B**QUALITY ASSURANCE -- NON-CONFORMANCE REPORT****Location:** Changxing Island, Shanghai, PRC**Report No:** NCR-000225**Prime Contractor:** American Bridge/Fluor Enterprises, a JV**Date:** 04-Jan-2009**Submitting Contractor:** Zhenhua Port Machinery Company, Ltd (ZPMC), Changxing Island**NCR #:** ZPMC-0200**Type of problem:**

<b>Welding</b>	<b>Concrete</b>	<b>Other</b>	
<b>Welding</b>	<b>Curing</b>	<b>Procedural</b>	<b>Bridge No:</b> 34-0006
<b>Joint fit-up</b>	<b>Coating</b>	<b>Other</b>	<b>Component:</b> ESD1-Lift 1
<b>Procedural</b>	<b>Procedural</b>	<b>Description:</b> Skin E, Longitudinal Stiffener E3 - 33m diaphragm

**Reference Description:** Incomplete fit lug weld terminations**Description of Non-Conformance:**

**Job Name:** SAS Superstructure  
**Document No:** 05.03.06-000194

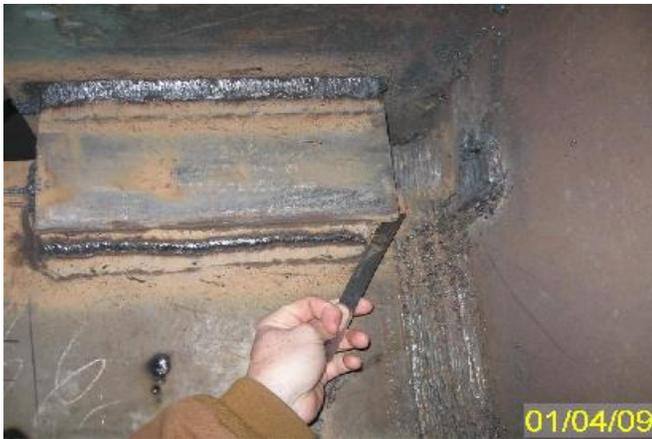
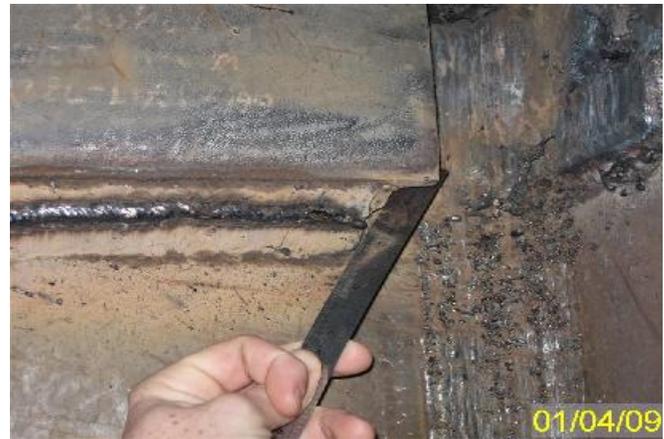
It was observed by QA that welds had been improperly terminated at the end of Partial Joint Penetration (PJP) weld joints. ZPMC weld personnel failed to ensure that weld metal was completely deposited in a manner that would ensure a sound weld.

AWS D1.5 / 2002, Section 3.12.1, "Welds shall be terminated at the end of a joint in a manner that will ensure sound welds. Whenever possible, this shall be done by use of weld tabs (extension bars and runoff plates) placed in a manner that will duplicate the joint detail being welded."

The weld termination is not acceptable, however, extension bars and run-off plates are not possible to be used in this case. As the picture shows, the weld in question is not complete, since the time of this NCR, the weld has been completed with no defects noted. As a preventative measure, ABF/CT have instituted a training program for both welders and grinders. This specific case of fit lug welding and grinding is one of the training subjects.

Propose a resolution for the identified non-conformance with revised procedures to prevent future occurrences.

Perform weld repairs.

All affected fit lug welds in East Tower, Lift 1 have been repaired and green tagged.
