Contract #: 04-0120F4Cty: SF/ALA Rte: 80 PM: 13.2/13.9File #: 69.25B**QUALITY ASSURANCE -- NON-CONFORMANCE REPORT****Location:** Changxing Island, Shanghai, PRC**Report No:** NCR-000226**Prime Contractor:** American Bridge/Fluor Enterprises, a JV**Date:** 04-Jan-2009**Submitting Contractor:** Zhenhua Port Machinery Company, Ltd (ZPMC), Changxing Island**NCR #:** ZPMC-0201**Type of problem:**

Reference Description: Premature removal of PJP fit lug "dogs"**Description of Non-Conformance:**

Job Name: SAS Superstructure

Subject: NCR No. ZPMC-0201

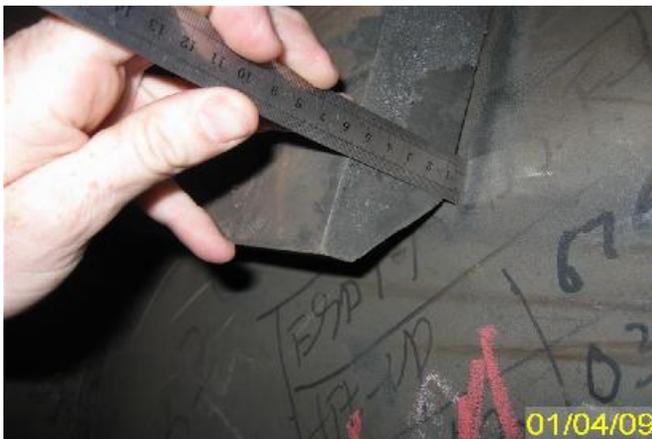
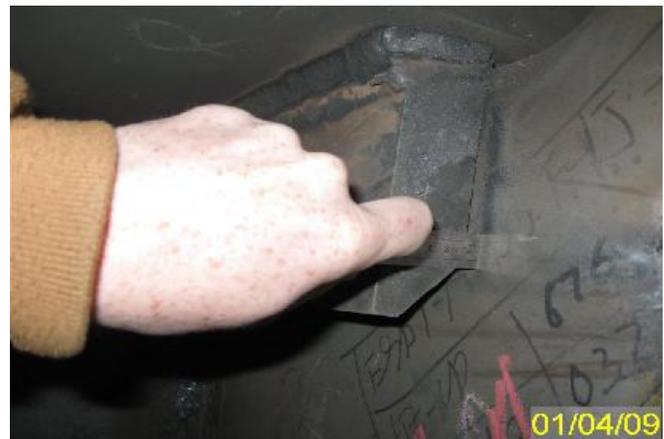
It was observed by QA that ZPMC welding personnel welded East Shaft, Lift 1, Skin C, fit lug partial joint penetration welds out of sequence. The Partial Joint Penetration (PJP) weld connecting the fit-lug to the longitudinal stiffener was completed. The "dog" securing the fit-lug to diaphragm plate was removed, prior to welding the fit lug to diaphragm.

The PJP fit lug welding sequence, as outlined in Submittal ABF-SUB-000101R03, indicates that final PJP weld passes must be completed for the fit lug to longitudinal stiffener welds and the fit lug to diaphragm welds prior to removing "dogs."

ZPMC applied the dogs incorrectly resulting in a condition where they could not finish the weld unless the dog was removed. The weld was subsequently finished without the dog in place without defects noted. ZPMC now does not remove the dogs until all welding is complete. As a preventative measure, ABF/CT have instituted a training program for both welders and grinders. This specific case of fit lug welding and grinding is one of the training subjects.

This is inconsistent with the fabrication procedure used for the successful completion of the partial mock-up. Propose a resolution for the identified non-conformance with the revised procedures to prevent future occurrences.

Remind ZPMC to follow the approved fit lug fabrication procedure and remove "dogs" only after weld completion.

ZPMC has been following the approved fit lug fabrication procedure and removing "dogs" only after weld completion. All affected fit lug welds in East Tower, Lift 1 have been green tagged.
