Contract #: 04-0120F4Cty: SF/ALA Rte: 80 PM: 13.2/13.9File #: 69.25B**QUALITY ASSURANCE -- NON-CONFORMANCE REPORT****Location:** Changxing Island, Shanghai, P.R. China**Report No:** NCR-000229**Prime Contractor:** American Bridge/Fluor Enterprises, a JV**Date:** 13-Feb-2009**Submitting Contractor:** Zhenhua Port Machinery Company, Ltd (ZPMC), Changxing Island**NCR #:** ZPMC-0204**Type of problem:**

Reference Description: Missing MT inspections after grinding of arc strikes**Description of Non-Conformance:**

Job Name: SAS Superstructure

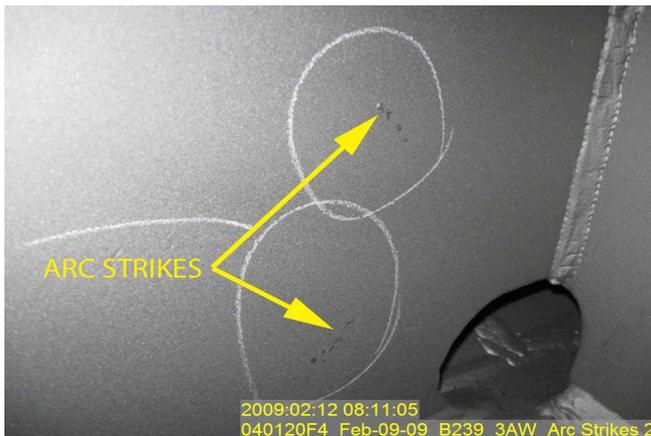
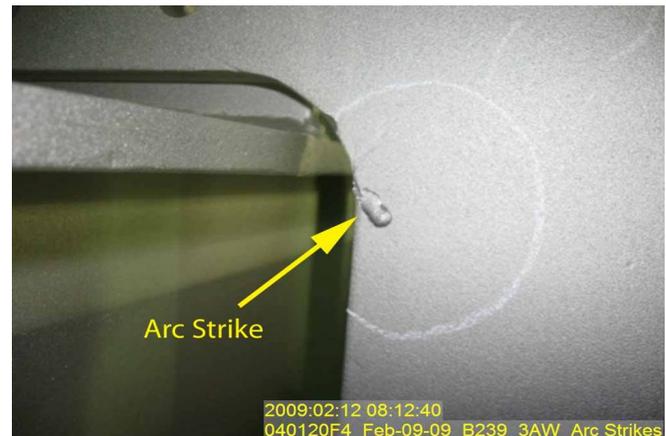
QA Inspector performed a preliminary random visual inspection after the grit blast of the internal components of the bottom panel and side panel super assemblies of segment 3AW. Arc strikes were found in various locations on the bottom and side plating components. ZPMC QC personnel were made aware of these locations and repairs were made by grinding without carrying out magnetic particle inspection as per section 9.2.2.1 of the ZPMC Welding Quality Control Plan (WQCP).

ABFJV has reminded ZPMC that arc strikes as well as temporary attachment removal areas require MT after grinding and prior to painting. ABFJV has conducted documented training with CWI and MT inspectors regarding this issue and have also reviewed this NCR during the training session. With the attached data, ZPMC requests closure of this NCR.

ZPMC has identified the arc strike areas, ground them and performed MT as required. Attached are the results of the MT inspection. ZPMC requests closure of this NCR.

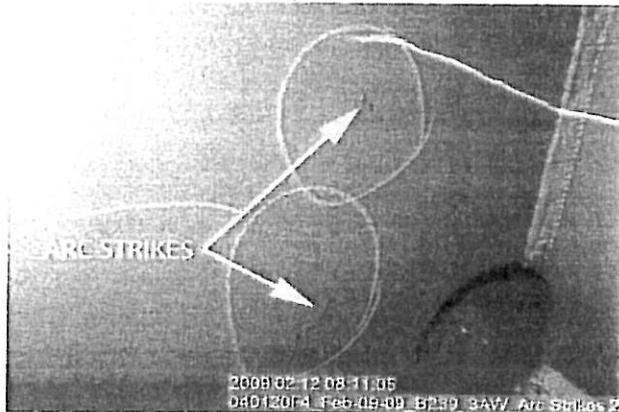
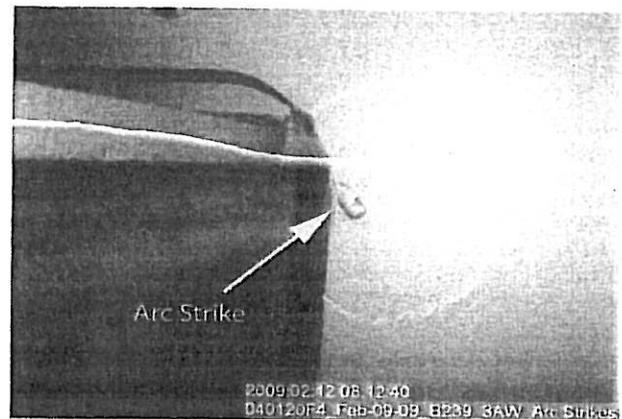
QA Inspector performed a preliminary random visual inspection after the grit blast of the internal components of the bottom panel and side panel super assemblies of segment 3AW. Arc strikes were found in various locations on the bottom and side plating components. ZPMC QC personnel were made aware of these locations and repairs were made by grinding without carrying out magnetic particle inspection as per section 9.2.2.1 of the ZPMC Welding Quality Control Plan (WQCP).

Grind all areas where arc strikers were documented and perform required NDT.

Contractor ground all areas in question and submitted MT report verifying base metal was not damaged.
