Contract #: 04-0120F4Cty: SF/ALA Rte: 80 PM: 13.2/13.9File #: 69.25B**QUALITY ASSURANCE -- NON-CONFORMANCE REPORT****Location:** Changxing Island, Shanghai, PRC**Report No:** NCR-000230**Prime Contractor:** American Bridge/Fluor Enterprises, a JV**Date:** 23-Feb-2009**Submitting Contractor:** Zhenhua Port Machinery Company, Ltd (ZPMC), Changxing Island**NCR #:** ZPMC-0205**Type of problem:**

Reference Description: South Shaft, Lift 1 PJP Fit Lug Improper Weld Terminations**Description of Non-Conformance:**

Job Name: SAS Superstructure

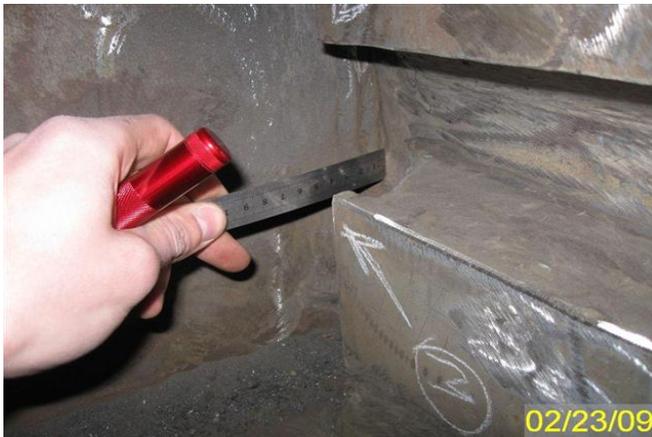
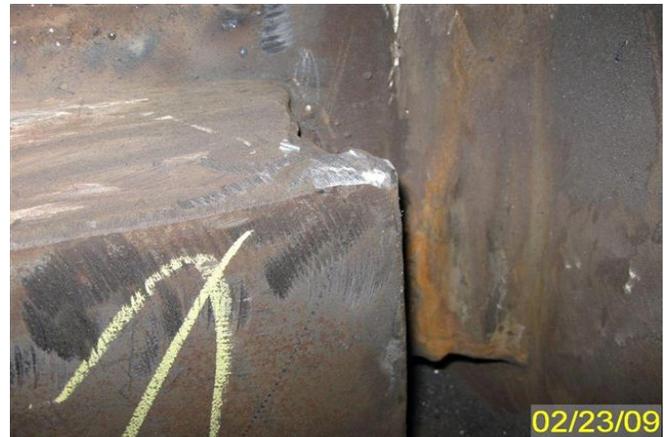
QA observed welds that had been improperly terminated at the end of Partial Joint Penetration (PJP) fit lug weld joints. ZPMC weld personnel failed to ensure that weld metal was deposited in a manner that would ensure a sound weld.

AWS D1.5 / 2002, Section 3.12.1: "Welds shall be terminated at the end of a joint in a manner that will ensure sound welds. Whenever possible, this shall be done by use of weld tabs (extension bars and runoff plates) placed in a manner that will duplicate the joint detail being welded."

Perform weld repairs.

All affected fit lug welds in South Tower, Lift 1 have been repaired and green tagged.
