**DEPARTMENT OF TRANSPORTATION**

Contract #: 04-0120F4Cty: SF/ALA Rte: 80 PM: 13.2/13.9File #: 69.25B**QUALITY ASSURANCE -- NON-CONFORMANCE REPORT****Location:** Changxing Island, Shanghai, P.R. China**Report No:** NCR-000237**Prime Contractor:** American Bridge/Fluor Enterprises, a JV**Date:** 28-Mar-2009**Submitting Contractor:** Zhenhua Port Machinery Company, Ltd (ZPMC), Changxing Island**NCR #:** ZPMC-0211**Type of problem:**

**Job Name:** SAS Superstructure

**Subject:** NCR No. ZPMC-0211

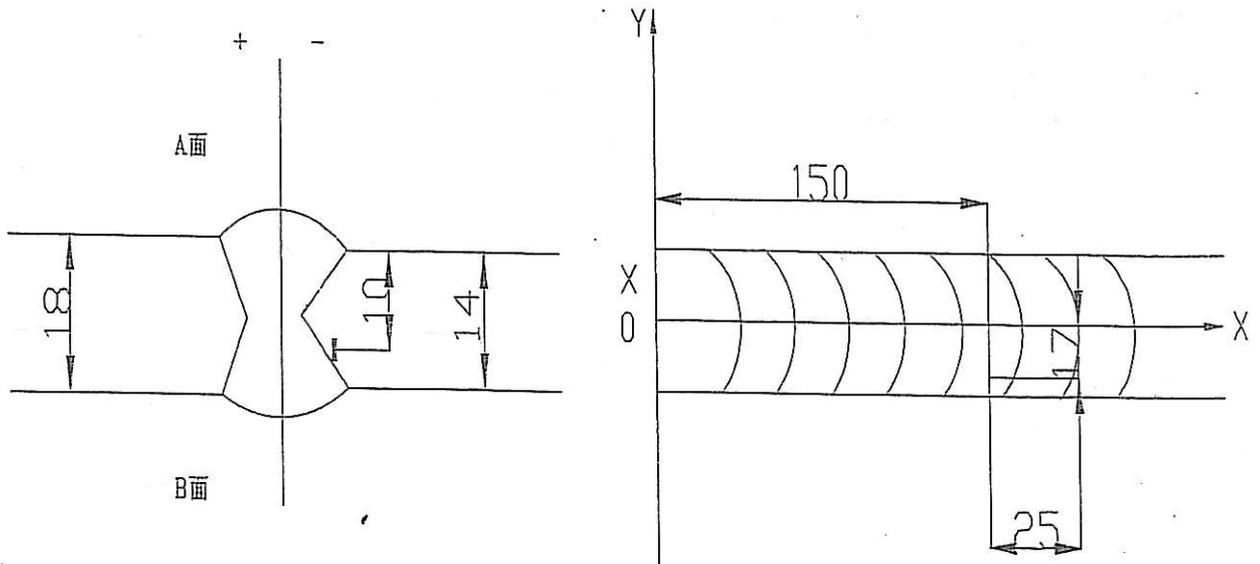
WELD NUMBER: CB202D-001-001

Rejected indication found by ultrasonic inspection is less than the maximum allowance aggregate length.

(UT探伤发现的缺陷总长度小于最大允许长度。) CB202D-001-001

1. Did not clear the weld pass completely in time.

参照的WPS编号 Repair WPS No.	WPS-345-SMAW-1 G(1F)-FCM-Repair WPS-345-FCAW-1 G(1F)-FCM-Repair	工艺员 technologist	<i>Niu Tiefeng</i> <i>09.03.25</i>
返修(碳刨)前预热温度 Preheat temperature before gouging	<i>76°C</i>	返修的缺陷 Description of discontinuity	<i>Slag</i>
焊前处理检查 Inspection before welding	<i>Acc</i>	焊前预热温度 Preheat temperature before welding	<i>100°C</i>
最大碳刨深度 Max. depth of gouging	<i>5mm</i>	碳刨总长 Total length of gouging	<i>100mm</i>
焊工 welder	<i>Yao Xuhe</i> <i>057795</i>	焊接类型 welding type	<i>SMAW</i>
焊接电流 Current	<i>130</i>	焊接电压 Voltage	<i>243</i>
		焊接位置 position	<i>1G</i>
		焊接速度 Speed	<i>110mm/min</i>

1. Gouge or grind from nearer side from metal edge ( $D \leq 0.65T$ , "D" is depth of defects, "T" is thickness of metal) to remove all defects;
2. Follow repair WPS for joint preparation, preheat, and weld deposit;
3. Verify with VT no defects remain in the weld joint prior to welding;
4. Grind the repaired area flush with base metal or the adjacent weld;
5. Check the welds according to the working drawings.

1. Improve monitoring of welding and interpass cleaning.
