Contract #: 04-0120F4Cty: SF/ALA Rte: 80 PM: 13.2/13.9File #: 69.25B**QUALITY ASSURANCE -- NON-CONFORMANCE REPORT****Location:** Changxing Island, Shanghai, P.R. China**Report No:** NCR-000238**Prime Contractor:** American Bridge/Fluor Enterprises, a JV**Date:** 28-Mar-2009**Submitting Contractor:** Zhenhua Port Machinery Company, Ltd (ZPMC), Changxing Island**NCR #:** ZPMC-0212**Type of problem:****Welding****Concrete****Other****Welding****Curing****Procedural****Bridge No:** 34-0006**Joint fit-up****Coating****Other****Component:** Segment 1BE: Floor Beam to Bottom Plate**Procedural****Procedural****Description:****Reference Description:** QA Inspector found additional MT indications**Description of Non-Conformance:**

Job Name: SAS Superstructure

Subject: NCR No. ZPMC-0212

Reference Description: QA Inspector found additional MT indications

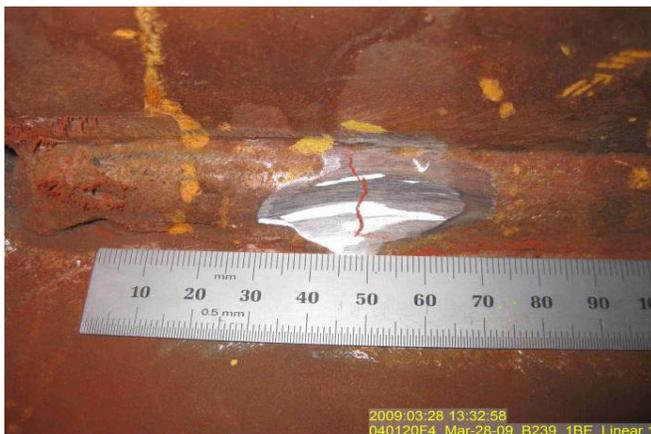
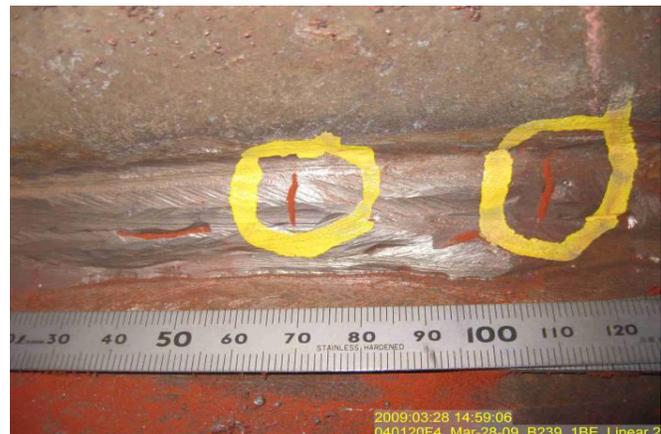
During random verification Magnetic Particle Testing (MT) of floor beam to bottom plate weld numbers SSD45-PP10.5-107, SSD49-PP12-106 and SSD49-PP12-107, Caltrans Quality Assurance (QA) Inspector discovered a total of eight (8) transverse linear indications ranging from 10 to 30mm in length. These linear indications were not found when Contractor performed 25% MT inspections.

AWS D1.5 (2002) - Section 6.26.2, "Welds that are subject to MT in addition to visual inspection shall have no cracks."

Reference Resolution: ZPMC has generated an internal NCR for this nonconformance, repaired and re-inspected the welds as required. ZPMC requests this NCR be closed.

Please provide documentation of the weld repairs that were performed and that the repairs were acceptable. The Department will review the Contractor's proposal to close Non-Conformance ZPMC-0212 at that time.

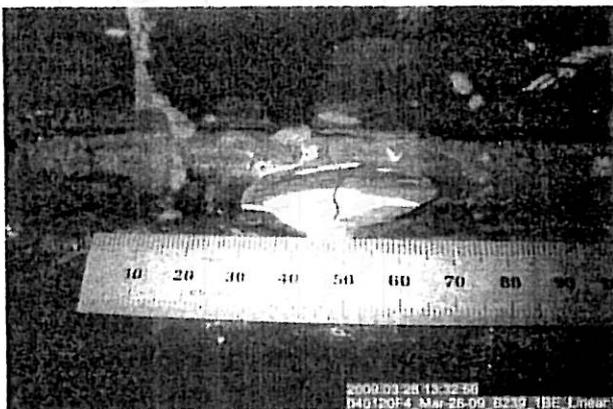
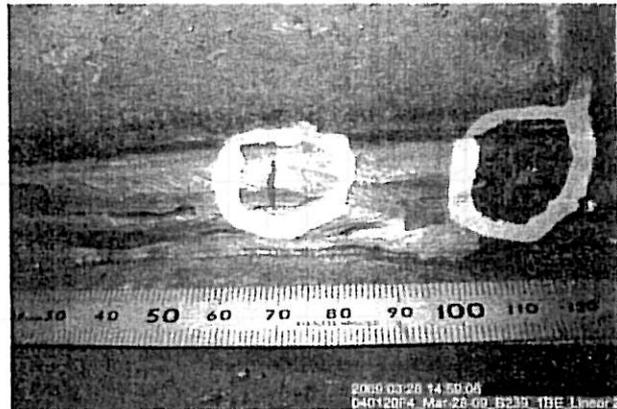
During random verification Magnetic Particle Testing (MT) of floor beam to bottom plate weld numbers SSD45-PP10.5-107, SSD49-PP12-106 and SSD49-PP12-107, Caltrans Quality Assurance (QA) Inspector discovered a total of eight (8) transverse linear indications ranging from 10 to 30mm in length. These linear indications were not found when Contractor performed 25% MT inspections.

AWS D1.5 (2002) - Section 6.26.2, "Welds that are subject to MT in addition to visual inspection shall have no cracks."

ZPMC QC inspectors to received training in regards to performing MT inspections in conformance with Section 6.26.2 of AWS D 1.5. The welds in question were repaired and accepted.

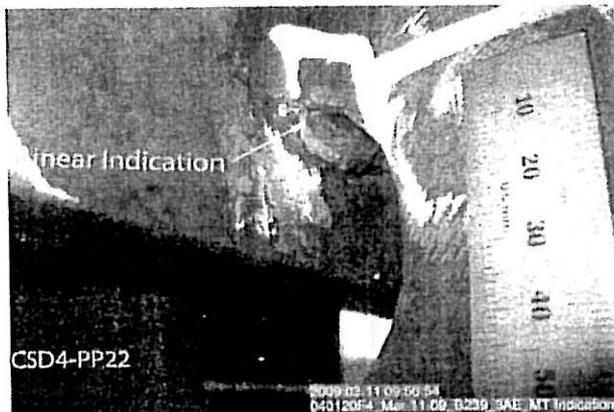
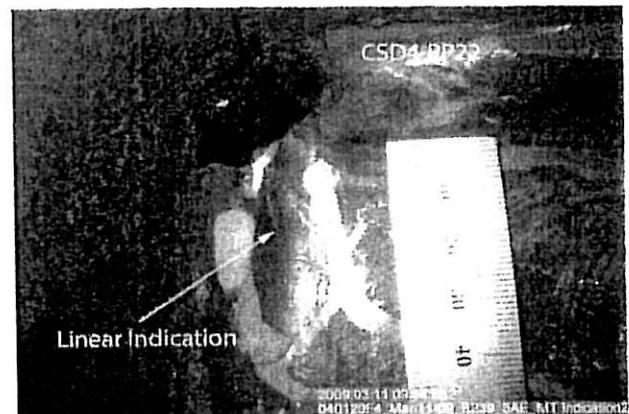
On March 10, 2009, ZPMC Quality Control (QC) representative Mr. Wang Lu notified Caltrans Quality Assurance (QA) inspector of the re-inspection of the corner assembly components by Magnetic Particle Testing (MT) of the linear indications discovered by QA inspectors on Segment 3AE Green Tag #8. Caltrans QA performed MT the second time on the following corner assembly welds: CSD4-PP22-069, CSD4-PP22-071, CSD4-PP22-073 and CSD4-PP22-134. Caltrans QA Inspector discovered additional linear indications ranging from 10 to 25mm long.

AWS D1.5 (02) Section 6.26.2 – “Welds that are subject to MT in addition to visual inspection shall have no cracks.”

扩大比例检测,对有裂纹的地方进行返修。

Enlarge inspection rate, and repair the crack area.

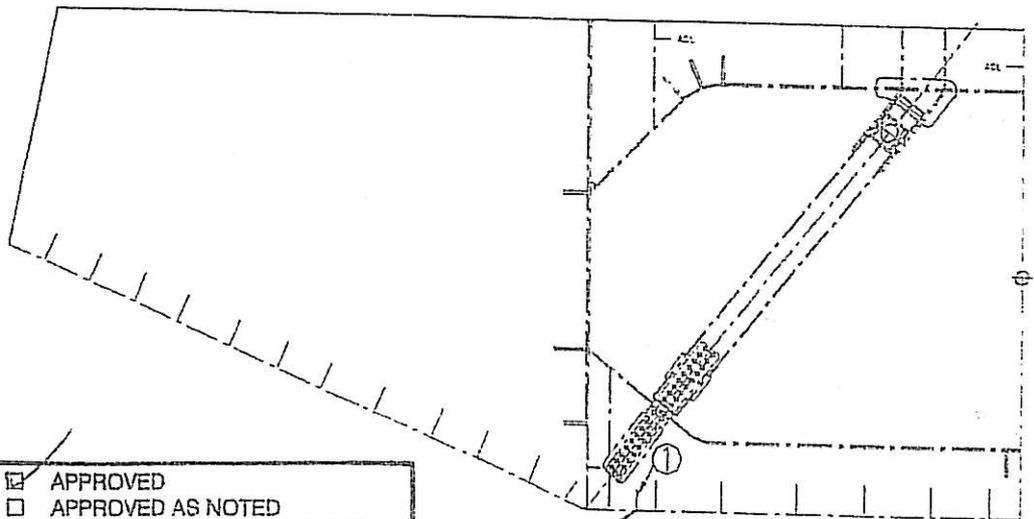
Draft of Welding Discontinuity:

A transverse crack was detected by MT in weld SSD45-PP10.5-107. Please see the Draft below.
(MT探伤发现焊缝上有1处横向裂纹。)

1. 火焰加热时, 水汽没有完全的去掉或者这个区域预热不够;
1. Moisture wasn't completely removed during drying operation (preheating) or the area wasn't preheated sufficiently.

1. QC and a Lead CWI shall be present and direct all gouging, grinding and welding operations during this repair.
2. QC and a Lead CWI shall have an approved copy of the CWR in hand and shall be at the repair location during the entire repair.

3. QC and a Lead CWI shall direct the repair to ensure the repair is per the disposition requirements.
4. Prepare the repair joint according to the relevant repair WPS.

5. Remove all indications by grinding.
6. Grind repair areas smooth to a shiny finish with tapered ends to ensure staggered stops and starts.
7. Perform VT and MT inspection.

8. QC and a Lead CWI shall verify and document all indications have been removed prior to repair welding.
9. Follow the repair WPS for preheat and weld deposition.

12. Grind and blend the repaired area flush with base metal and adjacent weld.
13. Check the welds according to the working drawings.

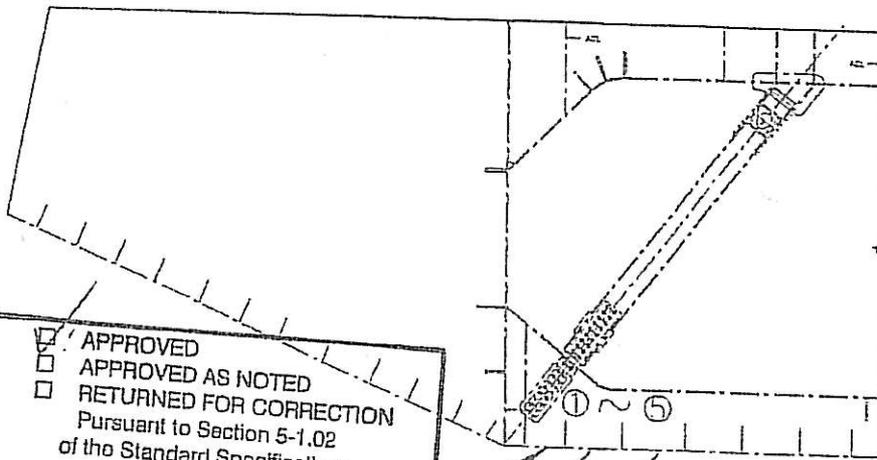
Draft of Welding Discontinuity:

In welds SSD49-PP12-106/107/108/109/110, a transverse crack was detected by MT in each weld. X, Y show the distance on X, Y axis.

In welds SSD49-PP12-106/107/108/109/110, transverse cracks were detected by MT in each weld. Please see the detail position in the sketch below. The details are as following.

1. 火焰加热时, 水汽没有完全的去掉或者这个区域预热不够;
1. Moisture wasn't completely removed during drying operation (preheating) or the area wasn't preheated sufficiently.

1. QC and a Lead CWI shall be present and direct all gouging, grinding and welding operations during this repair.
2. QC and a Lead CWI shall have an approved copy of the CWR in hand and shall be at the repair location during the entire repair.

3. QC and a Lead CWI shall direct the repair to ensure the repair is per the disposition requirements.
4. Prepare the repair joint according to the relevant repair WPS.

5. Remove all indications by grinding.
6. Grind repair areas smooth to a shiny finish with tapered ends to ensure staggered stops and starts.
7. Perform VT and MT inspection.

8. QC and a Lead CWI shall verify and document all indications have been removed prior to repair welding.
9. Follow the repair WPS for preheat and weld deposition.

12. Grind and blend the repaired area flush with base metal and adjacent weld.
13. Check the welds according to the working drawings.
