Contract #: 04-0120F4Cty: SF/ALA Rte: 80 PM: 13.2/13.9File #: 69.25B**QUALITY ASSURANCE -- NON-CONFORMANCE REPORT****Location:** Changxing Island, Shanghai, P.R. China**Report No:** NCR-000239**Prime Contractor:** American Bridge/Fluor Enterprises, a JV**Date:** 25-Mar-2009**Submitting Contractor:** Zhenhua Port Machinery Company, Ltd (ZPMC), Changxing Island**NCR #:** ZPMC-0213**Type of problem:****Welding****Concrete****Other****Welding****Curing****Procedural****Bridge No:** 34-0006**Joint fit-up****Coating****Other****Component:** OBG U-Rib Deck Panels**Procedural****Procedural****Description:****Reference Description:** Deck panel distortion due to excessive welding repair**Description of Non-Conformance:**

Reference Description: Deck panel distortion due to excessive welding repair

SAN FRANCISCO OAKLAND BAY BRIDGE, EAST SPAN SELF-ANCHORED SUSPENSION SPAN
 ROUTE 80 EAST OF YERBA BUENA ISLAND, DISTRICT 04, SF COUNTY, CA.
 BRIDGE Nos: 34-0008L PM B.2, KP 13.2 & 34-0008R PM B.7, KP 13.9
 STATE OF CALIFORNIA DEPT. OF TRANSPORTATION CONTRACT NO. 04-0120F4
 ENGINEER: CALTRANS --- T. YILIN / MOFFATT & NICHOL, JV.
 CONTRACTOR: AMERICAN BRIDGE / FLUOR ENTERPRISES, JV.
 repair procedu

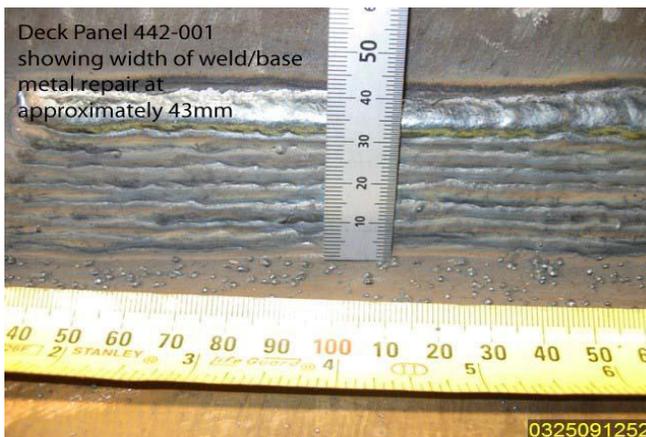
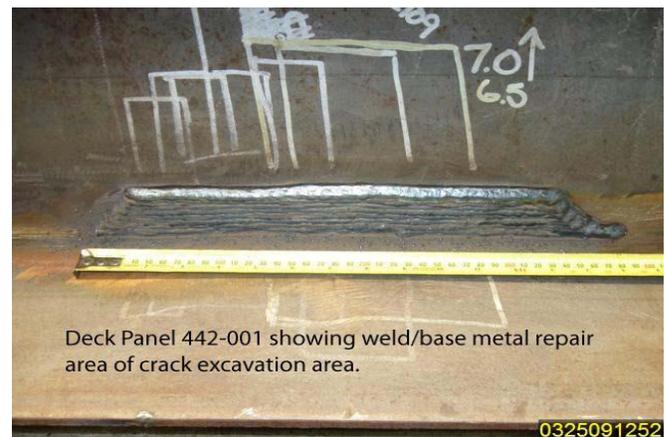
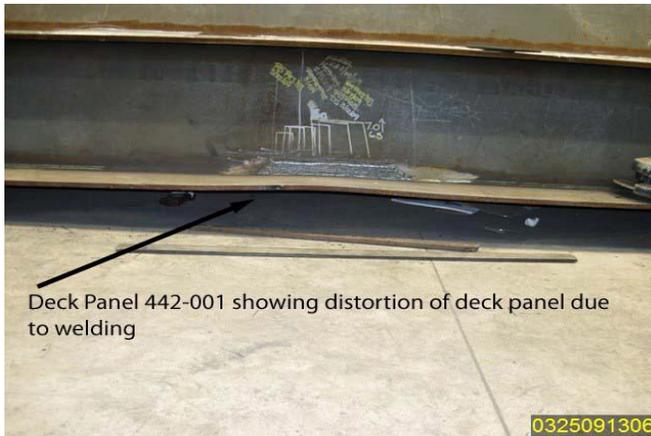
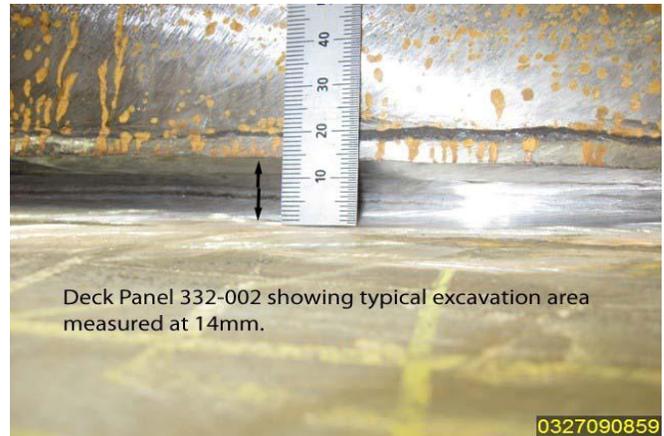
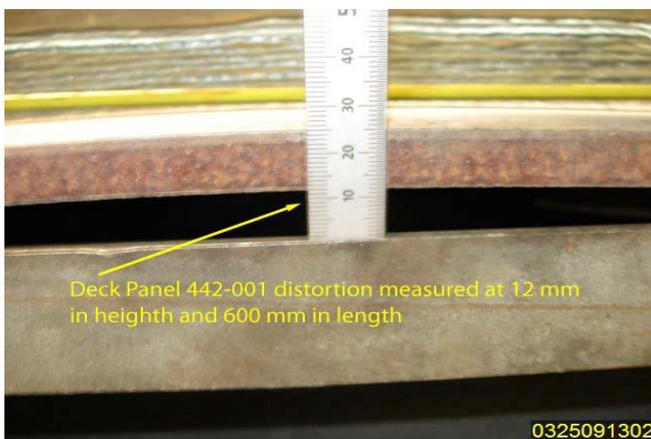
Caltrans Quality Assurance (QA) Inspector observed ZPMC welders performing base metal repairs on closed ribs of the deck panels. The repairs were located above the excavated cracks on the PJP weld joint for DP442-001, DP332-002, DP492-001, DP249-001, DP442-001, DP305-001, DP357-001, DP495-001, DP469-001, DP330-002, and DP415-001.

QA Inspector observed excessive welding on these repair area. Shortly after the welding, QA Inspector also noted the distortion of the deck panels. Also, QA Inspector confirmed with ZPMC QC Inspector Mr. Sun Bo that the repairs were done without an approved base metal repair procedure. These welding repairs were not performed according to the project requirements.
