Quality Assurance and Source Inspection

Contract #: 04-0120F4Cty: SF/ALA Rte: 80 PM: 13.2/13.9File #: 69.25B**QUALITY ASSURANCE -- NON-CONFORMANCE REPORT****Location:** Changxing Island, Shanghai, P.R. China**Report No:** NCR-000243**Prime Contractor:** American Bridge/Fluor Enterprises, a JV**Date:** 26-Feb-2009**Submitting Contractor:** Zhenhua Port Machinery Company, Ltd (ZPMC), Changxing Island**NCR #:** ZPMC-0217**Type of problem:**

Reference Description: Grinding of FB063-002 rib stiffener (RS) cutouts**Description of Non-Conformance:**

Job Name: SAS Superstructure
Document No: 05.03.06-000209

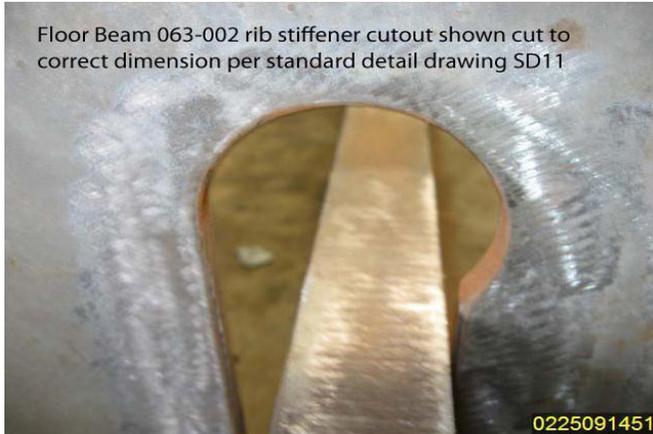
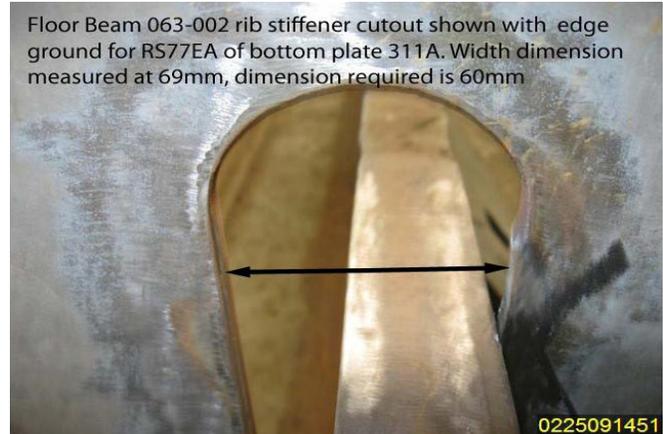
Caltrans Quality Assurance (QA) Inspector observed non-conformance on five floor beam cutouts for the bottom plate rib stiffeners (RS). These cutouts had been ground on one side to facilitate the fit-up with the RS. The approved shop drawing indicates that the floor beam cutout has a width of 60mm. ZPMC ground these cutouts to the following dimensions:

For bottom plate 309A:

RS77E cutout width: 68mm

RS78E cutout width: 66mm

For bottom plate 311A:

RS77EA cutout width: 69mm

RS87GA cutout width: 65mm

RS85C cutout width: 65mm

The fabrication of the floor beam cutouts for RS in segment 1AW is not according to the approved shop drawing.

The proposal to enlarge the web slots in SEG1AW is not acceptable.

Follow the repair procedure already provided in FCN 137A, which corrects the mislocated stiffener openings by cutting out the affected web and installing a patch plate.

Provide the locations where this procedure is required and the dimensions of the patch plate for review and approval by the Department's representatives at the fabrication shop.

As the 12mm web plates are welded to the bottom plate, provide 25mm rat holes in the web at the girder skin plate in order to perform the vertical butt joint on the web plate.

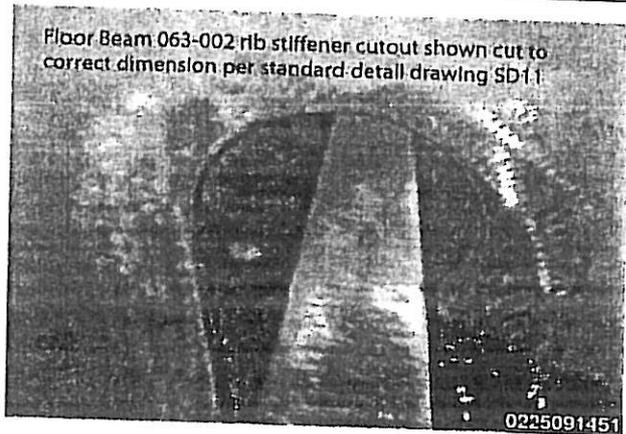
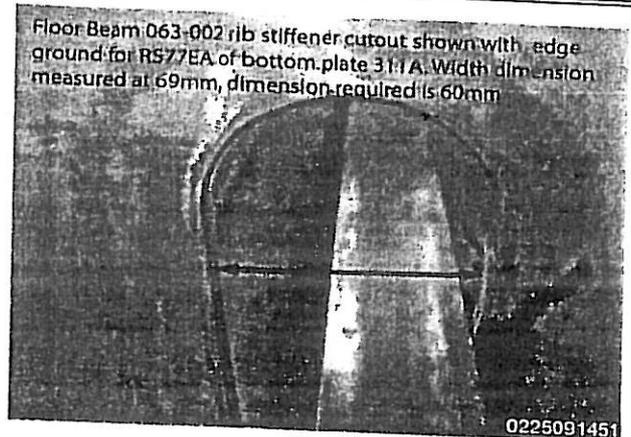
Caltrans Quality Assurance (QA) Inspector observed non-conformance on five floor beam cutouts for the bottom plate rib stiffeners (RS). These cutouts had been ground on one side to facilitate the fit-up with the RS. The approved shop drawing indicates that the floor beam cutout has a width of 60mm. ZPMC ground these cutouts to the following dimensions:

For bottom plate 309A:

RS77E cutout width: 68mm

RS78E cutout width: 66mm

For bottom plate 311A:

RS77EA cutout width: 69mm

RS87GA cutout width: 65mm

RS85C cutout width: 65mm

The fabrication of the floor beam cutouts for RS in segment IAW is not according to the approved shop drawing.

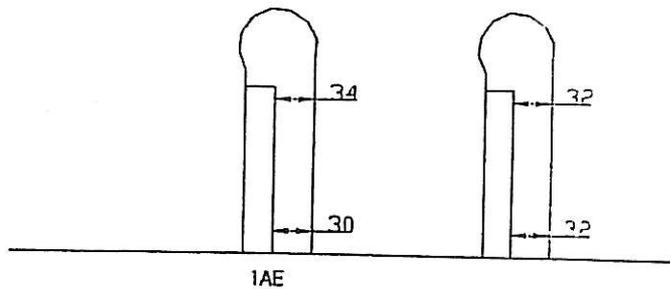
Draft of Welding Discontinuity:

1AE and 1AW box, the size between floor beam weld through hole and I-rib wasn't according to drawing requirement, 1AE(PP9) two position, 1AW (PP9) one position, it shall be 25mm according to drawing requirement, see the following draft.

Weld distortion and fabricate error.

1. QC and CWI should be present to witness the repair.
2. Grind the repairing area cleanly;
3. Prepare an right joint according to the approved WPS;
4. Perform 100%VT ^{± MT} to ensure no defects exist, and add steel backing before welding.
5. Preheat and weld according to the relevant WPS; and weld the unacceptable through holes to meet the requirement of work drawing;
6. Gouge off the steel backing after welding and then grind the weld flush with base metal.
7. Perform VT and MT ^{BOTH SIDES & WELD FRONT} inspection to the repaired area.
