Contract #: 04-0120F4Cty: SF/ALA Rte: 80 PM: 13.2/13.9File #: 69.25B**QUALITY ASSURANCE -- NON-CONFORMANCE REPORT****Location:** Changxing Island, Shanghai, PRC**Report No:** NCR-000244**Prime Contractor:** American Bridge/Fluor Enterprises, a JV**Date:** 07-Apr-2009**Submitting Contractor:** Zhenhua Port Machinery Company, Ltd (ZPMC), Changxing Island**NCR #:** ZPMC-0218**Type of problem:****Welding****Concrete****Other****Welding****Curing****Procedural****Bridge No:** 34-0006**Joint fit-up****Coating****Other****Component:** Deck Panels on 3AW, 3AE, 4BW**Procedural****Procedural****Description:****Reference Description:** Unapproved base metal welding and heat straightening**Description of Non-Conformance:**

Job Name: SAS Superstructure

Subject: NCR No. ZPMC-0218

Reference Description: Unapproved base metal welding and heat straightening

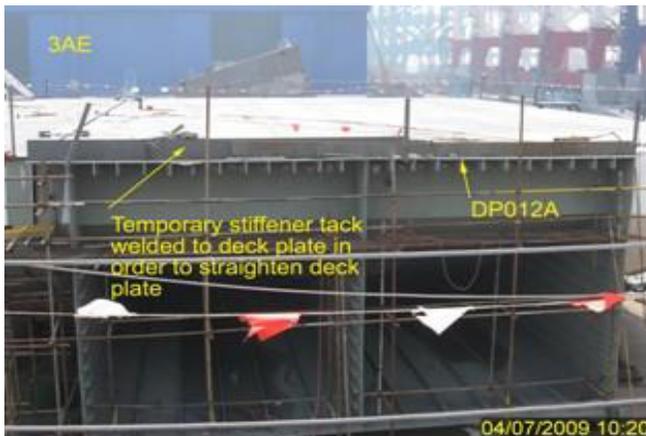
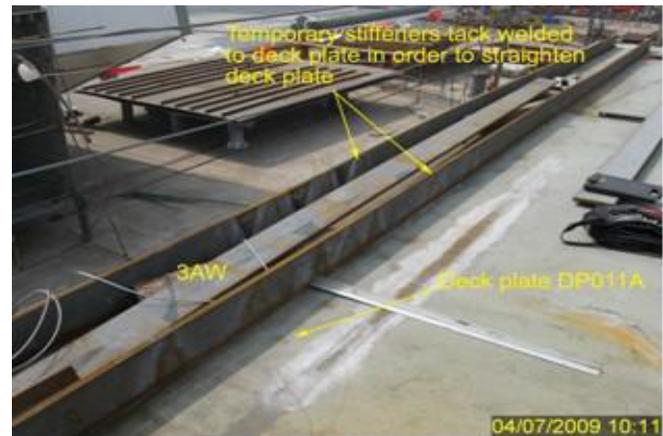
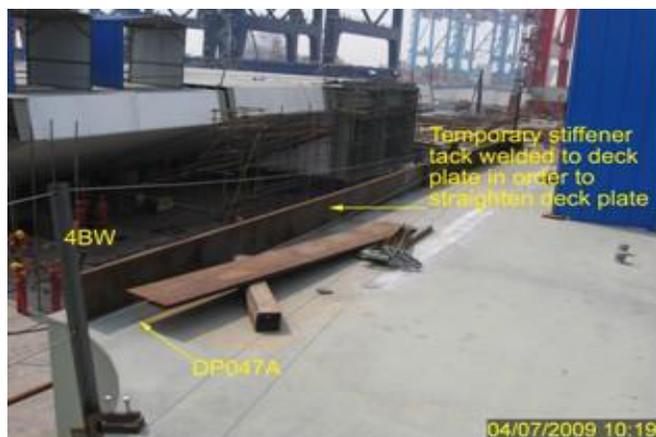
Quality Assurance Inspector observed that the Contractor welded temporary stiffener plates to deck panels DP011A (segment 3AW), DP012A (segment 3AE), and DP047A (segment 4BW) at the crossbeam locations. These stiffener plates and deck panels had heat straightened marks. The placement of these stiffener plates were not shown in the shop drawings and the fabrication procedures. The heat straightening operations were also not approved by the Engineer.

AWS D1.5 2002, Section 3.1.5 – “Welds shall be prohibited on the work except as follows:

AWS D1.5 2002, Section 3.7.3 – “Members distorted by welding shall be straightened by mechanical means or by carefully supervised application of a limited amount of localized heat as approved by the Engineer.”

For the areas where the temporary welds were removed, please provide documentation of the weld repairs that were performed and that the areas have been accepted by MT. The Department will review the Contractor's proposal to close Non-Conformance ZPMC-0218 at that time.

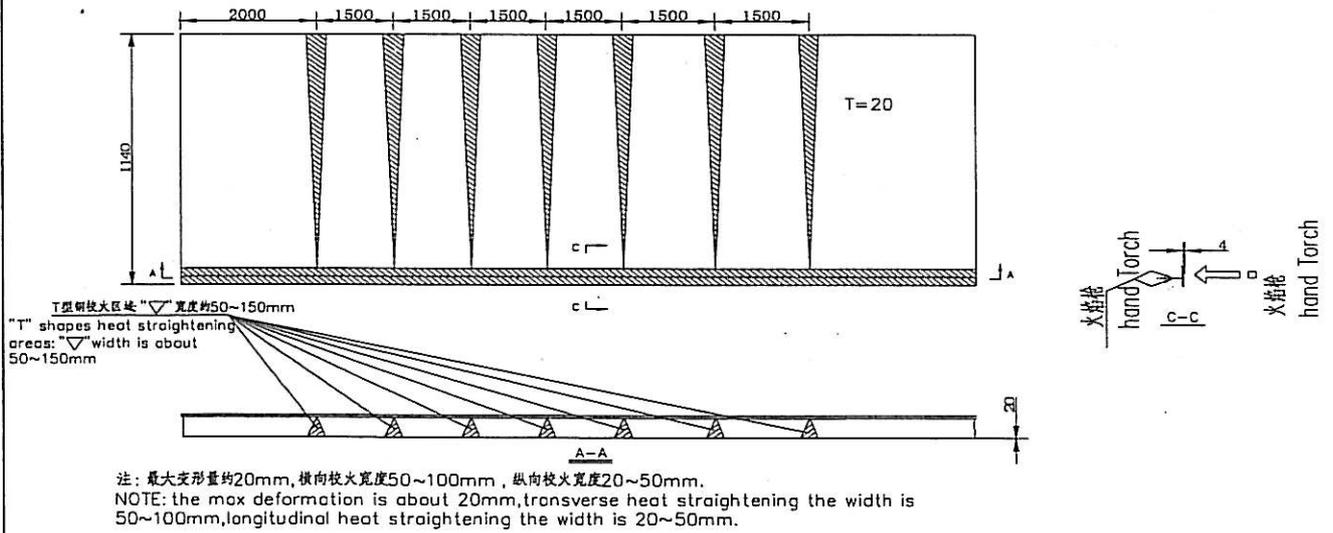
装配 Assembly:	质检代表/Quality Control Representative
部装 Sub-Assembly:	Xu Jun
梁段 Gird: 4BW DP47(A)	质检经理/Quality Assurance Manager-Approval
塔段 Tower: N/A	Lu Jianhua
焊缝号 Weld No: 038.039.040.041	
焊缝地图号 Weld Map No: SEG019

Cause原因 Welding distortion 焊接变形

Type of Defect缺陷类型 Welding distortion 焊接变形

缺陷去除方法(Defect Removal Method): Flame Straightening by oxygen acetylene

纠正措施(Corrective Action(s)): Control current, voltage and weld speed according to relevant WPS. If necessary anti-deformation or hold down device can be added.

最高温度(Maximum temperature): <650°C

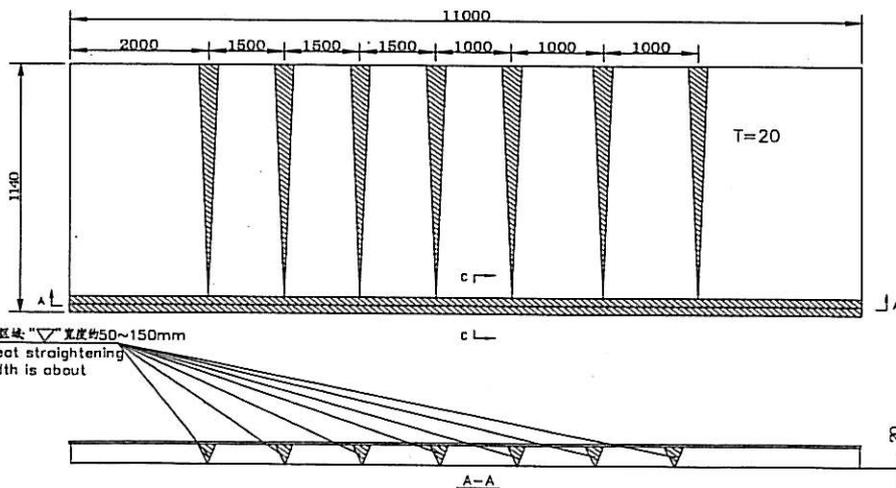
梁段 Gird: 3AE PL9B

Cause 原因 Welding distortion 焊接变形

T型梁火工区域: "T" 宽度的50~150mm
 "T" shapes heat straightening areas: "T" width is about 50~150mm

注: 最大变形量约20mm, 横向枝火宽度50~100mm, 纵向枝火宽度20~50mm.
 NOTE: the max deformation is about 20mm, transverse heat straightening the width is 50~100mm, longitudinal heat straightening the width is 20~50mm.

缺陷去除方法(Defect Removal Method): Flame Straightening by oxygen acetylene

Control current, voltage and weld speed according to relevant WPS. If necessary anti-deformation or hold down device can be added.

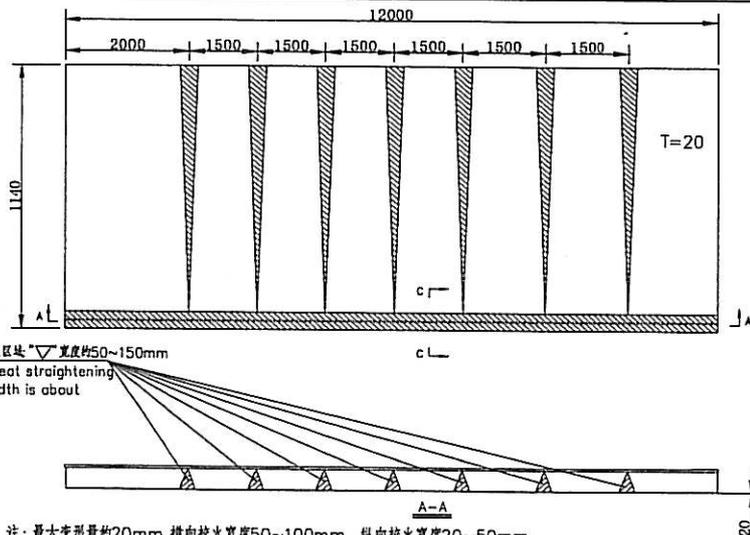
装配 Assembly:	质检代表/Quality Control Representative
部装 Sub-Assembly:	<i>In Yehong Aug. 3. 17</i>
梁段 Gird: 3AW DP11(A)	质检经理/Quality Assurance Manager-Approval
塔段 Tower: N/A	<i>Cujianhua</i>
焊缝号 Weld No: 045.046	
焊缝地图号 Weld Map No: SEG013

Cause 原因: Welding distortion 焊接变形
 Type of Defect 缺陷类型: Welding distortion 焊接变形
 Inspection Method 检查方法: Visual 目检

T型钢热火区: "T" shapes heat straightening areas: "V" width is about 50~150mm

注: 最大变形量约20mm, 横向热火宽度50~100mm, 纵向热火宽度20~50mm.
 NOTE: the max deformation is about 20mm, transverse heat straightening the width is 50~100mm, longitudinal heat straightening the width is 20~50mm.

缺陷去除方法 (Defect Removal Method): Flame Straightening by oxygen acetylene

纠正措施 (Corrective Action(s)): Control current, voltage and weld speed according to relevant WPS. If necessary anti-deformation or hold down device can be added.

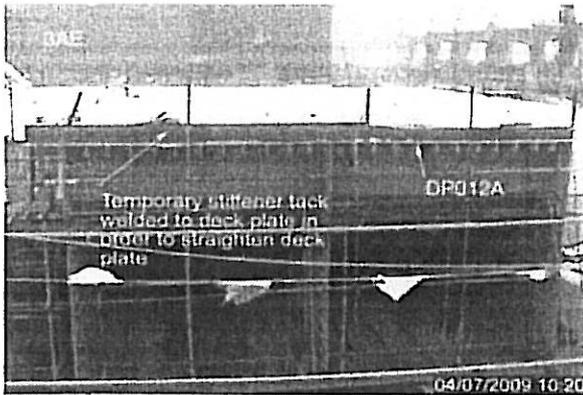
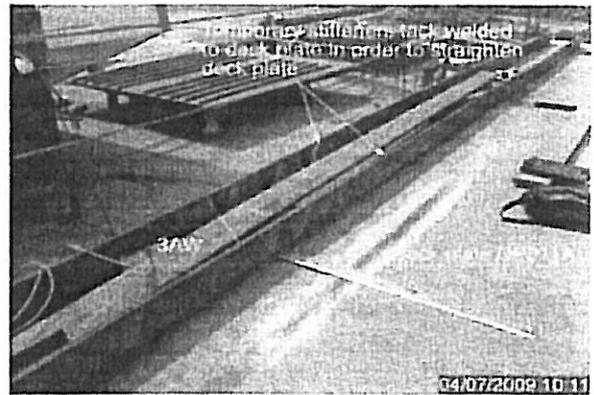
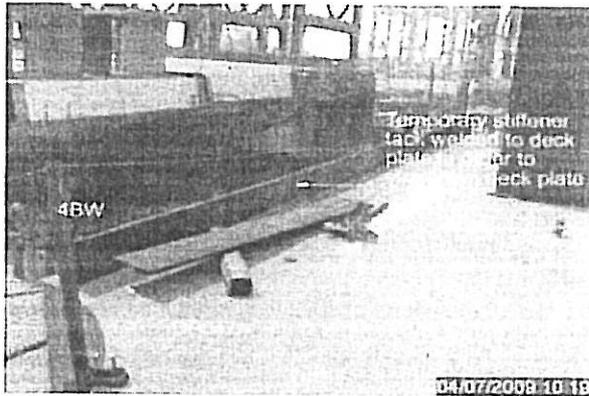
Quality Assurance Inspector observed that the Contractor welded temporary stiffener plates to deck panels DP011A (segment 3AW), DP012A (segment 3AE), and DP047A (segment 4BW) at the crossbeam locations. These stiffener plates and deck panels had heat straightened marks. The placement of these stiffener plates were not shown in the shop drawings and the fabrication procedures. The heat straightening operations were also not approved by the Engineer.
