Contract #: 04-0120F4
 Cty: SF/ALA Rte: 80 PM: 13.2/13.9
 File #: 69.25B

QUALITY ASSURANCE -- NON-CONFORMANCE REPORT

Report No: NCR-000249

Reference Description: Missed MT indication on Lift 2, East Tower, CD interior corner seam

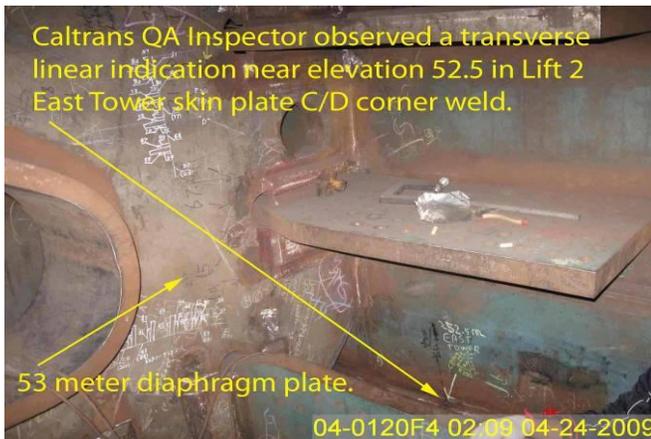
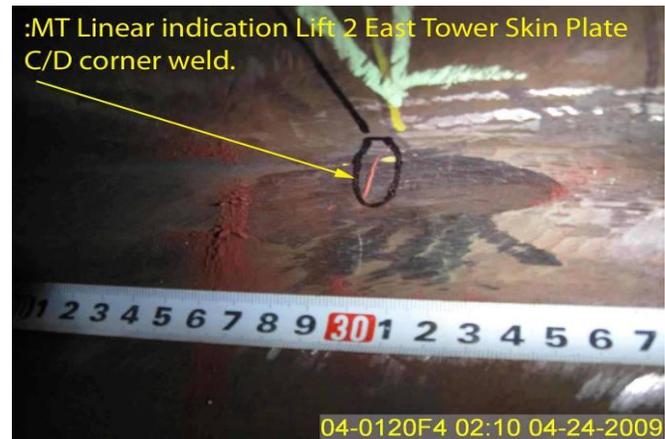
During random verification Magnetic Particle Testing (MT) of weld ESD1-TL7B/L-3A/B, QA discovered one transverse linear indication with a length of approximately 15mm. The weld is located at the skin plates C & D interior corner seam of East Tower, Lift 2. The "Y" location is approximately 52.5 meters. See the photographs below for additional information.

AWS D1.5 (2002) Section 6.26.2 – "Welds that are subject to MT in addition to visual inspection shall have no cracks"

Repair affected weld.

The affected weld has been repaired and a NDT report indicating a sound weld has been submitted. The weld has been verified by QA and green tagged.
