Contract #: 04-0120F4Cty: SF/ALA Rte: 80 PM: 13.2/13.9File #: 69.25B**QUALITY ASSURANCE -- NON-CONFORMANCE REPORT****Location:** Changxing Island, Shanghai, PRC**Report No:** NCR-000250**Prime Contractor:** American Bridge/Fluor Enterprises, a JV**Date:** 10-Apr-2009**Submitting Contractor:** Zhenhua Port Machinery Company, Ltd (ZPMC), Changxing Island**NCR #:** ZPMC-0224**Type of problem:**

**Reference Description:** East Shaft, Lift 2, Skin E Gusset Plate p650 welded at incorrect location**Description of Non-Conformance:**

**Job Name:** SAS Superstructure

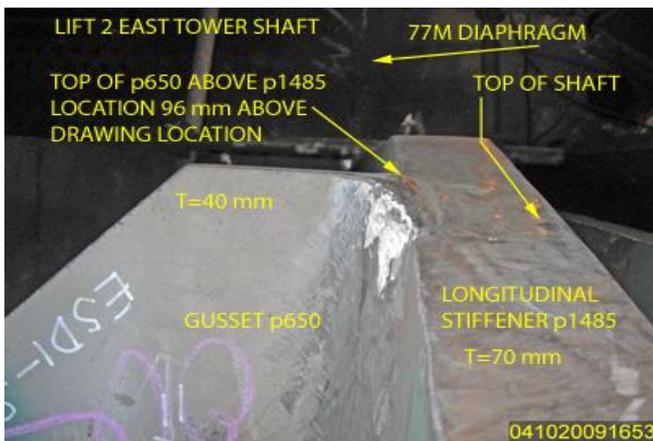
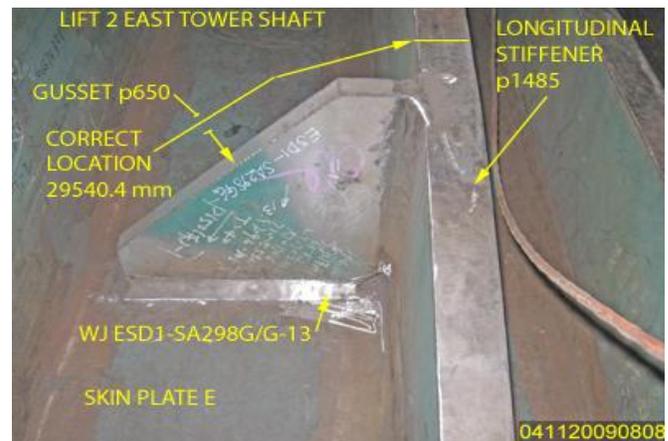
During a Final Visual Inspection per ZPMC NDT Inspection Notification Sheet 002605, QA observed that Gusset Plate p650 appeared to be in the wrong location. P650 is welded to Longitudinal Stiffener p1485 and Skin Plate E between the 77 m and 80.75 m Diaphragms in East Tower, Lift 2. The location specified in the shop drawings is 29540.4 mm from the bottom of p1485. The as-welded location is 29636 mm.

The proposed resolution is acceptable. The Request for Information (RFI-1723) regarding the location of this gusset plate was approved. The Department concurs that Non-Conformance ZPMC-0224 is closed.

It is acceptable to leave the fabricated kink in Stiffener E2 as-built 90mm higher than per plan provided the End PL elevation is consistent with approved shop drawing. Submit the affected drawings via the FCN process

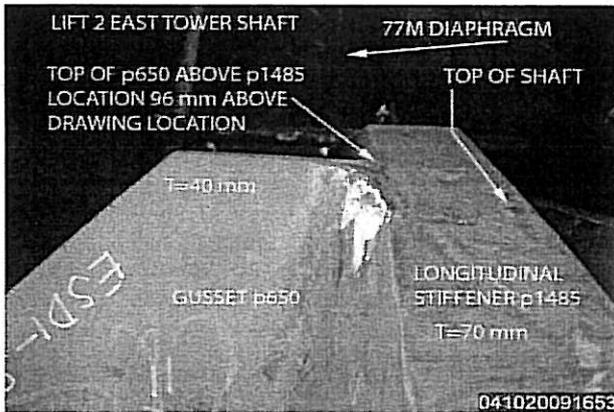
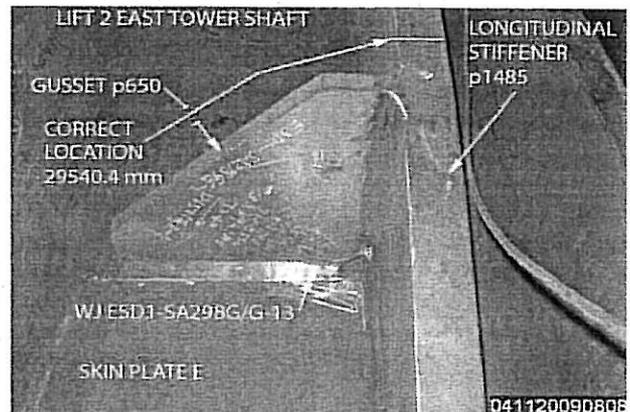
During a Final Visual Inspection per ZPMC NDT Inspection Notification Sheet 002605, QA observed that Gusset Plate p650 appeared to be in the wrong location. P650 is welded to Longitudinal Stiffener p1485 and Skin Plate E between the 77 m and 80.75 m Diaphragms in East Tower, Lift 2. The location specified in the shop drawings is 29540.4 mm from the bottom of p1485. The as-welded location is 29636 mm.

As stated in ABF-RFI-001723R00, it is acceptable to leave Kink Plate p650 at the as-built elevation.
