Contract #: 04-0120F4Cty: SF/ALA Rte: 80 PM: 13.2/13.9File #: 69.25B**QUALITY ASSURANCE -- NON-CONFORMANCE REPORT****Location:** Changxing Island, Shanghai, PRC**Report No:** NCR-000251**Prime Contractor:** American Bridge/Fluor Enterprises, a JV**Date:** 13-Apr-2009**Submitting Contractor:** Zhenhua Port Machinery Company, Ltd (ZPMC), Changxing Island**NCR #:** ZPMC-0225**Type of problem:****Welding****Concrete****Other****Welding****Curing****Procedural****Bridge No:** 34-0006**Joint fit-up****Coating****Other****Component:** North Shaft, Lift 3, Skin A**Procedural****Procedural****Description:** Longitudinal Stiffener A, LS3-6IN**Reference Description:** Excessive heat input during heat straightening for Longitudinal Stiffener LS3-6IN**Description of Non-Conformance:**

Job Name: SAS Superstructure

Subject: NCR No. ZPMC-0225

Reference Description: Heat Straightening / Excessive Heat Input / Tower North Shaft Lift 3 / Longitudinal Stiffener

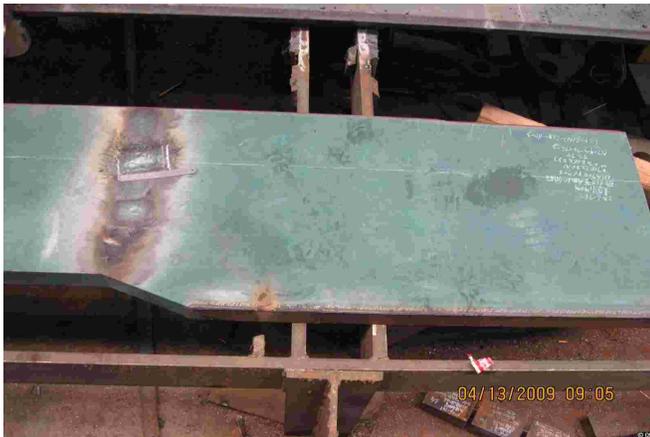
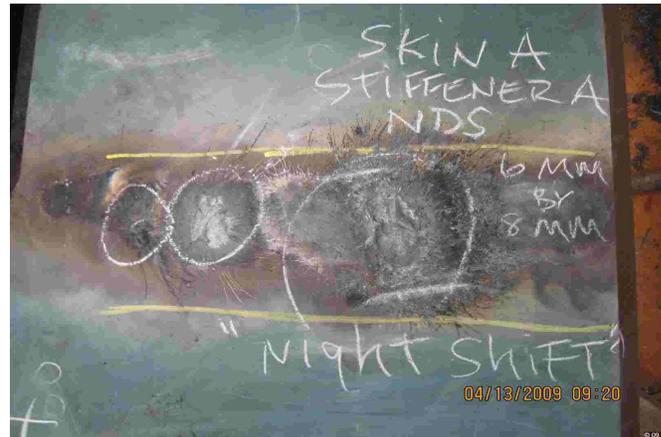
Quality Assurance observed that the contractor has performed heat straightening of Longitudinal Stiffener LS3-6IN. ZPMC Quality Control (QC) Inspector Mr. Jieng Xiao Bo informed the QA Inspector that ZPMC attempted to straighten the member but exceeded the maximum heat input limits causing base metal to melt and crater.

AWS D1.5, Section 3.7.3: "Members distorted by welding shall be straightened by mechanical means or by carefully supervised application of localized heat as approved by the Engineer."

While no further action with regard to the material is required, as per direction from ABFJV, the material has been removed and replaced. Provide the steps that have been or will be taken by the Quality Control Manager to prevent future occurrences.

Reference Resolution: ZPMC has cut this material back from the demolished base metal and welded in a new piece using a CJP with full inspection requirements for a CJP weld as well as documenting the weld via FCN.

The proposed resolution is acceptable. The affected portion of the stiffener has been removed and a new steel plate has been spliced in its place. Also, the welds have been accepted by MT and UT as shown in the attached documents. The Department concurs that Non-Conformance ZPMC-0225 is closed.

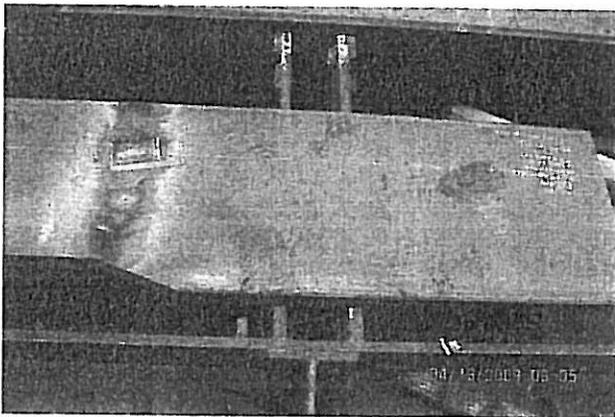
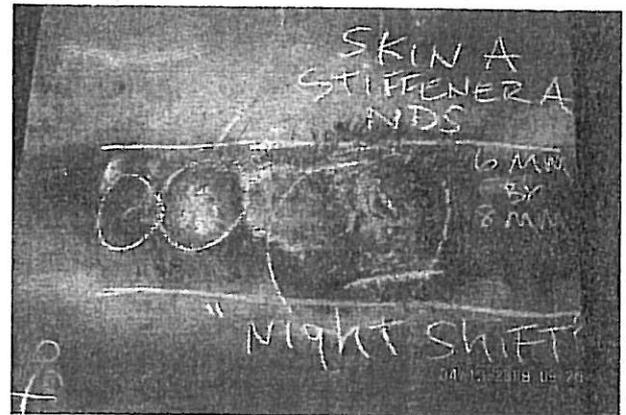
Quality Assurance observed that the contractor has performed heat straightening of Longitudinal Stiffener LS3-6IN. ZPMC Quality Control (QC) Inspector Mr. Jieng Xiao Bo informed the QA Inspector that ZPMC attempted to straighten the member but exceeded the maximum heat input limits causing base metal to melt and crater.

AWS D1.5, Section 3.7.3: "Members distorted by welding shall be straightened by mechanical means or by carefully supervised application of localized heat as approved by the Engineer."

While no further action with regard to the material is required, as per direction from ABFJV, the material has been removed and replaced. Provide the steps that have been or will be taken by the Quality Control Manager to prevent future occurrences.

The affected portion of the stiffener has been removed and a new steel plate has been spliced in its place. NDT results indicating a sound weld at the new weld joint (NSD1-FASA3-1E/E-28A/B-1) have been submitted.

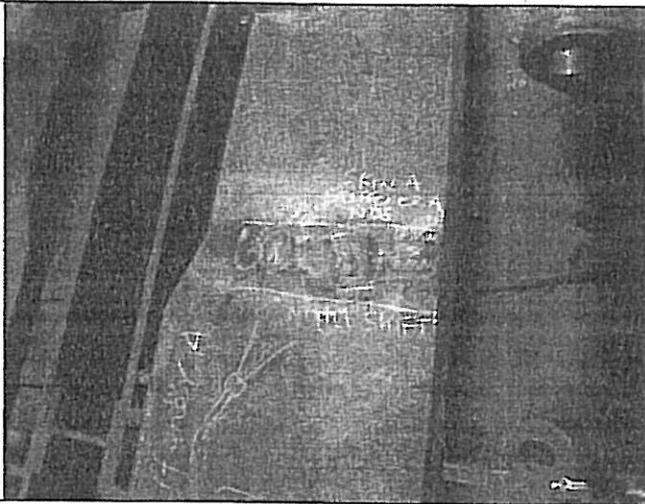
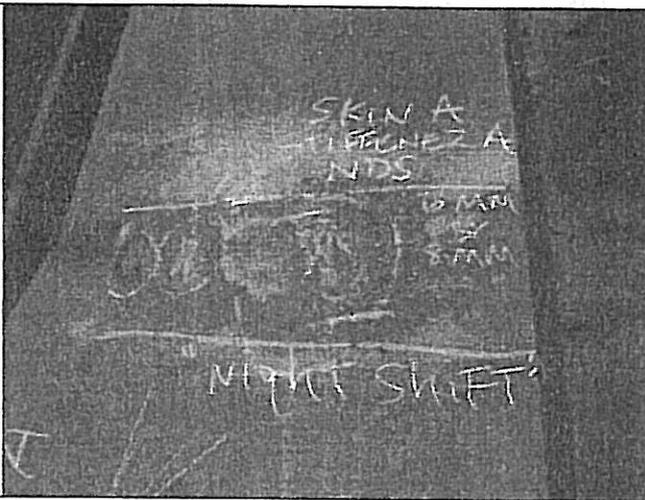
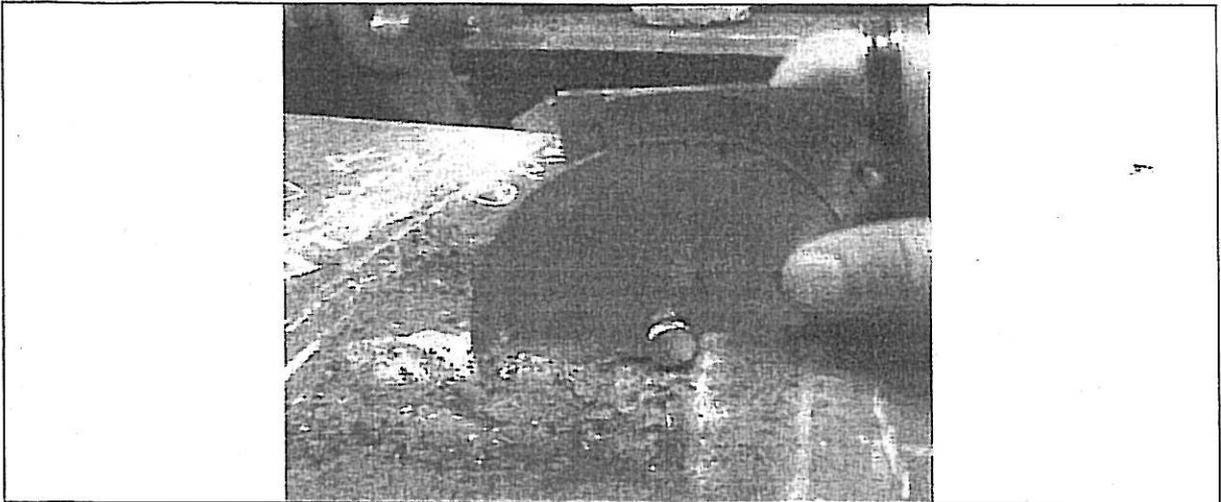
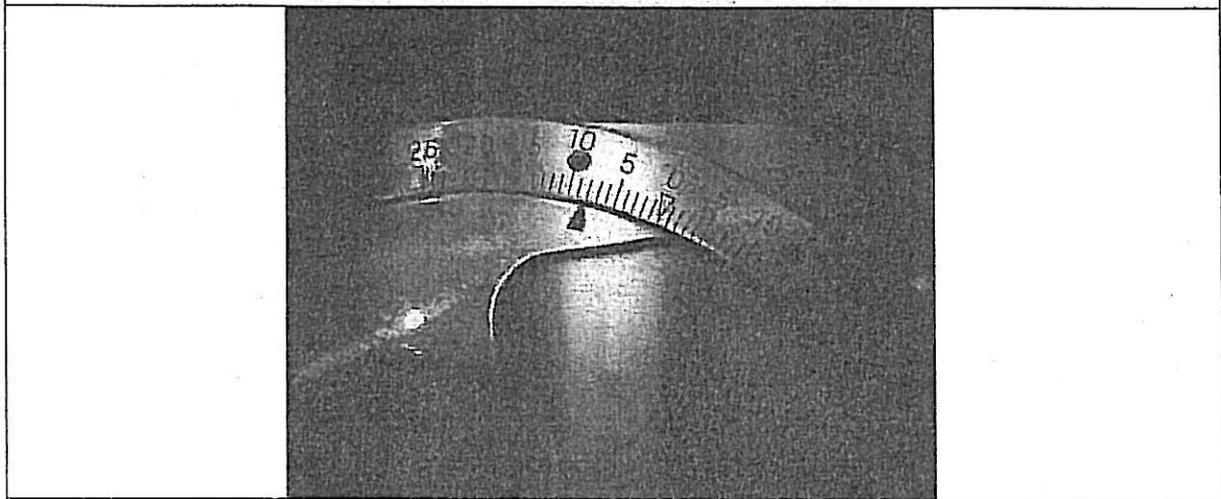
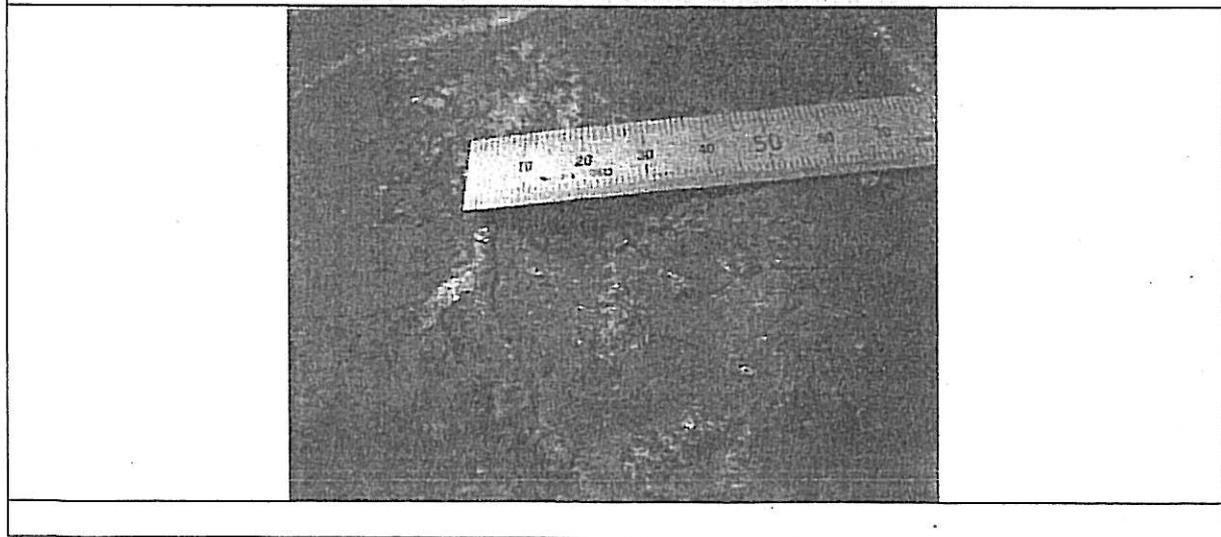
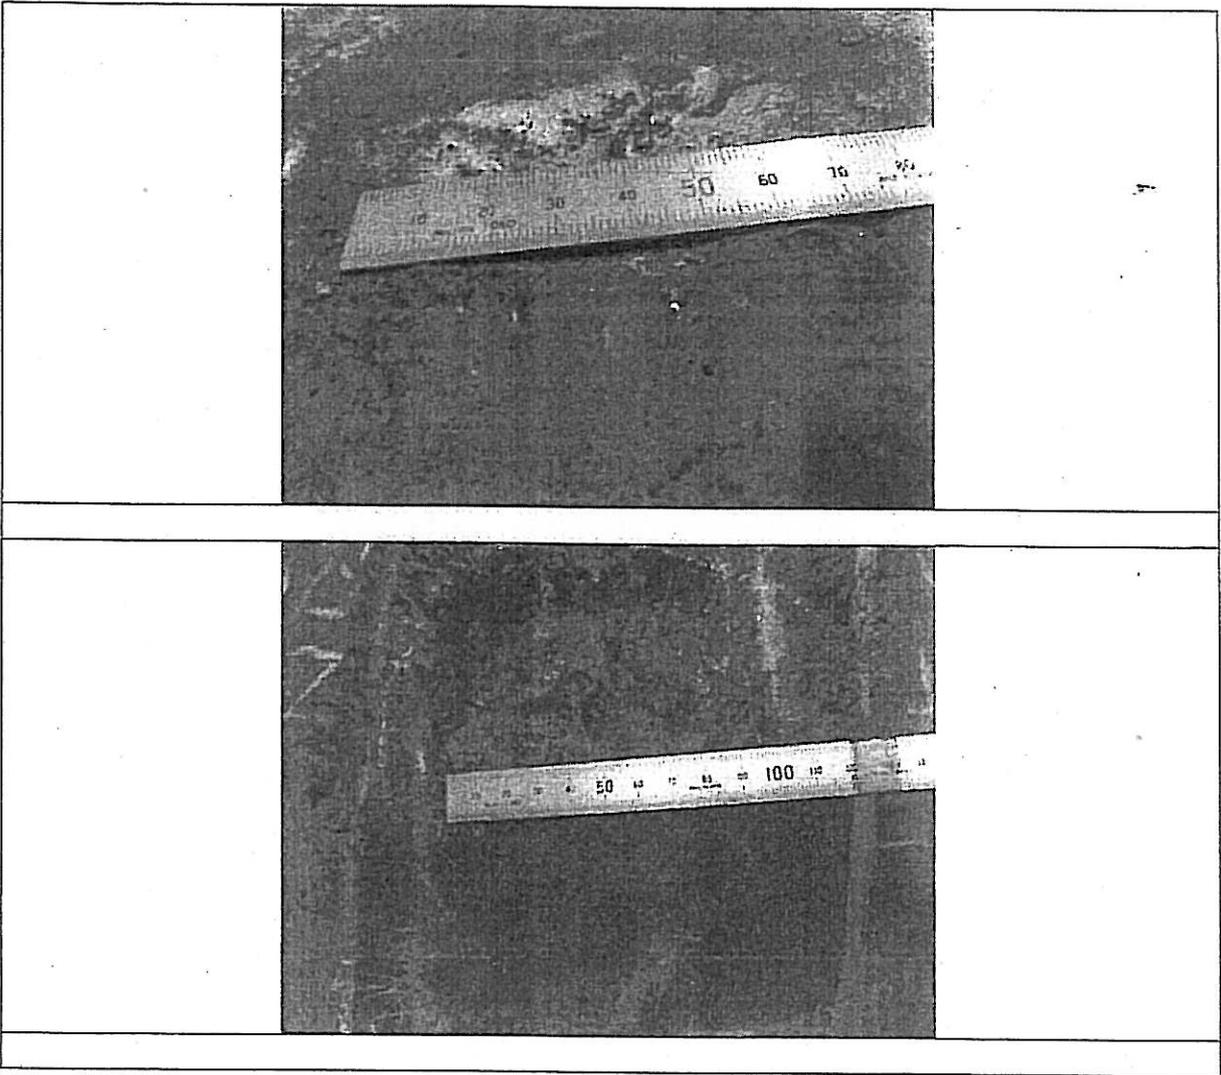
Description of Non-Conformance
 The surface was melted due to overheating during the heat straightening process on lift 3 NSD1-Skin A stiffener A3

Disposition:
 Hardness test to the damaged area and weld repair.

Proposal to prevent re-occurrence:
 During the heat straightening process, ZPMC QC have to monitoring and check the temperature.

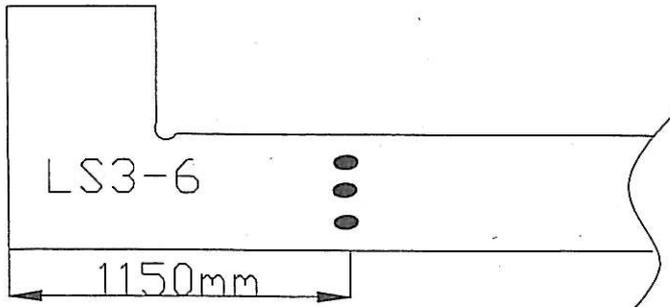
北塔第三吊段, A 面板 A3 纵向筋, LS3-6 校火过烧。具体如图:

将 LS3-6 端部切除, 增加焊缝, 焊缝位置图打在 1700 处
 Cutting off the melting metal area for about 1700mm length, replace it with a part.
 请提交 ABF 确认。 焊缝的厚度为 WT208 距端部
