Contract #: 04-0120F4Cty: SF/ALA Rte: 80 PM: 13.2/13.9File #: 69.25B**QUALITY ASSURANCE -- NON-CONFORMANCE REPORT****Location:** Changxing Island, Shanghai, PRC**Report No:** NCR-000252**Prime Contractor:** American Bridge/Fluor Enterprises, a JV**Date:** 29-Apr-2009**Submitting Contractor:** Zhenhua Port Machinery Company, Ltd (ZPMC), Changxing Island**NCR #:** ZPMC-0226**Type of problem:****Welding****Concrete****Other****Welding****Curing****Procedural****Bridge No:** 34-0006**Joint fit-up****Coating****Other****Component:** OBG Segments 3AW-3BW & 4AW-4BW**Procedural****Procedural****Description:****Reference Description:** Distortion of Bottom Panel/Side Panel at Segment Splices 3AW-3BW & 4AW-4BW**Description of Non-Conformance:**

Job Name: SAS Superstructure

Subject: NCR No. ZPMC-0226

Reference Description: Distortion of Bottom Panel/Side Panel at Segment Splices 3AW-3BW & 4AW-4BW

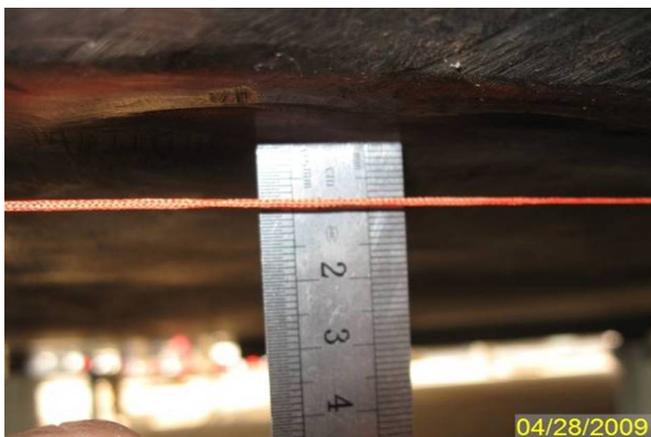
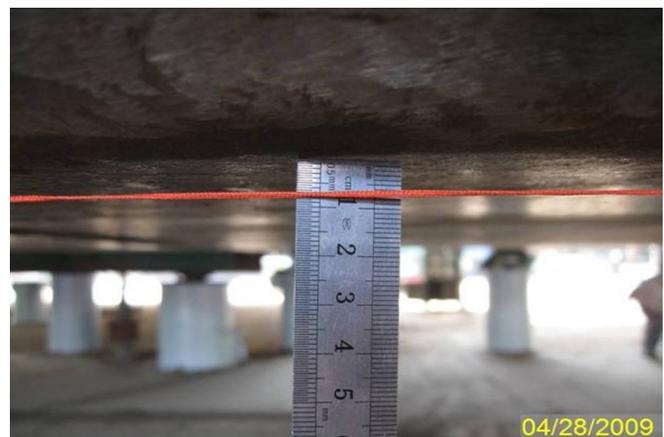
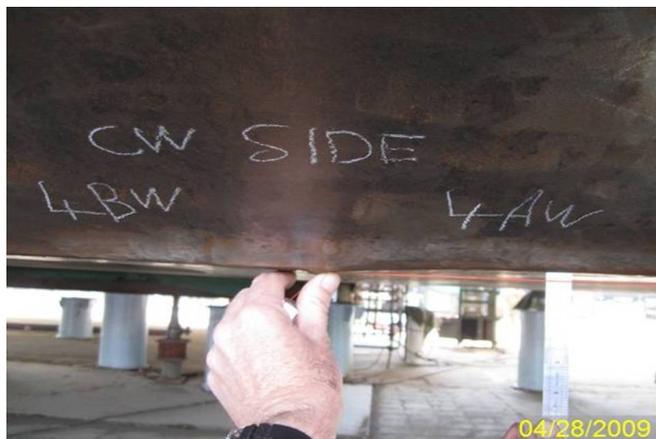
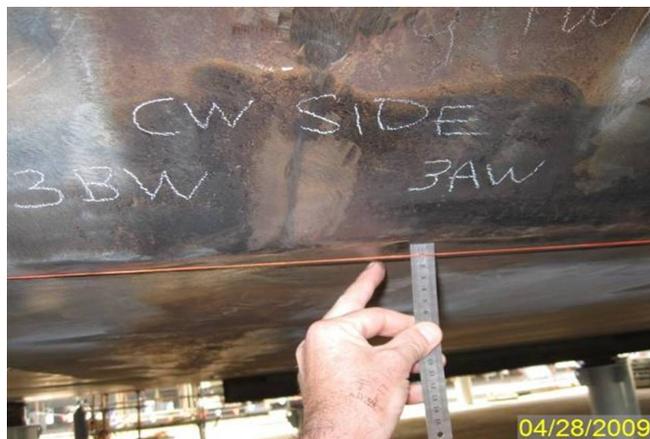
Caltrans Quality Assurance Inspector observed welding distortion occurred at the transverse splice welds joining segments 3AW to 3BW and 4AW to 4BW. The distortion is located on the counterweight side of both segment transverse welds and has been measured at the corners where the side panel meets the bottom panel.

The measured distortion is as follows:

- 3AW/3BW – 10mm in 1000mm
- 4AW/4BW – 8mm in 1000mm

AWS D1.5 (2002), Section 3.4.3 - "The Contractor shall prepare a welding sequence for a member or structure which, in conjunction with the WPSs and overall fabrication methods, will produce members or structures meeting the quality requirements specified. The welding sequence and distortion control program shall be submitted to the Engineer, for information and comment, before the start of welding on a member or structure in which shrinkage or distortion is likely to affect the adequacy of the member or structure."

The ZPMC survey was not complete prior to this NCR being generated, therefore ZPMC requests this NCR be closed or retracted. Remedial action has been taken after the ZPMC survey to bring the distortion into compliance.

ZPMC had repaired the areas with subsequent acceptable NDT result.
