QUALITY ASSURANCE -- NON-CONFORMANCE REPORT

Location: Changxing Island, Shanghai, P.R. China **Report No:** NCR-000253
Prime Contractor: American Bridge/Fluor Enterprises, a JV **Date:** 28-Apr-2009
Submitting Contractor: Zhenhua Port Machinery Company, Ltd (ZPMC), Changxing Island **NCR #:** ZPMC-0227

Reference Description: Counterweight Plate Section Removal/Replacement

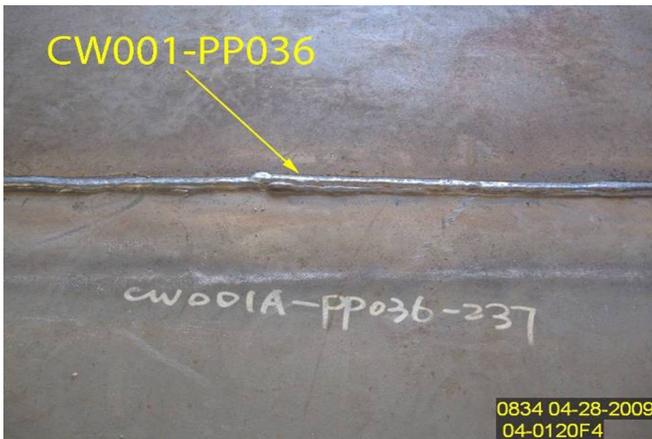
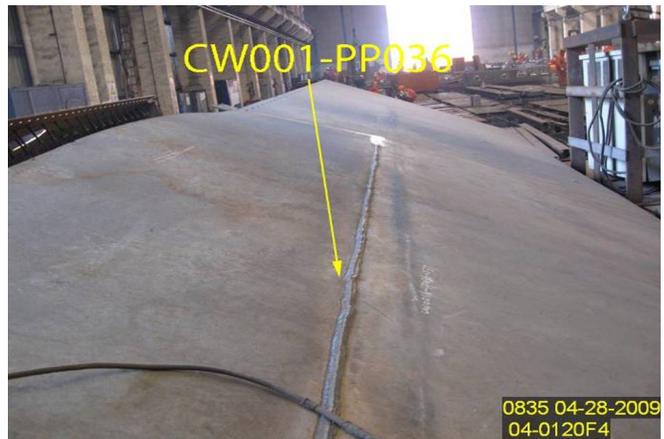
During random in-process inspection of Counterweight CW001-PP36, Caltrans Quality Assurance Inspector discovered that ZPMC personnel had cut and removed a section of the counterweight plate and re-welded a new plate section in place without the Engineer's approval. The dimensions of the base metal section removed are as follows:

Length: 3450mm
 Width: 740mm

The section was removed and replaced due to holes drilled in the plate that were not part of the approved shop drawings.

Perform the required NDT to verify that the welds are in conformance with Contract requirements.

ZPMC performed visual inspection along with magnetic particle testing and ultrasonic testing of the area in question and submitted the respective reports showing that the welds are in conformance.
