Contract #: 04-0120F4Cty: SF/ALA Rte: 80 PM: 13.2/13.9File #: 69.25B**QUALITY ASSURANCE -- NON-CONFORMANCE REPORT****Location:** Changxing Island, Shanghai, PRC**Report No:** NCR-000254**Prime Contractor:** American Bridge/Fluor Enterprises, a JV**Date:** 29-Apr-2009**Submitting Contractor:** Zhenhua Port Machinery Company, Ltd (ZPMC), Changxing Island**NCR #:** ZPMC-0228**Type of problem:****Welding****Concrete****Other****Welding****Curing****Procedural****Bridge No:** 34-0006**Joint fit-up****Coating****Other****Component:** OBG Segments 3AW, 3BW**Procedural****Procedural****Description:****Reference Description:** Buttering of Bottom Panel Faces to Correct Distortion, Segment Splice 3AW - 3BW**Description of Non-Conformance:**

Job Name: SAS Superstructure

Reference Description: Buttering of Bottom Panel Faces to Correct Distortion, Segment Splice 3AW - 3BW

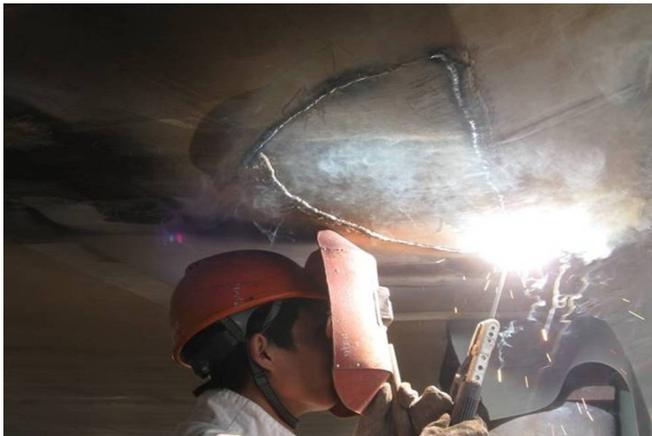
Caltrans Quality Assurance (QA) Inspector observed weld buttering of base metal to compensate for out of tolerance flatness. The repair area is located on the bottom panels at the transverse splice of Segments 3AW and 3BW, Working Point W3 (bottom panel to side panel, counterweight side). The previously noted distortion at this location was 10mm in 1000mm. An approved WPS for this repair was not available for QA Inspector review.

AWS D1.5 (2002) Section 3.1.5 – “Welds shall be prohibited on the work except as follows:

- (1) Base-metal repair performed in conformance with AASHTO M160/M160M (ASTM A 6/A 6M), Specification for General Requirements for Rolled Steel Plates, Shapes, Sheet Piling, and Bars for Structural Use, Article 9, by the mill or fabricator
- (2) All welds detailed on approved shop drawings
- (3) Repair welds authorized by this code

(4) Other welds approved by the Engineer”

AWS D1.5 (2002) Section 3.4.3 – “The Contractor shall prepare a welding sequence for a member or structure which, in conjunction with the WPSs and overall fabrication methods, will produce members or structures meeting the quality requirements specified. The welding sequence and distortion control program shall be submitted to the Engineer, for information and comment, before the start of welding on a member or structure in which shrinkage or distortion is likely to affect the adequacy of the member or structure.”

Reference Resolution: ZPMC will provide inspection documentation of this weld buttering at a later date as objective evidence to close this NCR.

In the areas that received weld build-up (buttering) to correct for misalignment, please provide documentation of the buttering that was performed and MT testing of the buttered areas. The Department will review the Contractor's proposal to close Non-Conformance ZPMC-0228 at that time.

Perform NDT on area in question.

Contractor submitted MT report verifying base metal repairs were done in accordance with Contract specifications.
