Contract #: 04-0120F4Cty: SF/ALA Rte: 80 PM: 13.2/13.9File #: 69.25B**QUALITY ASSURANCE -- NON-CONFORMANCE REPORT****Location:** Changxing Island, Shanghai, PRC**Report No:** NCR-000255**Prime Contractor:** American Bridge/Fluor Enterprises, a JV**Date:** 25-Apr-2009**Submitting Contractor:** Zhenhua Port Machinery Company, Ltd (ZPMC), Changxing Island**NCR #:** ZPMC-0229**Type of problem:**

Reference Description: Weld Repair on Wet Material, Crossbeam CB1**Description of Non-Conformance:**

Job Name: SAS Superstructure

Subject: NCR No. ZPMC-0229

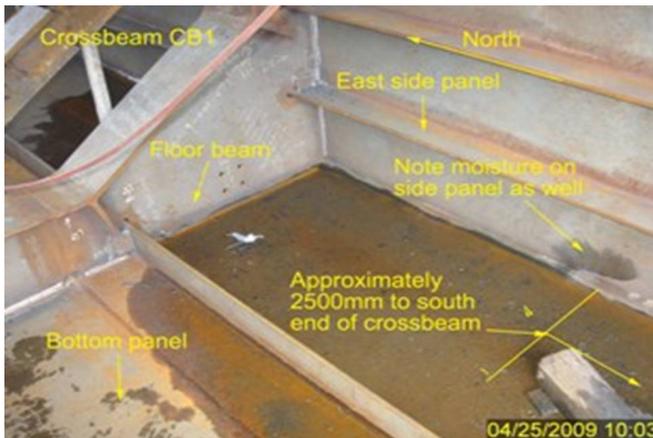
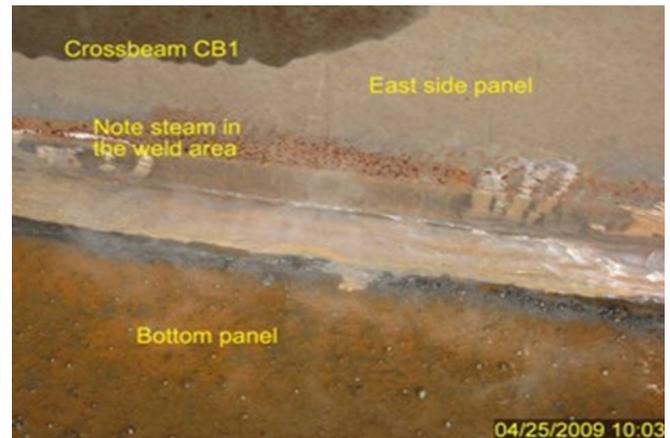
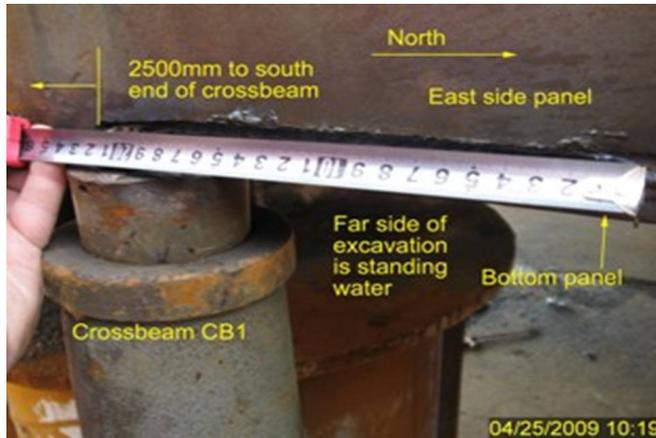
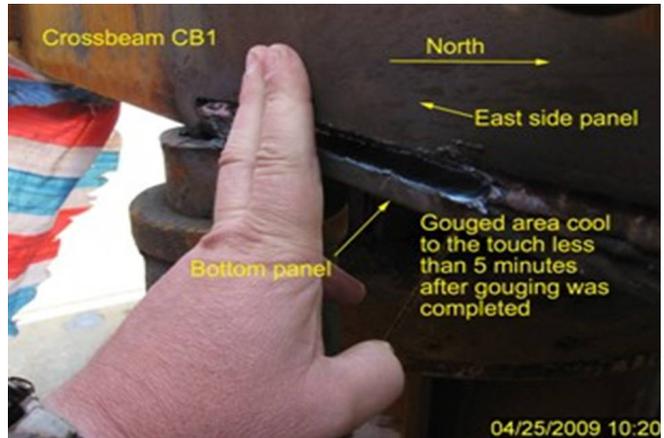
Caltrans Quality Assurance (QA) Inspector observed the Contractor excavating weld repairs on SPCM material while the material was wet on the adjacent side of the repaired area. The welder was arc gouging on the corner joint between the east side panel and bottom panel approximately 2500mm from the south end of the crossbeam. Four areas were being excavated. All four excavations were located in a 1500mm area along the length of the weld.

AWS D1.5 2002 Section 3.1.3 - "Welding shall not be done when the ambient temperature is lower than -20°C [0°F] (see 4.2), when surfaces are wet or exposed to rain, snow, or high wind velocities, nor when welders are exposed to inclement conditions".

AWS D1.5 2002 Section 3.2.1 - "Surfaces to be welded and surfaces adjacent to a weld shall also be free from loose or thick scale, slag, rust, moisture, grease, and other foreign material that would prevent proper welding or produce objectionable fumes."

- 1. 由于下雨后未清理箱体内存水; 1' Didn't remove rain completely;
- 2. 工人盲目施工作业, 未检查作业前环境; 2' Worker didn't inspect environment before fabrication.
- 3. 现场管理人员, 检验人员未及时发现问题, 未及时发现不良环境, 未及时发现并制止工人作业; 3. Didn't prohibit worker immediately by management personnel and QC.

- 1. 严格要求施工人员, 检验人员检查作业环境。
- 2. 对积水区域清理干净, 对已碳刨区域, 做MT检测后施焊, 未碳刨区域预热后方可作业。
- 1' Perform work after QC inspect environment;
- 2' Remove rain completely and perform MT for gouging area and weld, preheat for non-gouging area. before welding.

Performed VT, MT, and UT and submitted reports with NPR.
