## QUALITY ASSURANCE -- NON-CONFORMANCE REPORT

**Report No:** NCR-000260

**NCR #:** ZPMC-0234

**Reference Description:** West Shaft, Lift 3, Skin C; Missed MT indication

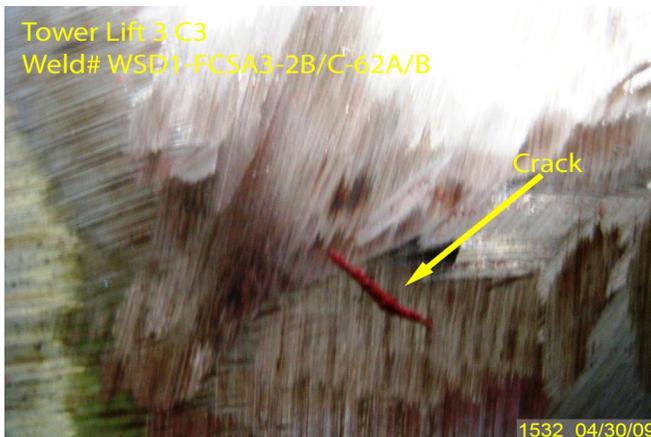
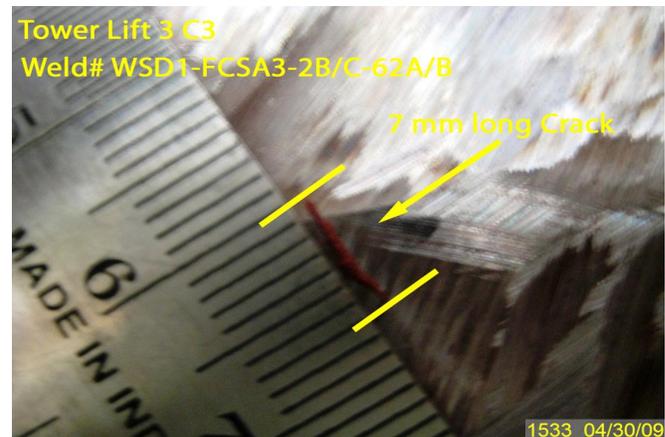
QA discovered a 7mm long linear indication in weld WSD1-FCSA3-2B/C-62A/B that had been previously inspected and accepted by ZPMC QC. The indication is located in West Shaft, Lift 3, Skin C.

AWS D1.5-2002 Section 6.26.2 – “Welds that are subject to MT in addition to visual inspection shall have no cracks”

Documentation supporting successful removal of this indication by grinding and NDT results specific to this non conformance (ZPMC-0234) is attached.

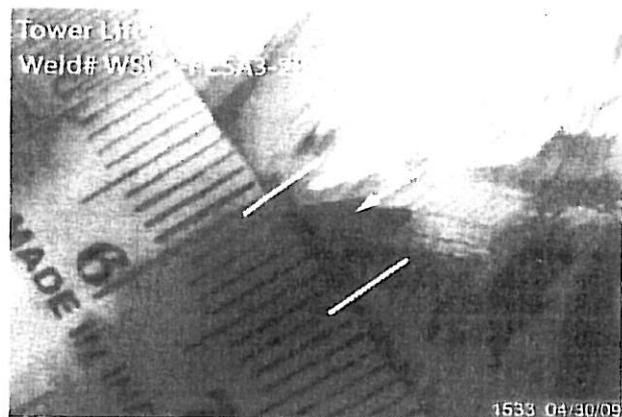
QA discovered a 7mm long linear indication in weld WSD1-FCSA3-2B/C-62A/B that had been previously inspected and accepted by ZPMC QC. The indication is located in West Shaft, Lift 3, Skin C.

AWS D1.5-2002 Section 6.26.2 – "Welds that are subject to MT in addition to visual inspection shall have no cracks"

The affected weld has been repaired and a NDT report indicating sound weld has been submitted. The weld has been verified by QA and green tagged.
