QUALITY ASSURANCE -- NON-CONFORMANCE REPORT

Report No: NCR-000261

Reference Description: Missed MT Indications on East Tower, Lift 3, Skin D Longitudinal Stiffener Weld

Job Name: SAS Superstructure

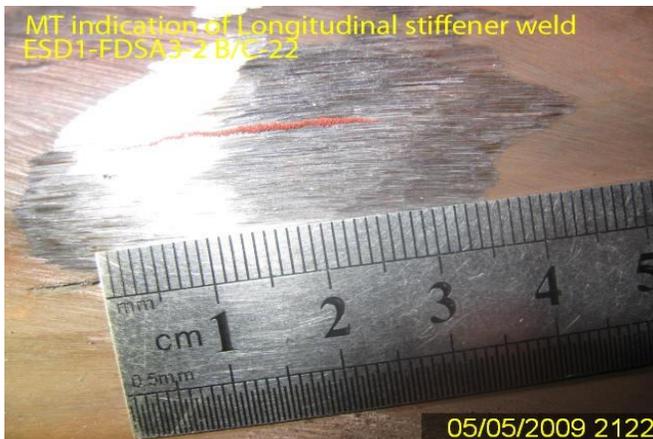
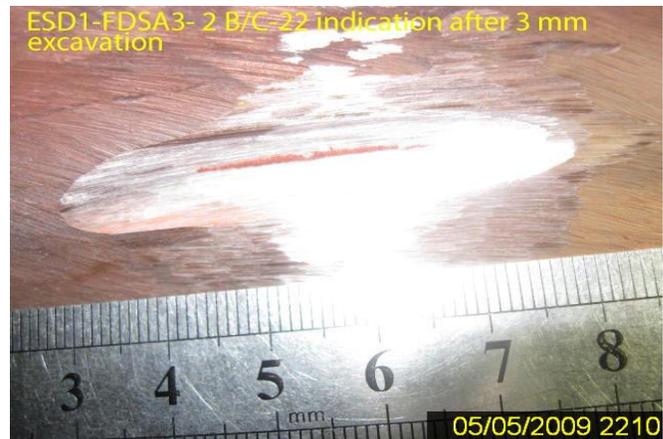
During random verification Magnetic Particle Testing (MT) of East Tower, Lift 3, Skin Plate D, longitudinal stiffener welds, QA discovered a 30 mm long indication on weld ESD1-FDSA3-2 B/C-22. This weld was previously tested and accepted by ZPMC QC MT Technicians.

AWS D1.5 (02) Section 6.26.2 – “Welds that are subject to MT in addition to visual inspection shall have no cracks”

Propose a resolution for this systematic non-conformance that addresses the failure of Quality Control to identify the linear indication (NDT). Provide documentation of the steps taken by the Quality Control Manager to prevent future occurrences.

In addition to the Quality Control failure, propose a resolution for the identified material/workmanship non-conformance, documenting that the repaired weld is in compliance with the contract requirements.

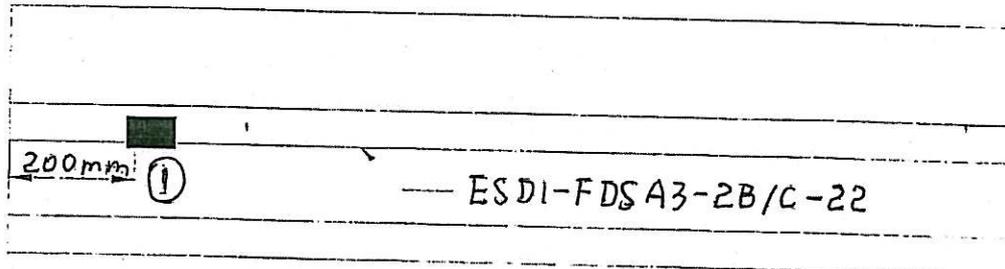
Draft of Welding Discontinuity:

A longitudinal crack was detected by MT in weld ESD1-FDSA3-2B/C-22. Please see the detail position in the sketch below.

1. L=30mm;

1. Moisture wasn't completely removed during drying operation (preheating) or the area wasn't preheated sufficiently.
2. It didn't grind smoothly after backing gouging.

- 1、 Grind repair area smoothly
- 2、 Verify with VT and MT to ensure no defects remain in the weld joint prior to welding ;
- 3、 QC will monitor and direct welder and grinder doing repair;
- 4、 QC shall monitor all welding passes being deposited;
- 5、 QC shall ensure all slag has been removed prior the deposition of next pass
- 6、 Preheat and maintain interpass temperature control in accordance with the WPS ;
- 7、 Perform NDT in accordance with contract requirements.
