Contract #: 04-0120F4Cty: SF/ALA Rte: 80 PM: 13.2/13.9File #: 69.25B**QUALITY ASSURANCE -- NON-CONFORMANCE REPORT****Location:** Changxing Island, Shanghai, P.R. China**Report No:** NCR-000266**Prime Contractor:** American Bridge/Fluor Enterprises, a JV**Date:****Submitting Contractor:** Zhenhua Port Machinery Company, Ltd (ZPMC), Changxing Island**NCR #:** ZPMC-0240**Type of problem:****Welding****Concrete****Other****Welding****Curing****Procedural****Bridge No:** 34-0006**Joint fit-up****Coating****Other****Component:** OBG Crossbeam CB1**Procedural****Procedural****Description:****Reference Description:** Critical Weld Repair Performed Without the Engineer's Approval, CB1**Description of Non-Conformance:**

Job Name: SAS Superstructure

Reference Description: Critical Weld Repair Performed Without the Engineer's Approval, CB1

Project Name: S.F.O.B.B 项目名称: 美国加州海湾大桥		NCR Number: NCR 编号: NCR-B-152 (ZPMC-240)	
Item: Critical weld repair performed without the engineer's approval 名称描述: CWR 未经工程师批准就返修	Item Number: 件号: OBG CB1	Drawing: 图号: CB203	
Location: OBG CB1 位置:		Date: 2009-05-20 日期:

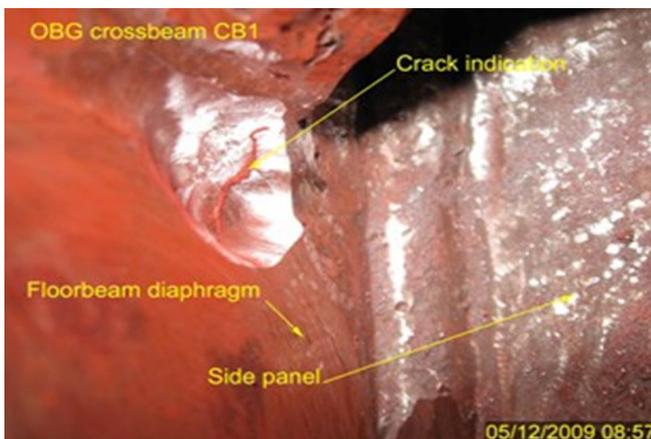
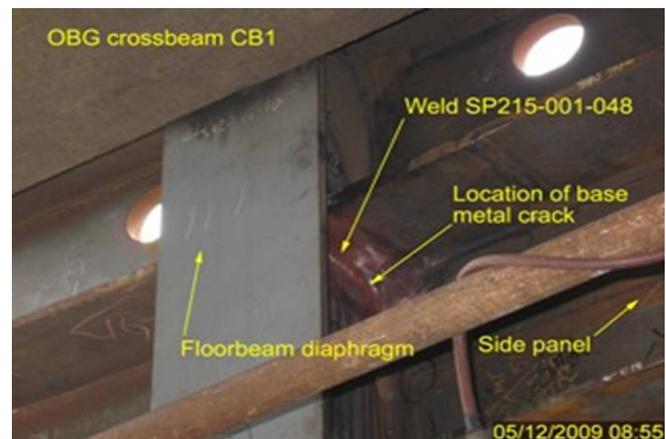
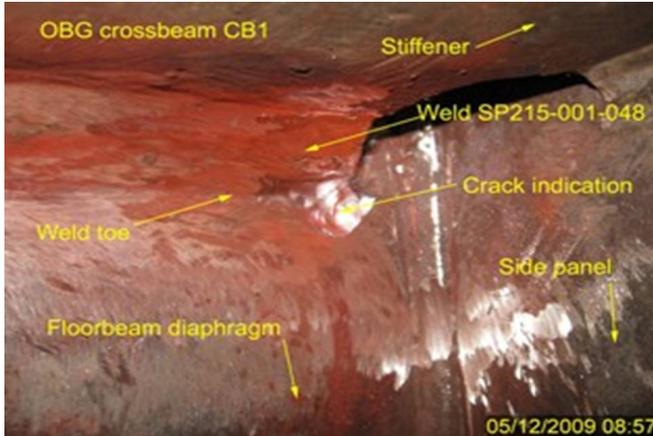
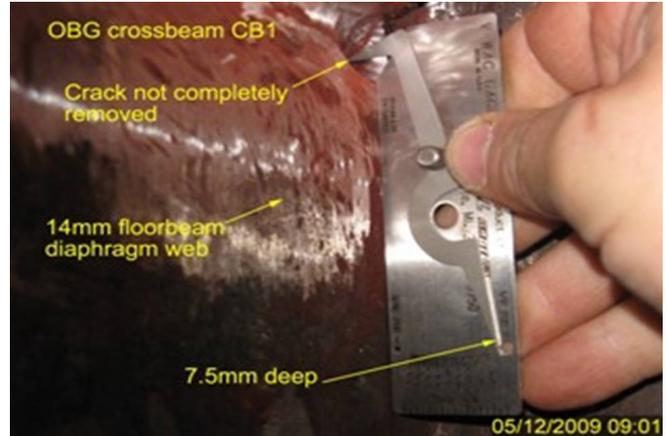
Caltrans Quality Assurance (QA) Inspector observed that the Contractor has performed base metal repair of a linear indication without an approved repair procedure. The Complete Joint Penetration (CJP) weld (SP215-001-048, Crossbeam CB1) in the area of this repair has previously been repaired three times; one time for two toe indications discovered visually on 5/6/09 and two additional times after ZPMC Quality Control (QC) Ultrasonic Testing (UT) technicians rejected the repaired area of the weld. A CWR was provided to the Engineer after the work had already been performed.

AWS D1.5 (2002) Paragraph 3.7.4: "Prior approval of the Engineer shall be obtained for repairs to base metal, repair of major or delayed cracks,"

Reference Resolution: ABF has notified ZPMC to document repairs and obtain the necessary approval prior to repairs being commenced. ZPMC QA has notified their QC and Production staff.

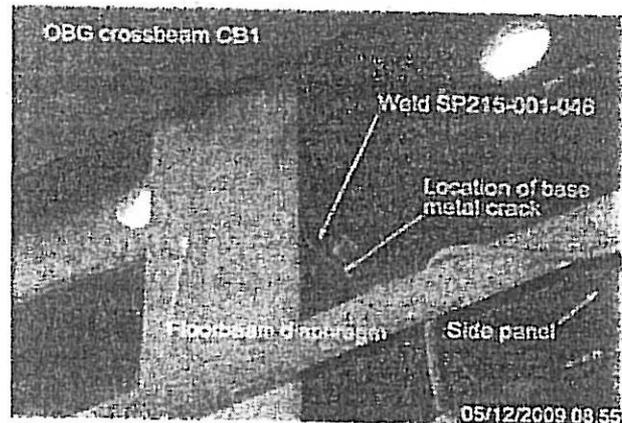
Caltrans Quality Assurance (QA) Inspector observed that the Contractor has performed base metal repair of a linear indication without an approved repair procedure. The Complete Joint Penetration (CJP) weld (SP215-001-048, Crossbeam CB1) in the area of this repair has previously been repaired three times; one time for two toe indications discovered visually on 5/6/09 and two additional times after ZPMC Quality Control (QC) Ultrasonic Testing (UT) technicians rejected the repaired area of the weld. A CWR was provided to the Engineer after the work had already been performed.

AWS D1.5 (2002) Paragraph 3.7.4: "Prior approval of the Engineer shall be obtained for repairs to base metal, repair of major or delayed cracks,"

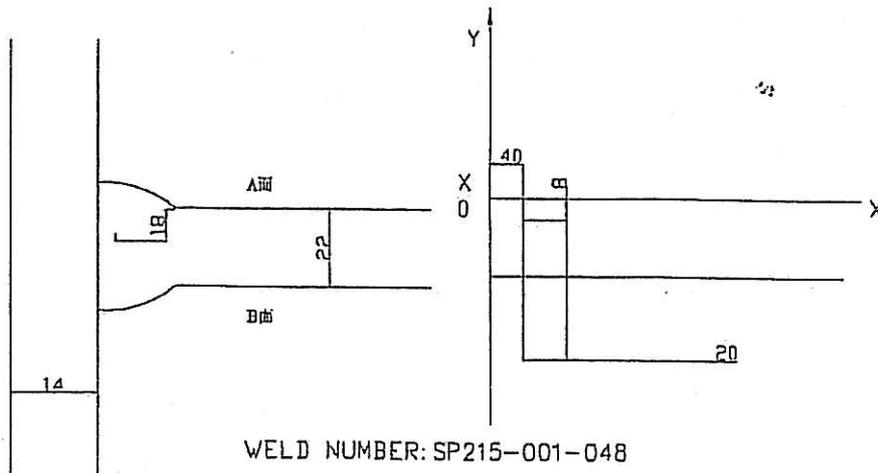
WELD NUMBER: SP215-001-048

A Rejectable indication was found by Ultrasonic Inspection for a **SECOND** repair. *third*

(UT二次缺陷) SP215-001-048

1. 焊工在第一次反面消跟时, 没有注意, 导致焊接缺陷没有全部去除;

2. 在焊返修前, QC没有确认所有的焊接缺陷已经去除。

1. QC and a Lead CWI shall be present and monitor all gouging, grinding and welding operations during this repair.

2. QC shall have a copy of the CWR available to ensure the repair is per the disposition requirements.

3. If gouging is performed, preheat per the repair WPS minimum requirements.

4. Gouge and/or grind to remove all the defects from the Face A.

5. Prepare the repair joint according to the relevant repair WPS.

7. Perform VT and MT to ensure the defects have been removed.

8. Preheat and weld according to the relevant repair WPS.

9. Perform VT, MT and UT to the repair areas.

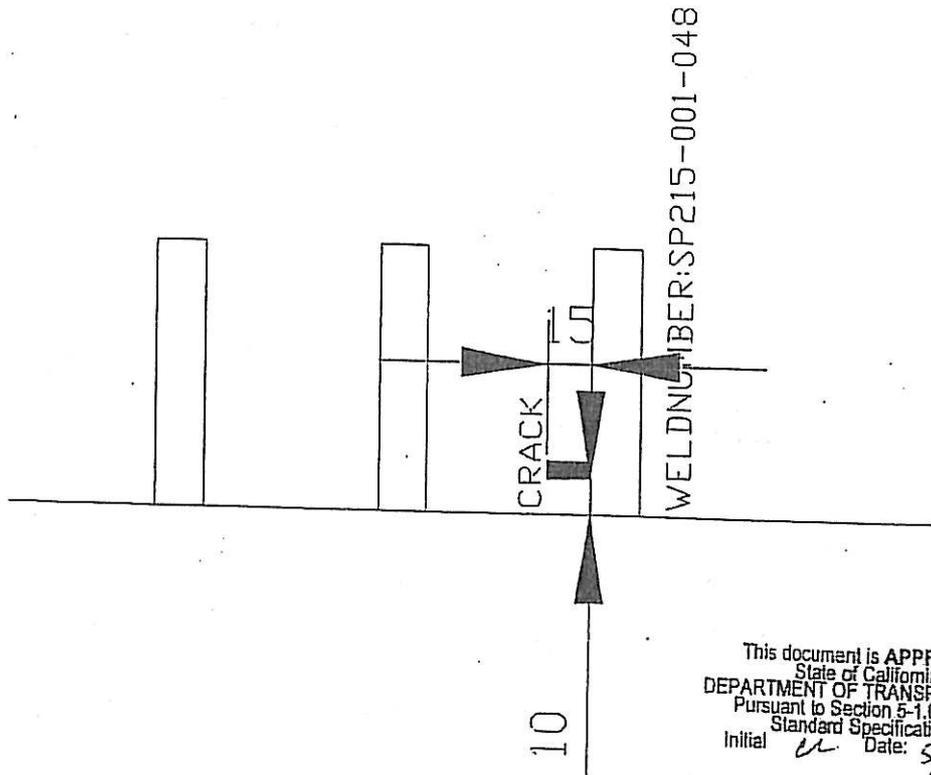
在对SP215-001-048检测时,发现一处横向裂纹,长度15mm。

We found one transverse crack in SP215-001-048.

1. 火焰加热时, 水汽没有完全的去掉或者这个区域预热不够;
2. 翻身碳刨清根后, 打磨不到位,。
1. Moisture wasn't completely removed during drying operation (preheating) or the area wasn't preheated sufficiently.
2. It didn't grind smoothly after backing gouging.

1. 这次返修时, QC到现场指导打磨, 焊接;
 2. QC指导返修, 以保证返修按照处理意见进行;
 3. 采用打磨的方式去除裂纹;
 4. 准备一个正确的接头型式, 具体参照相应的返修WPS;
 5. VT和MT检测确认返修区域没有裂纹;
 6. 根据批准的返修焊接工艺规程
 7. 预热温度应不小于100℃,
 8. 预热范围在修补区域周围不应小于150mm;
 9. 将修补区域打磨与母材或相邻焊缝平齐;
 10. 对修补区域做VT与MT检测。
1. QC shall be present and direct all grinding and welding operations during this repair.
 2. QC shall direct the repair to ensure the repair is per the disposition requirements.
 3. Remove the crack by means of grinding.
 4. Prepare excavation according to the approved repair WPS.
 5. Verify with VT and MT repair areas are crack free.
 6. Preheat and weld according to the approved repair WPS.
 7. Preheat prior to welding to a minimum temperature of 100°C
 8. The preheat area shall be a minimum of 150mm in all directions around the repair area.
 9. Grind the repaired area flush with base metal or the adjacent weld.
 10. Perform VT and MT of the repair areas.

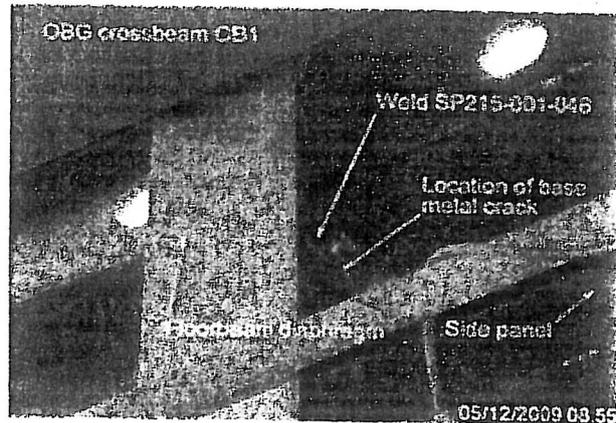
Caltrans Quality Assurance (QA) Inspector observed that the Contractor has performed base metal repair of a linear indication without an approved repair procedure. The Complete Joint Penetration (CJP) weld (SP215-001-048, Crossbeam CB1) in the area of this repair has previously been repaired three times; one time for two toe indications discovered visually on 5/6/09 and two additional times after ZPMC Quality Control (QC) Ultrasonic Testing (UT) technicians rejected the repaired area of the weld. A CWR was provided to the Engineer after the work had already been performed.

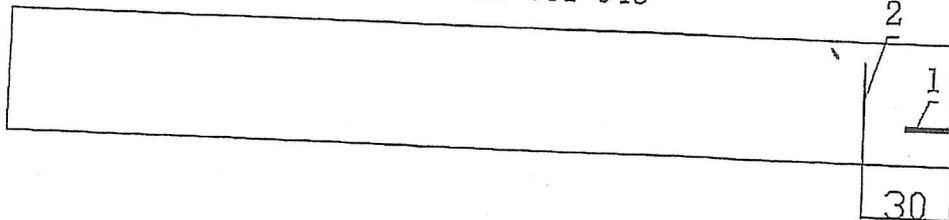
WELD NUMBER: SP215-001-048

在对SP215-001-048检测时, 发现2处裂纹。1、L=15 L2=10mm;
Welder ID No. (焊工编号): 2#6667 Position:(位置): 2F
One crack found by use of MT on weld SP215-001-048

1. 火焰加热时, 水汽没有完全的去掉或者这个区域预热不够;
1. Moisture wasn't completely removed during drying operation (preheating) or the area wasn't preheated sufficiently.

1. QC and a Lead CWI shall be present, direct and supervise all grinding and welding operations during this repair to ensure the repair is per the disposition requirements

2. QC and a Lead CWI shall have an approved copy of the CWR in hand prior to the repair.
 3. Remove paint ≥ 25 mm in all direction of HAZ prior to MT.
 4. Remove cracks by grinding, repair area shall extend a minimum of 50mm beyond each end of single crack repairs;

5. If base metal is damaged by grinding, the damaged area shall be ground clean prior to performing weld repair. If gap > 5 mm is found during or after grinding, a separate CWR to make the weld joint a CJP is required in that location, and perform MT after performing grinding the defects away.

6. Prepare excavation in accordance with an approved repair WPS prior to welding.
 7. Before this repair, Verify with VT and MT repair areas are defects free;

8. Perform MT on the weld metal adjacent to the repair area to ensure that crack did not propagate into base metal. If crack is discovered in base metal, approval of a separate CWR is required before continuing with repair work.

9. Preheat and weld according to the approved repair WPS.
 10. Grind the repaired area flush with base metal or the adjacent weld.
 11. Perform 100%VT and MT inspection to all repaired welds (along with an additional 50mm at each end of the weld repair) which include the near side and far side on the upper Perform UT and MT inspection to CJP weld.

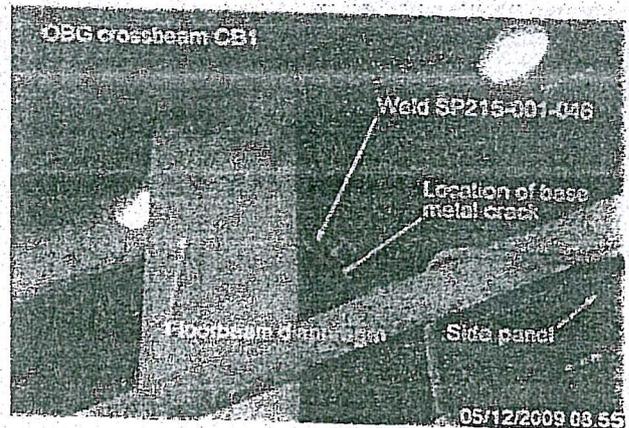
Caltrans Quality Assurance (QA) Inspector observed that the Contractor has performed base metal repair of a linear indication without an approved repair procedure. The Complete Joint Penetration (CJP) weld (SP215-001-048, Crossbeam CB1) in the area of this repair has previously been repaired three times; one time for two toe indications discovered visually on 5/6/09 and two additional times after ZPMC Quality Control (QC) Ultrasonic Testing (UT) technicians rejected the repaired area of the weld. A CWR was provided to the Engineer after the work had already been performed.

AWS D1.5 (2002) Paragraph 3.7.4: "Prior approval of the Engineer shall be obtained for repairs to base metal, repair of major or delayed cracks."

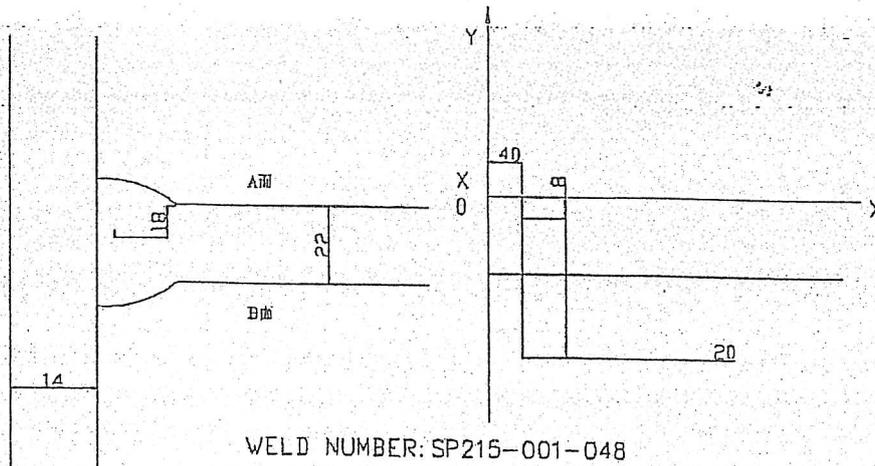
A Rejectable indication was found by Ultrasonic Inspection for a **SECOND** repair. *third*
(UT二次缺陷) SP215-001-048

1. 焊工在第一次反面清根时, 没有注意, 导致焊接缺陷没有全部去除;
 2. 在焊返修前, QC没有确认所有的焊接缺陷已经去除。
1. The welder was not observant during the first backgouging operation resulting in the Indications not being completely removed.
 2. QC did not verify the indications had been removed prior to re-welding.

6. 将缺陷区域打磨平滑;
 7. 采用MT和VT检测方法保证缺陷完全被消除;
 8. 预热及焊接要求参照已批准的返修WPS执行;
 9. 返修后,VT,MT,UT检测焊缝;
 10. 将焊缝打磨与相邻焊缝平齐;
 11. 根据批准的车间图纸检查焊缝;
1. QC and a Lead CWI shall be present and monitor all gouging, grinding and welding operations during this repair.

2. QC shall have a copy of the CWR available to ensure the repair is per the disposition requirements.
 3. If gouging is performed, preheat per the repair WPS minimum requirements.

4. Gouge and/or grind to remove all the defects from the Face A.
 5. Prepare the repair joint according to the relevant repair WPS.
 6. Grind area smooth to a shiny finish.

7. Perform VT and MT to ensure the defects have been removed.
 8. Preheat and weld according to the relevant repair WPS.
 9. Perform VT, MT and UT to the repair areas.

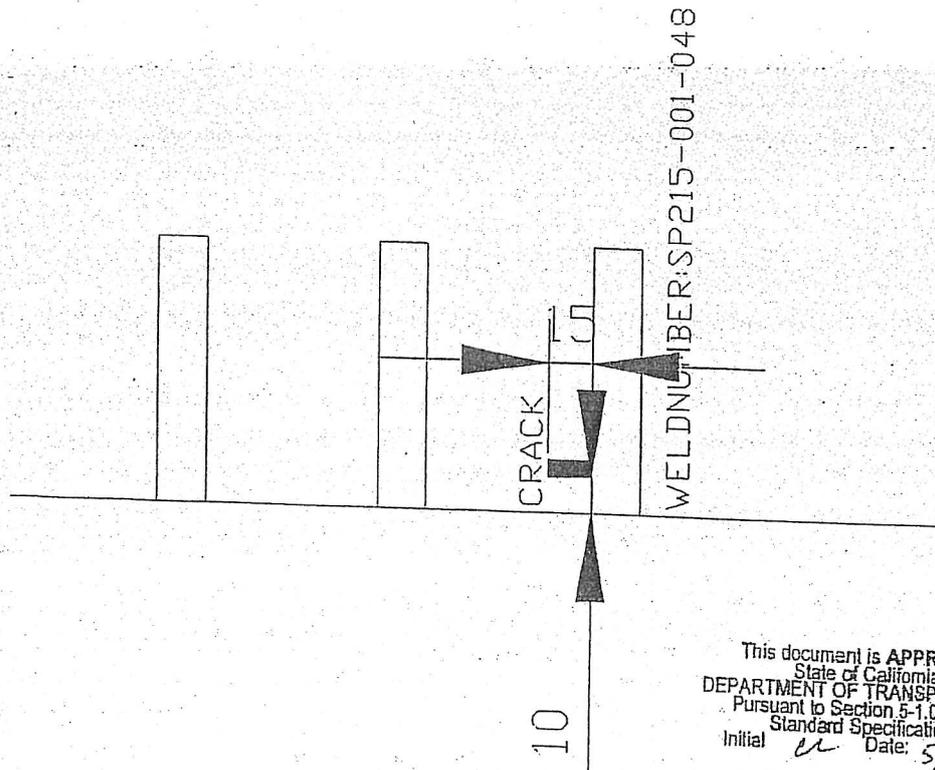
在对SP215-001-048检测时,发现一处横向裂纹,长度15mm。

We found one transverse crack in SP215-001-048.

2. 翻身破刨清根后, 打磨不到位。

1. Moisture wasn't completely removed during drydown operation (backheating) or the area wasn't preheated sufficiently.

1. QC shall be present and direct all grinding and welding operations during this repair.

2. QC shall direct the repair to ensure the repair is per the disposition requirements.

3. Remove the crack by means of grinding.

4. Prepare excavation according to the approved repair WPS.

5. Verify with VT and MT repair areas are crack free.

6. Preheat and weld according to the approved repair WPS.

8. The preheat area shall be a minimum of 150mm in all directions around the repair area.

9. Grind the repaired area flush with base metal or the adjacent weld.

10. Perform VT and MT of the repair areas.
