Contract #: 04-0120F4Cty: SF/ALA Rte: 80 PM: 13.2/13.9File #: 69.25B**QUALITY ASSURANCE -- NON-CONFORMANCE REPORT****Location:** Changxing Island, Shanghai, PRC**Report No:** NCR-000267**Prime Contractor:** American Bridge/Fluor Enterprises, a JV**Date:** 24-Apr-2009**Submitting Contractor:** Zhenhua Port Machinery Company, Ltd (ZPMC), Changxing Island**NCR #:** ZPMC-0241**Type of problem:**

Reference Description: Continuity Plate Retrofit, Doubler Plates**Description of Non-Conformance:**

Job Name: SAS Superstructure

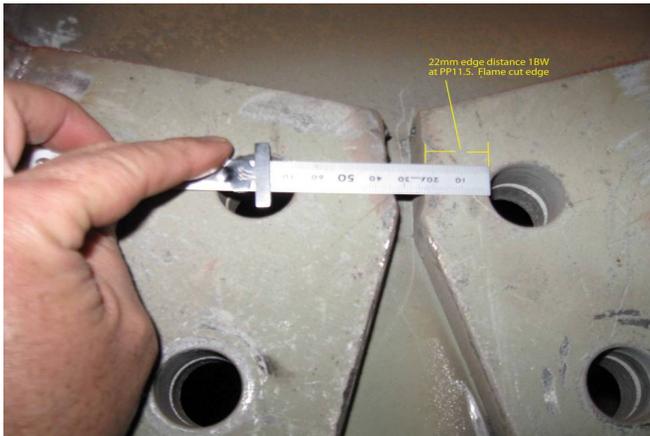
At locations where there are consecutive doubler plates between the closed ribs, trimming the corners of the doublers is necessary for proper fit-up. On Segment 1BW, Panel points PP11.5 and PP12.5, the bolt hole edge distance to the trimmed (flame cut) edge of the doubler plates was observed to be 22mm (edge of hole to edge of plate). This does not meet the minimum edge distance requirement of 1.75D, which in this case is 28.5mm from the edge of the 27mm hole to the edge of plate.

At locations where there are consecutive doubler plates between the closed ribs, trimming the corners of the doublers is necessary for proper fit-up. On Segment 1BW, Panel points PP11.5 and PP12.5, the bolt hole edge distance to the trimmed (flame cut) edge of the doubler plates was observed to be 22mm (edge of hole to edge of plate). This does not meet the minimum edge distance requirement of 1.75D, which is 42mm.

With this letter of response, ZPMC requests closure for Caltrans NCR-00267(ZPMC-0241). We have prepared one internal NCR for the fabrication, with the response from the technology, the bolt hole edge distance should be within the tolerance of the AISC specification, in the code we can find the minimum distance should be 34mm, and subtract the radius, then we think the 20.5mm is enough and also reach the requirement.

Reference Resolution: Fitting these plates required trimming the corners, in doing so, ZPMC violated the edge distance. ZPMC will grind the Flame cut edge sufficiently and submit an RFI requesting to leave as is.

The proposed resolution is acceptable. RFI-1783 approved these bolt hole edge distances as fit for purpose at these locations. The Department concurs that Non-Conformance ZPMC-0241 is closed.

Bolt holes were determined to be fit for purpose by RFI 1783.
