Contract #: 04-0120F4Cty: SF/ALA Rte: 80 PM: 13.2/13.9File #: 69.25B**QUALITY ASSURANCE -- NON-CONFORMANCE REPORT****Location:** Changxing Island, Shanghai, PRC**Report No:** NCR-000268**Prime Contractor:** American Bridge/Fluor Enterprises, a JV**Date:** 17-May-2009**Submitting Contractor:** Zhenhua Port Machinery Company, Ltd (ZPMC), Changxing Island**NCR #:** ZPMC-0242**Type of problem:**

Reference Description: East Tower, Lift 1, Visual Indications Between 43m to 47.6m Diaphragms after Shot Blast**Description of Non-Conformance:**

Reference Description: Visual Indications After Shot Blasting / Tower East Shaft Lift 1 / Between 43m to 47.6m Diaphragms

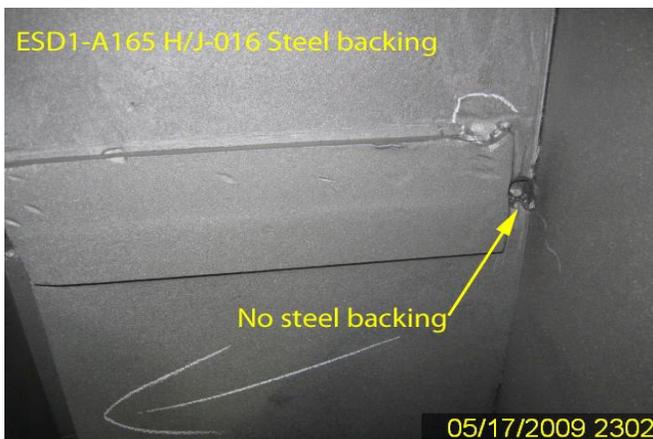
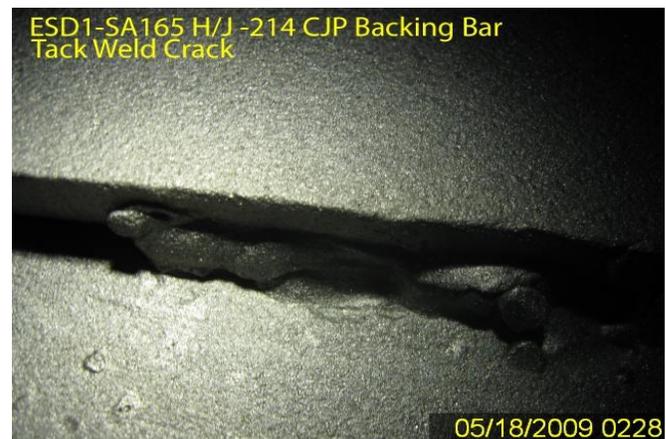
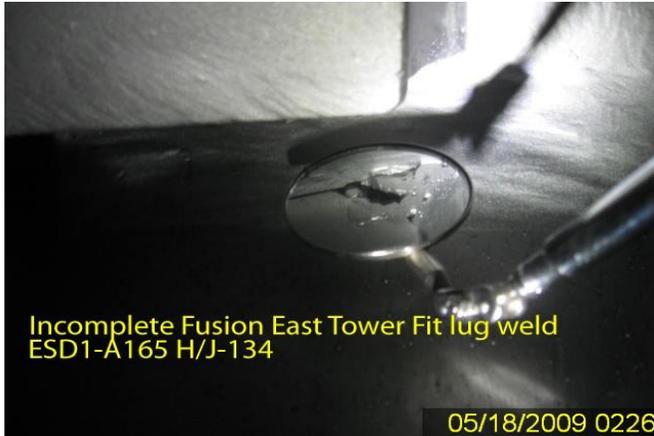
QA performed random internal visual inspection of East Tower, Lift 1 between 43m and 47.6m diaphragms after grit blasting. It was observed that steel backing tack welds were cracked for 47.6m diaphragm to diaphragm insert plate CJP welds at Skin AE and ED corners. ZPMC personnel did not weld a continuous fillet the full length of the steel backing. ZPMC backing for Weld ESD1-A165 H/J-016 did not run the full length of the weld. It was also noted that gouges up to 4 mm were found at steel backing tack weld locations. Other discontinuities were found including slag, porosity, crater cracks, weld spatter, base metal gouges, and arc strikes.

AWS D1.5-2002, Section 6.26.2 – Welds that are subject to MT in addition to visual inspection shall have no cracks.

AWS D1.5-2002, Section 3.3.7.6 - Tack welds used to attach steel backing and placed external to the weld joint shall be made continuous by fillet welding for the full length of the backing or shall be removed.

AWS D1.5 (02) Section 3.13.2- “Groove welds made with the use of steel backing shall have the weld metal thoroughly fused with the backing. Steel backing shall be continuous for the full length of each weld made with backing”

Reference Resolution: ZPMC will grind away the cracked tack welds. As for the lack of backing plate, ZPMC will backgouge this area and repair. All welds will be re-inspected as required.

1、 About ESD1-A165H/J-016 we did the grind work at the area which did not run the full length of the weld(see the NCR photo)and did the MT work, then re-welded this area and at last we did the MT+UT about this weld to make sure no problem about this weld.

2、 About the ESD1-A165H/J-214 we did the grind work then did the MT to make remove the tack crack.

3、 About the ESD1-A165H/J-134 we did the grind work then weld then MT+UT to make sure no problem about this fit lug.

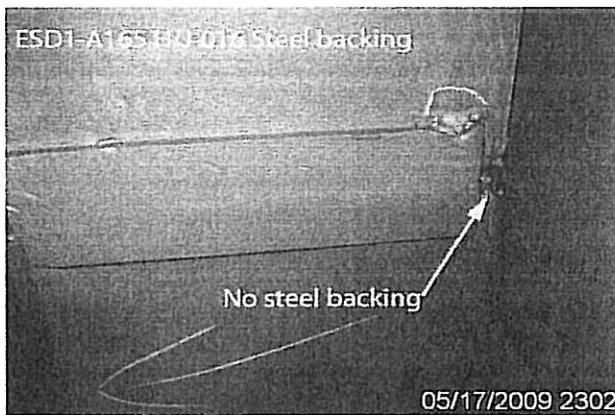
QA performed random internal visual inspection of East Tower, Lift 1 between 43m and 47.6m diaphragms after grit blasting. It was observed that steel backing tack welds were cracked for 47.6m diaphragm to diaphragm insert plate CJP welds at Skin AE and ED corners. ZPMC personnel did not weld a continuous fillet the full length of the steel backing. ZPMC backing for Weld ESD1-A165 H/J-016 did not run the full length of the weld. It was also noted that gouges up to 4 mm were found at steel backing tack weld locations. Other discontinuities were found including slag, porosity, crater cracks, weld spatter, base metal gouges, and arc strikes.

AWS D1.5-2002, Section 6.26.2 – Welds that are subject to MT in addition to visual inspection shall have no cracks.

AWS D1.5-2002, Section 3.3.7.6 - Tack welds used to attach steel backing and placed external to the weld joint shall be made continuous by fillet welding for the full length of the backing or shall be removed.

AWS D1.5 (02) Section 3.13.2- "Groove welds made with the use of steel backing shall have the weld metal thoroughly fused with the backing. Steel backing shall be continuous for the full length of each weld made with backing"
