Contract #: 04-0120F4
 Cty: SF/ALA Rte: 80 PM: 13.2/13.9
 File #: 69.25B

QUALITY ASSURANCE -- NON-CONFORMANCE REPORT

Report No: NCR-000270

Reference Description: Missed NDT Indications by Quality Control, Segment 1AAW

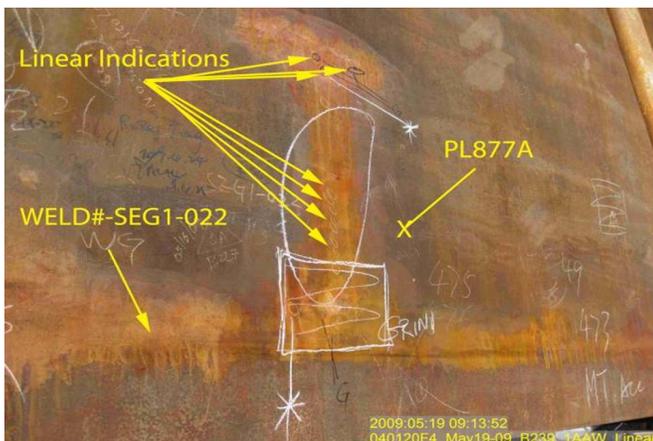
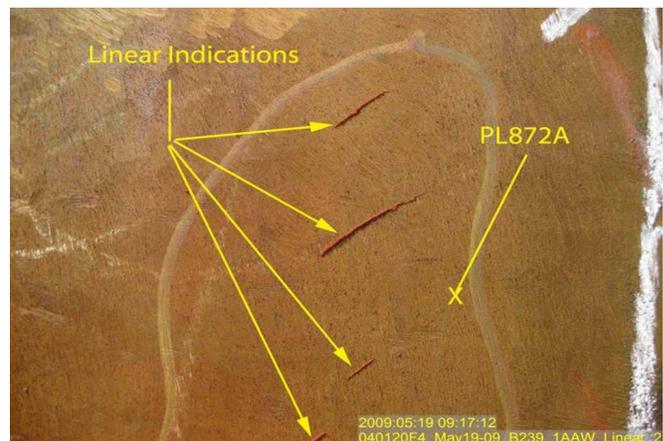
During random verification Magnetic Particle Testing (MT) of 1AAW, Top plate and Top plate to Bulkhead plate welds (SEG001-001, 017, 019, 020, 022, 023 and 026), Caltrans Quality Assurance (QA) Inspector discovered a total of forty nine (49) linear indications from 5 to 75mm in length. These areas have been previously tested and accepted by ZPMC NDT personnel.

AWS D1.5 (02) Section 6.26.2 – “Welds that are subject to MT in addition to visual inspection shall have no cracks”

Please provide documentation of the weld repairs that were performed and that the repairs were acceptable. The Department will review the Contractor's proposal to close Non-Conformance ZPMC-0244 at that time.

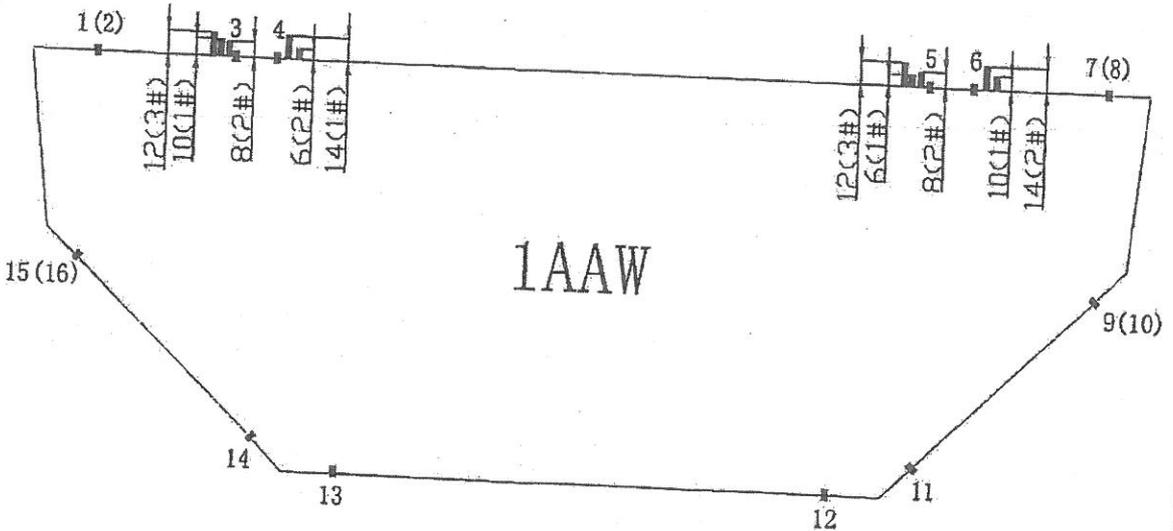
Draft of Welding Discontinuity:

Ten transverse cracks were found by use of MT in material after removing lifting.

1、L=10mm; 2、L=8mm; 3、L=12mm; 4、L=14mm; 5、L=6mm; 6、L=6mm; 7、L=8mm; 8、L=12mm; 9、L=10mm; 10、L=14mm;

1. The tack crack was caused during assembly lifting, and cracks extended to base metal after removing lifting.
2. Welding contraction stresses and insufficient preheat and post heat control caused the crack.

1. 采用打磨的方式去除裂纹;
 2. 准备一个正确的接头型式, 具体参照相应的返修WPS;
 3. VT和MT检测确认返修区域没有裂纹;
 4. 根据批准的返修焊接工艺规程
 5. 预热温度应不小于100℃,
 6. 预热范围在修补区域周围不应小于150mm;
 7. 将修补区域打磨与母材或相邻焊缝平齐;
 8. 对修补区域做VT与MT检测.
1. Remove the crack by means of grinding.
 2. Prepare excavation according to the approved repair WPS.
 3. Verify with VT and MT repair areas are crack free.
 4. Preheat and weld according to the approved repair WPS.
 5. Preheat prior to welding to a minimum temperature of 100°C
 6. The preheat area shall be a minimum of 150mm in all directions around the repair area.
 7. Grind the repaired area flush with base metal or the adjacent weld.
 8. Perform VT and MT of the repair areas.

- 加强装配和焊接时监控和控制, 减少点焊裂纹;
 - 在焊后严格控制其后热程序, 避免裂纹现象发生。
- Enhance supervision and controlling during assembly and welding to reduce tack welding cracks.
 - Enhance supervision during the post heating operation to avoid cracks.

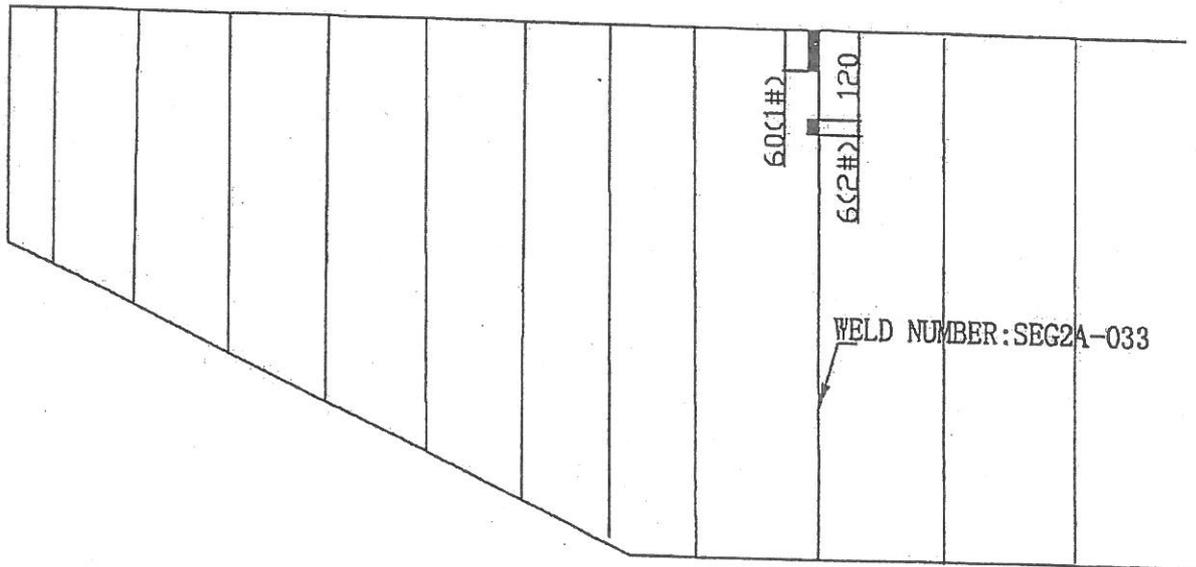
Draft of Welding Discontinuity:

We found two longitudinal cracks in SEG2A-033.

1. 火焰加热时, 水汽没有完全的去掉或者这个区域预热不够;
1. Moisture wasn't completely removed during drying operation (preheating) or the area wasn't preheated sufficiently.

1. 采用打磨的方式去除裂纹;
 2. 准备一个正确的接头型式, 具体参照相应的返修WPS;
 3. VT和MT检测确认返修区域没有裂纹;
 4. 根据批准的返修焊接工艺规程
 5. 预热温度应不小于100℃;
 6. 预热范围在修补区域周围不应小于150mm;
 7. 将修补区域打磨与母材或相邻焊缝平齐;
 8. 对修补区域做VT与MT检测。
1. Remove the crack by means of grinding.
 2. Prepare excavation according to the approved repair WPS.
 3. Verify with VT and MT repair areas are crack free.
 4. Preheat and weld according to the approved repair WPS.
 5. Preheat prior to welding to a minimum temperature of 100°C
 6. The preheat area shall be a minimum of 150mm in all directions around the repair area.
 7. Grind the repaired area flush with base metal or the adjacent weld.
 8. Perform VT and MT of the repair areas.

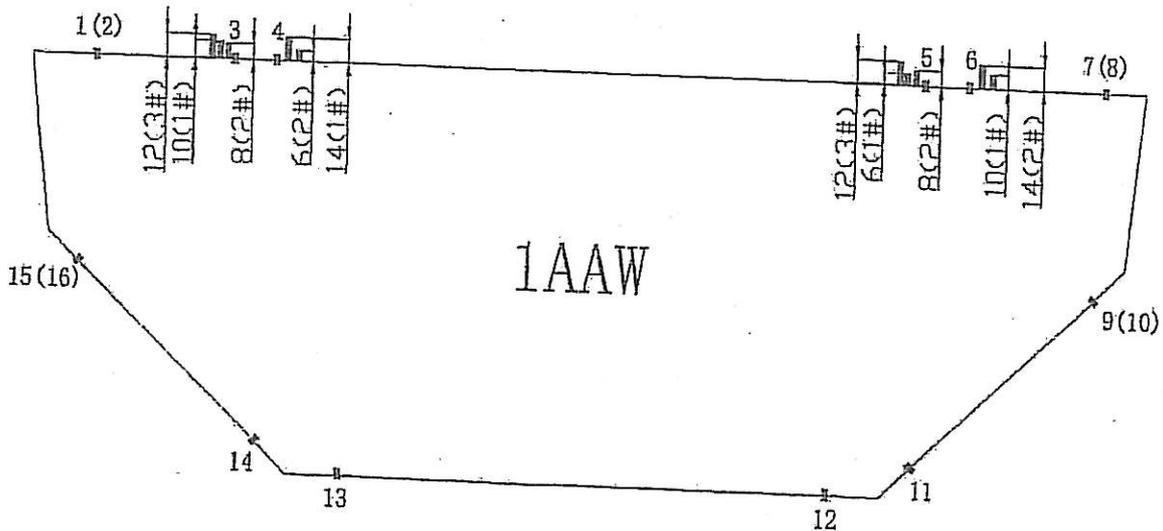
Draft of Welding Discontinuity:

Ten transverse cracks were found by use of MT in material after removing lifting.

- 1. The lack crack was caused during assembly lifting, and cracks extended to base metal after removing lifting.
- 2. Welding contraction stresses and insufficient preheat and post heat control caused the crack.

- 1. Remove the crack by means of grinding.
- 2. Prepare excavation according to the approved repair WPS.
- 3. Verify with VT and MT repair areas are crack free.
- 4. Preheat and weld according to the approved repair WPS.
- 5. Preheat prior to welding to a minimum temperature of 100°C
- 6. The preheat area shall be a minimum of 150mm in all directions around the repair area.
- 7. Grind the repaired area flush with base metal or the adjacent weld.
- 8. Perform VT and MT of the repair areas.

1. Enhance supervision and controlling during assembly and welding to reduce tack welding cracks.

2. Enhance supervision during the post heating operation to avoid cracks.
