Contract #: 04-0120F4Cty: SF/ALA Rte: 80 PM: 13.2/13.9File #: 69.25B**QUALITY ASSURANCE -- NON-CONFORMANCE REPORT****Location:** Changxing Island, Shanghai, PRC**Report No:** NCR-000273**Prime Contractor:** American Bridge/Fluor Enterprises, a JV**Date:** 20-May-2009**Submitting Contractor:** Zhenhua Port Machinery Company, Ltd (ZPMC), Changxing Island**NCR #:** ZPMC-0247**Type of problem:**

Reference Description: East Tower, Lift 1 unacceptable weld on backing plate at diaphragm corner piece**Description of Non-Conformance:**

Job Name: SAS Superstructure
Document No: 05.03.06-000238

Reference Description: Backing Plate Welds / East Shaft Lift 1 / Diaphragm Corner Plate

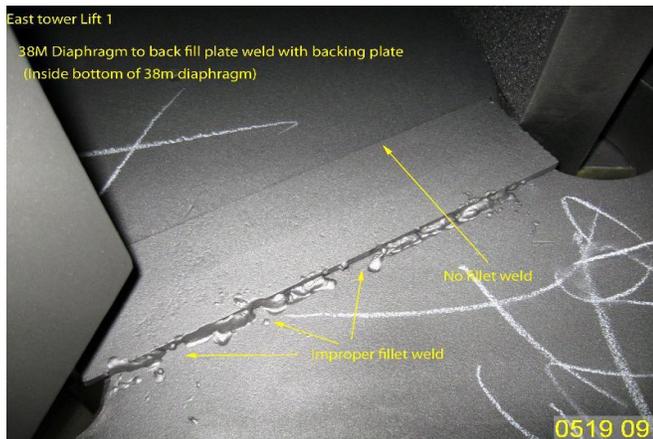
During random visual inspection of East Tower, Lift 1, after grit blasting, QA observed that tack welds used to attach steel backing were placed external to the weld joint but were not made by continuous fillet welding for the full length of the backing plate at weld joint ESD1-A165F/J-97. This weld was previously tested and accepted by ZPMC personnel.

AWS D1.5-2002, Section 3.3.7.6 - Tack welds used to attach steel backing and placed external to the weld joint shall be made continuous by fillet welding for the full length of the backing or shall be removed.

The proposed resolution is acceptable. The intermittent tack welds attaching the backing bar have been removed, and the welds in question have been accepted by MT and UT as shown in the attached documents. The Department concurs that Non-Conformance ZPMC-0247 is closed.
