Contract #: 04-0120F4Cty: SF/ALA Rte: 80 PM: 13.2/13.9File #: 69.25B**QUALITY ASSURANCE -- NON-CONFORMANCE REPORT****Location:** Changxing Island, Shanghai, P.R. China**Report No:** NCR-000274**Prime Contractor:** American Bridge/Fluor Enterprises, a JV**Date:** 20-May-2009**Submitting Contractor:** Zhenhua Port Machinery Company, Ltd (ZPMC), Changxing Island**NCR #:** ZPMC-0248**Type of problem:****Welding****Concrete****Other****Welding****Curing****Procedural****Bridge No:** 34-0006**Joint fit-up****Coating****Other****Component:** OBG Segments 2AW, 2BW**Procedural****Procedural****Description:****Reference Description:** Welding Wet Material, OBG Segment Slice 2AW/2BW**Description of Non-Conformance:**

Dear: Mr. Charles Kanapicki
Job Name: SAS Superstructure

Reference Description: Welding Wet Material, OBG Segment Slice 2AW/2BW

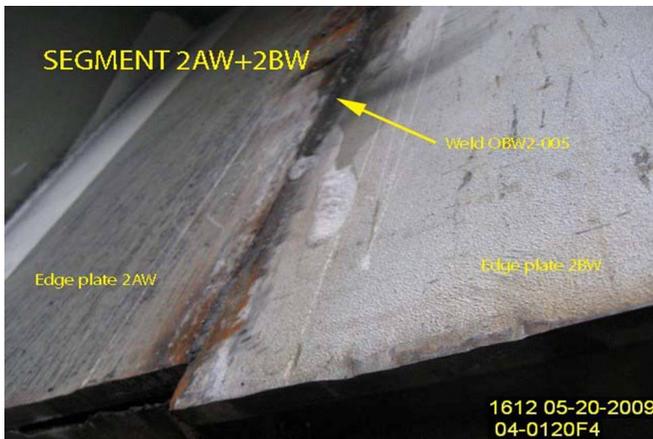
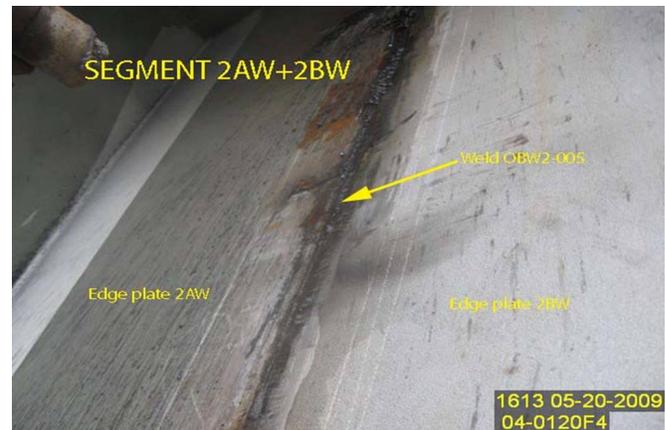
Caltrans Quality Assurance (QA) Inspector observed ZPMC welding personnel perform SMAW welding on SPCM material while the material was wet. The weld joint is identified as OBW2-005(segment splice 2AW-2BW).

- 1) AWS D1.5 2002 section 3, paragraph 3.1.3 "Welding shall not be done when the surfaces are wet or exposed to rain.
- 2) AWS D1.5 2002 section 3, paragraph 3.2.1 "Surfaces to be welded and surfaces adjacent to a weld shall also be free from moisture that would prevent proper welding.

Reason for Nonconformance:
 不符合原因:
 由于坡口表面潮湿没有烘干使用手工焊焊接。
 The groove surface was wet, and didn't dry before welding.
 预防措施:
 加强现场监控或检查。
 Enhance supervision and inspection on-site.
 Approved by/批准: Gao JUN 01.6.5

The proposed resolution is not acceptable. In the areas that were welded while wet, the welds shall be removed and re-welded.

Please provide documentation of the weld removal, and provide inspection documents for the welds after they have been re-welded. The Department will review the Contractor's proposal to close Non-Conformance ZPMC-0248 at that time.

ZPMC has submitted the required documentation verifying the weld is in conformance and has enhanced on-site supervision of welders.
