DEPARTMENT OF TRANSPORTATION

Contract #: 04-0120F4Cty: SF/ALA Rte: 80 PM: 13.2/13.9File #: 69.25B**QUALITY ASSURANCE -- NON-CONFORMANCE REPORT****Location:** Changxing Island, Shanghai, PRC**Report No:** NCR-000275**Prime Contractor:** American Bridge/Fluor Enterprises, a JV**Date:** 25-May-2009**Submitting Contractor:** Zhenhua Port Machinery Company, Ltd (ZPMC), Changxing Island**NCR #:** ZPMC-0249**Type of problem:****Welding****Concrete****Other****Welding****Curing****Procedural****Bridge No:** 34-0006**Joint fit-up****Coating****Other****Component:** North Tower, Lift 3, Skin E**Procedural****Procedural****Description:** North Tower, Lift 3, Skin E**Reference Description:** Inadequate preheat on North Tower, Lift 3, Skin E doubler plate welds**Description of Non-Conformance:**

Reference Description: Preheat / North Shaft Lift 3 Skin E / Doubler Plate to Skin Plate Weld

Reference Description: Inadequate preheat on North Tower, Lift 3, Skin E doubler plate welds

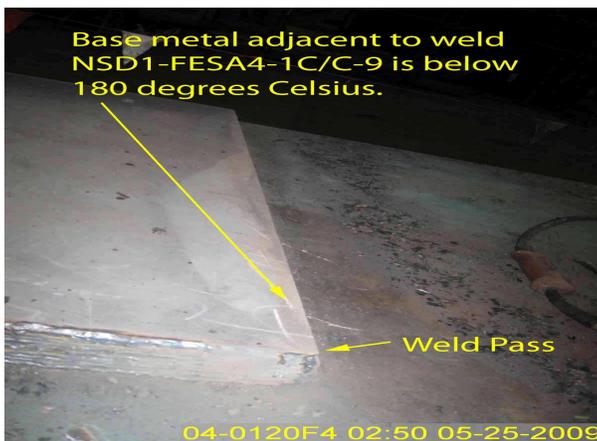
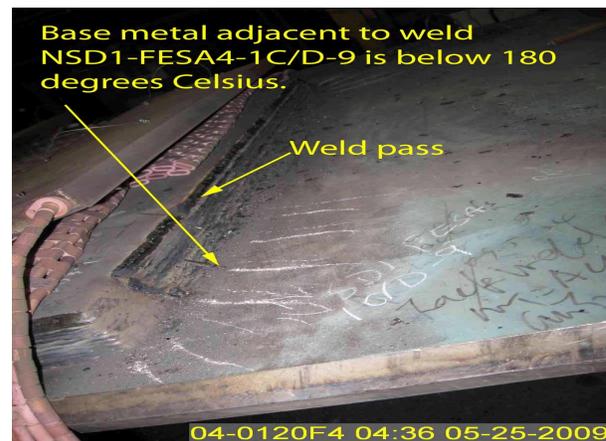
QA observed ZPMC personnel welding North Tower, Skin E, Lift 3 doubler plate welds

NSD1-FESA3-1D/D-9, NSD1-FESA3-1DD-18 and NSD1-FESA3-1C/D-9 without the required base metal preheat. The photographs below indicate an unmelted 180 degree Celsius temperature indicating crayon adjacent to welds NSD1-FESA3-1C/D-9 and NSD1-FESA3-1D/D-9.

Welding procedure WPS B-T-4332-TC-P6-F requires a minimum base material preheat temperature of 180 degrees Celsius.

Reference Resolution: ABF QCM has informed ZPMC QA and QC to first educate the person (s) performing the pre-heat of the WPS requirements to pre-heat based on material thickness as well as the welder.

The Non-Destructive Testing (NDT) for these welds should be at least 72 hours after welding to ensure that there are no delayed cracks from any possible hydrogen contamination.

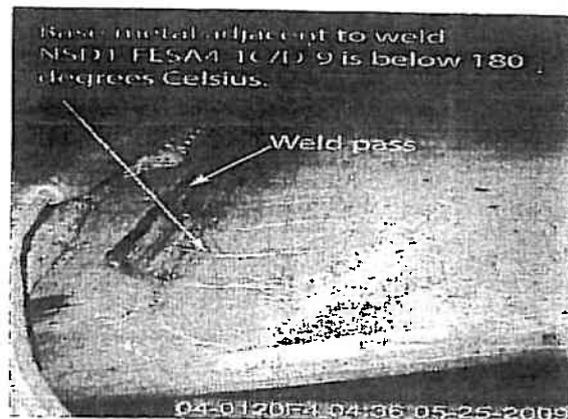
QA observed ZPMC personnel welding North Tower, Skin E, Lift 3 doubler plate welds NSD1-FESA3-1D/D-9, NSD1-FESA3-1DD-18 and NSD1-FESA3-1C/D-9 without the required base metal preheat. The photographs below indicate an unmelted 180 degree Celsius temperature indicating crayon adjacent to welds NSD1-FESA3-1C/D-9 and NSD1-FESA3-1D/D-9.

Welding procedure WPS B-T-4332-TC-P6-F requires a minimum base material preheat temperature of 180 degrees Celsius.

Propose a resolution for the identified non-conformance including documentation that the welds placed are in compliance with the contract requirements. In addition to the material/workmanship non-conformance, propose a resolution that addresses the failure of Quality Control to identify the lack of preheat of the base material. Provide documentation of the steps taken by the Quality Control Manager to prevent future occurrences.
