Contract #: 04-0120F4Cty: SF/ALA Rte: 80 PM: 13.2/13.9File #: 69.25B**QUALITY ASSURANCE -- NON-CONFORMANCE REPORT****Location:** Changxing Island, Shanghai, PRC**Report No:** NCR-000276**Prime Contractor:** American Bridge/Fluor Enterprises, a JV**Date:** 25-May-2009**Submitting Contractor:** Zhenhua Port Machinery Company, Ltd (ZPMC), Changxing Island**NCR #:** ZPMC-0250**Type of problem:**

QUALITY ASSURANCE -- NON-CONFORMANCE REPORT

Report No: NCR-000276

NCR #: ZPMC-0250

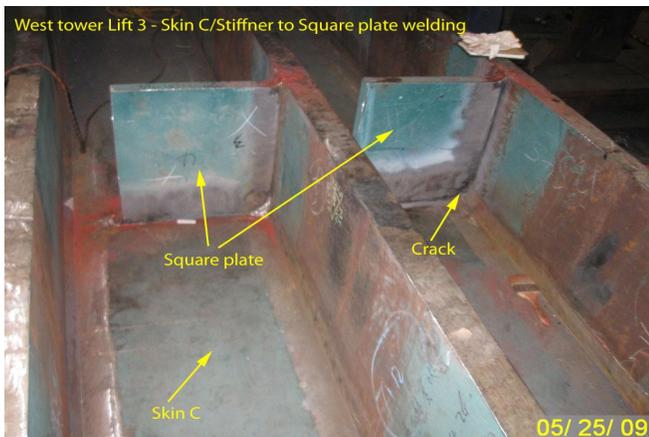
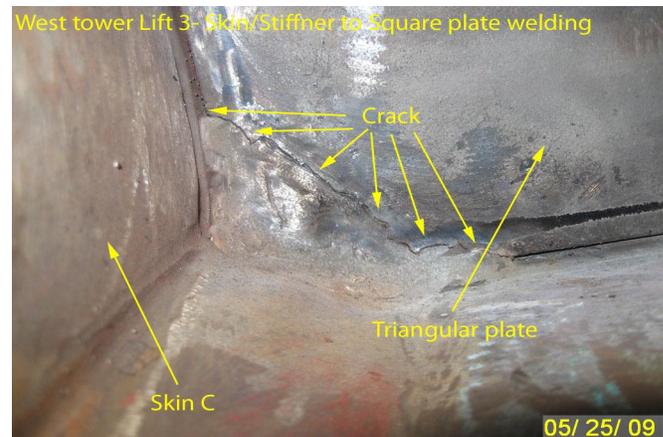
During random verification of West Tower, Lift 3, Skin C welds, QA discovered a linear indication at the toe of fillet weld WSD1-FCSA3-2C/C-3,4. This weld was previously tested and accepted by ZPMC personnel.

AWS D1.5-2002 Section 6.26.1.1 "The welds shall have no cracks."

Section 6.26.1.2 "Thorough fusion shall exist between adjacent layers of weld metal and between weld metal and base metal."

Reference Resolution: ZPMC has repaired the missed indication and performed MT to ensure that the weld is acceptable. In the future, ZPMC QC will ensure that the weld is preheat sufficiently to eliminate the hydrogen.

ZPMC has repaired the missed indication and performed MT to ensure that the weld is acceptable. ZPMC believes that this indication was the result of insufficient preheat of to remove the hydrogen from the weld. In the future, ZPMC QC will ensure that the weld is preheat sufficiently to eliminate the hydrogen. Additionally, the ABFJV QCM will has schedule training on the topic of pre heat for the QC inspectors.

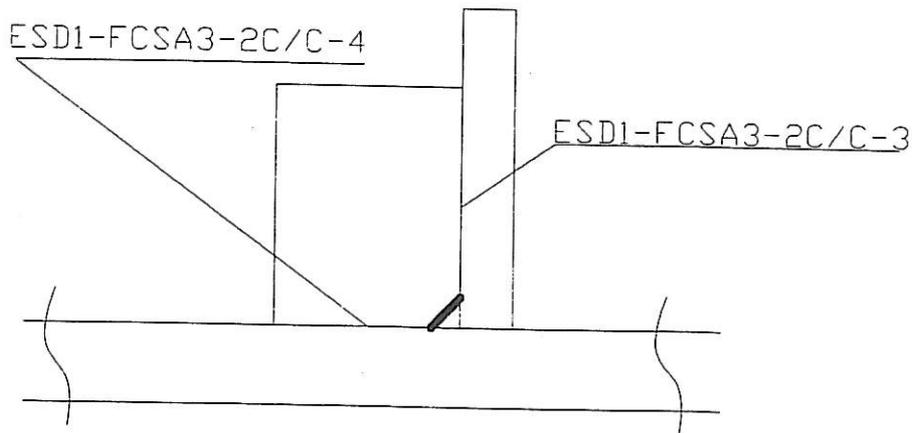
The linear defect was found at weld WSD1-FCSA3-2C/C-3,4 of west tower Skin C stiffener, the detail sees the following draft.

注:阴影部分为缺陷位置 Remark: defect position in shadow.

1. 火焰加热时, 水汽没有完全的去掉或者这个区域预热不够;
1. Moisture wasn't completely removed during drying operation (preheating) or the area wasn't preheated sufficiently.

1. QC shall verify sufficient preheat has been applied, to remove moisture, prior to welding.

1. QC shall monitor gouging/grinding/welding
2. Gouge defects & grind smoothly
3. Verify that defects have been removed with VT
4. Welding shall be in accordance with WPS
5. QC shall ensure all slag is removed prior to deposition of subsequent weld passes
6. Blend repair area with adjacent base metal
7. Perform VT, MT, & UT to repaired area

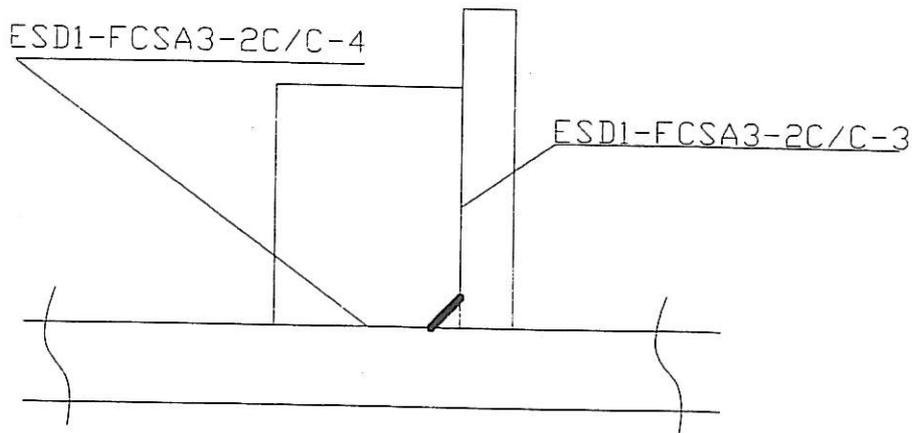
The linear defect was found at weld WSD1-FCSA3-2C/C-3,4 of west tower Skin C stiffener, the detail sees the following draft.

注:阴影部分为缺陷位置 Remark: defect position in shadow.

1. 火焰加热时, 水汽没有完全的去掉或者这个区域预热不够;
1. Moisture wasn't completely removed during drying operation (preheating) or the area wa sn't preheated sufficiently.

1. QC shall verify sufficient preheat has been applied, to remove moisture, prior to welding.

1. QC shall monitor gouging/grinding/welding
2. Gouge defects & grind smoothly
3. Verify that defects have been removed with VT
4. Welding shall be in accordance with WPS
5. QC shall ensure all slag is removed prior to deposition of subsequent weld passes
6. Blend repair area with adjacent base metal
7. Perform VT, MT, & UT to repaired area
