QUALITY ASSURANCE -- NON-CONFORMANCE REPORT

Report No: NCR-000277

NCR #: ZPMC-0251

Reference Description: South Tower, 135m Diaphragm inadequate pre-heat

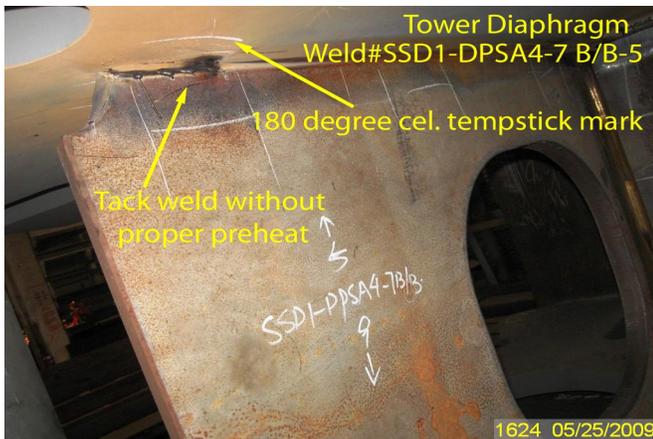
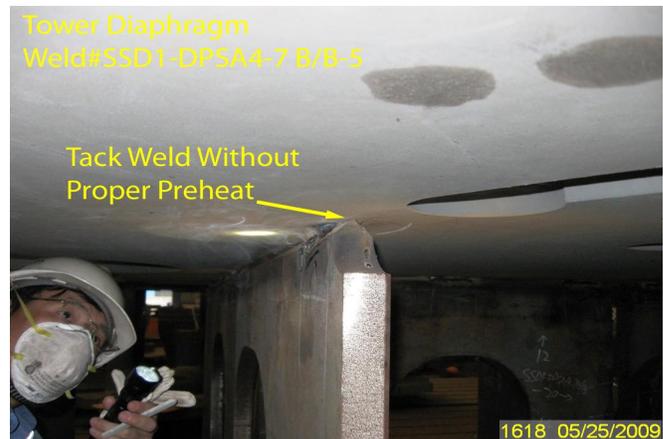
QA observed tack welding without adequate pre-heat on tower diaphragm weld joint SSD1-DPSA4-7 B/B-5. The recorded temperature at the tack weld and adjacent base material was 100 degrees Celcius. The required pre-heat temperature according to approved WPS is 180 degrees Celcius.

AWS D1.5-2002 Section 3.3.7.1 "Tack welds shall be subject to the same quality requirements as final welds"

Propose a resolution for the identified non-conformance including documentation that the tack welds placed are in compliance with the contract requirements. In addition to the material/workmanship non-conformance, propose a resolution that addresses the failure of Quality Control to identify the lack of preheat of the base material. Provide documentation of the steps taken by the Quality Control Manager to prevent future occurrences.

The Non-Destructive Testing (NDT) for this weld should be at least 72 hours after welding to ensure that there are no delayed cracks from any possible hydrogen contamination.
