Contract #: 04-0120F4Cty: SF/ALA Rte: 80 PM: 13.2/13.9File #: 69.25B**QUALITY ASSURANCE -- NON-CONFORMANCE REPORT****Location:** Changxing Island, Shanghai, PRC**Report No:** NCR-000278**Prime Contractor:** American Bridge/Fluor Enterprises, a JV**Date:** 26-May-2009**Submitting Contractor:** Zhenhua Port Machinery Company, Ltd (ZPMC), Changxing Island**NCR #:** ZPMC-0252**Type of problem:**

Reference Description: Missing backing bar at East Tower, Lift 1, 18m Diaphragm CJP weld**Description of Non-Conformance:**

Job Name: SAS Superstructure

Subject: NCR No. ZPMC-0252

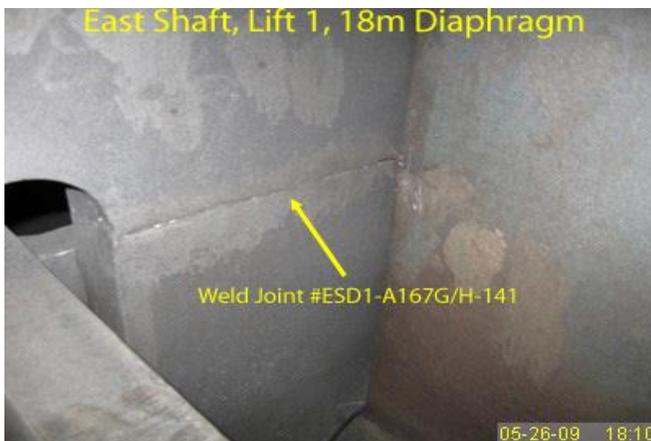
During random after-blast visual verification of East Tower, Lift 1, QA observed that there was no backing bar at 18m diaphragm weld joint ESD1-A167G/H-141.

Approved Weld Joint Detail No. WT-63 requires a backing bar.

Propose a resolution for the identified non-conformance including documentation that the deficiency has been brought into compliance with the contract requirements.

Reference Resolution: The backing bar was removed to repair an indication found by UT from the opposite side. It was not feasible to repair from the other side, also the backing bar is not required for structural purposes

Backgouge and reweld affected weld.

The weld has been backgouged and rewelded. NDT results indicating a sound weld have been submitted and the weld has been verified by QA.
