Contract #: 04-0120F4Cty: SF/ALA Rte: 80 PM: 13.2/13.9File #: 69.25B**QUALITY ASSURANCE -- NON-CONFORMANCE REPORT****Location:** Changxing Island, Shanghai, P.R. China**Report No:** NCR-000279**Prime Contractor:** American Bridge/Fluor Enterprises, a JV**Date:** 21-May-2009**Submitting Contractor:** Zhenhua Port Machinery Company, Ltd (ZPMC), Changxing Island**NCR #:** ZPMC-0253**Type of problem:**

**Reference Description:** Heat Straightening Without Approved Procedure, Crossbeam CB7**Description of Non-Conformance:**

**Job Name:** SAS Superstructure

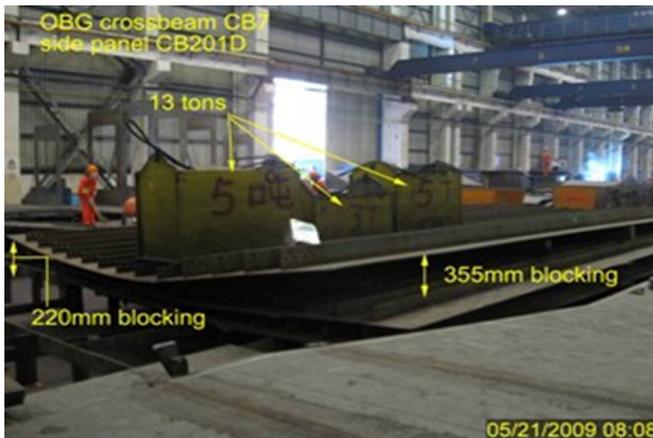
Caltrans Quality Assurance (QA) Inspector observed that the Contractor has performed heat straightening without an approved procedure on Crossbeam CB7 (Side Panel). The procedure presented to QA Inspector indicated that the distortion was 5mm on 18mm plate. Furthermore, the Contractor's personnel did not follow the available procedure on the shop floor. The procedure did not indicate the use of blocks under each edge of the panel as shown in the photo below.

1. ZPMC Heat Straightening Report number HSR1(B)-6427
2. AWS D1.5 2002 section 3.7.3 "Members distorted by welding shall be straightened by mechanical means or by carefully supervised application of a limited amount of localized heat as approved by the Engineer."
3. Contract Special Provisions 8-3.01 "for material more than 16mm, the contractor shall not heat straighten members more than 3 in 1000 without prior approval of the Engineer."

**Reference Resolution:** ABF has instructed ZPMC to provide an HSR that properly documents the method of heat straightening, furthermore, ZPMC is to address all affected welds by providing the necessary NDT reports.

ABF has instructed ZPMC to provide an HSR that properly documents the method of heat straightening, furthermore, ZPMC is to address all affected welds by providing the necessary NDT reports. ZPMC has been instructed by the ABF QCM to perform heat straightening in strict accordance with the special provisions. ZPMC will provide the required documentation at a later date.

Please provide documentation of the heat straightening that was performed and inspection documents on all affected welds. The Department will review the Contractor's proposal to close Non-Conformance ZPMC-0253 at that time.

ZPMC acknowledged this problem and has issued internal NCR. ZPMC will enhance QC to control the Heat Straightening work according to approved procedure. To ensure the affected weld quality, ZPMC performed VT and MT on it.

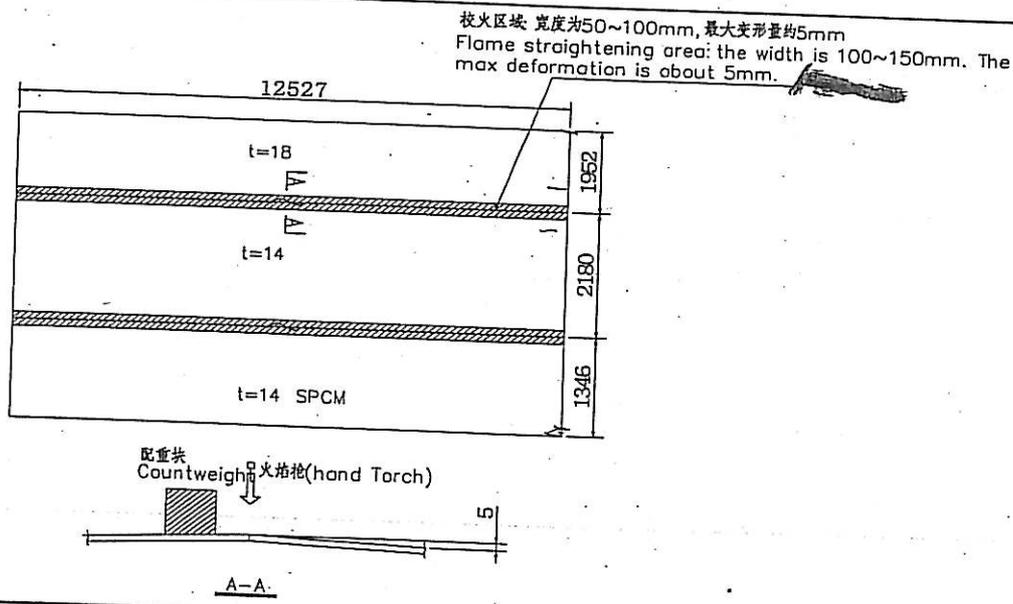
简图 Sketch

Cause 原因: Welding distortion 焊接变形  
 Type of Defect 缺陷类型: Welding distortion 焊接变形  
 Inspection Method 检查方法: Visual 目检

缺陷去除方法 (Defect Removal Method): Flame Straightening by oxygen acetylene  
 后续 NDE (Post-Removal NDE): After finishing heat straightening, the weld of the heat area shall perform NDT according to the approved shop drawing.  
 纠正措施 (Corrective Action(s)): Control current, voltage and weld speed according to relevant WPS. If necessary anti-deformation or hold down device can be added.  
 实施次数 (Number of application): 1~3  
 最高温度 (Maximum temperature): <600°C
