Contract #: 04-0120F4Cty: SF/ALA Rte: 80 PM: 13.2/13.9File #: 69.25B**QUALITY ASSURANCE -- NON-CONFORMANCE REPORT****Location:** Changxing Island, Shanghai, P.R. China**Report No:** NCR-000280**Prime Contractor:** American Bridge/Fluor Enterprises, a JV**Date:** 26-May-2009**Submitting Contractor:** Zhenhua Port Machinery Company, Ltd (ZPMC), Changxing Island**NCR #:** ZPMC-0254**Type of problem:**

Reference Description: Missed UT Indication by QC Technician, SB006-028**Description of Non-Conformance:**

Subject: NCR No. ZPMC-0254

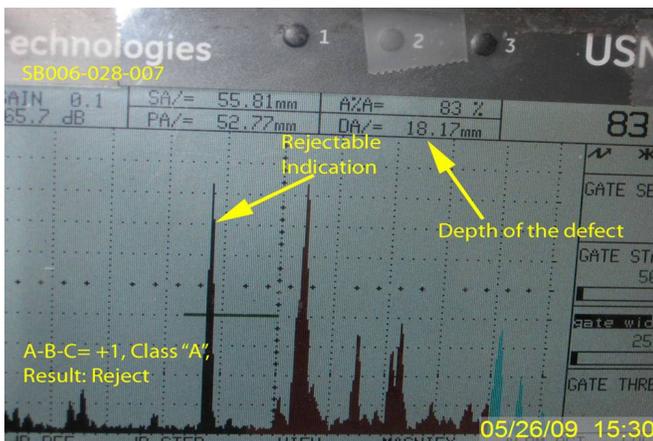
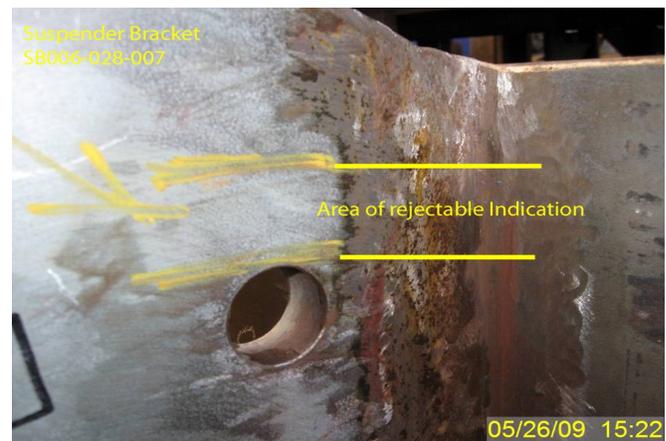
Caltrans Quality Insurance (QA) Inspector performed 10% verification ultrasonic testing (UT) on weld joint identified as SB006-028-007 for Suspender Bracket SB006-028. QA Inspector discovered a class "A" rejectable indication measuring approximately 52mm in length. This weld was previously tested and accepted by ZPMC quality control (QC) UT technicians.

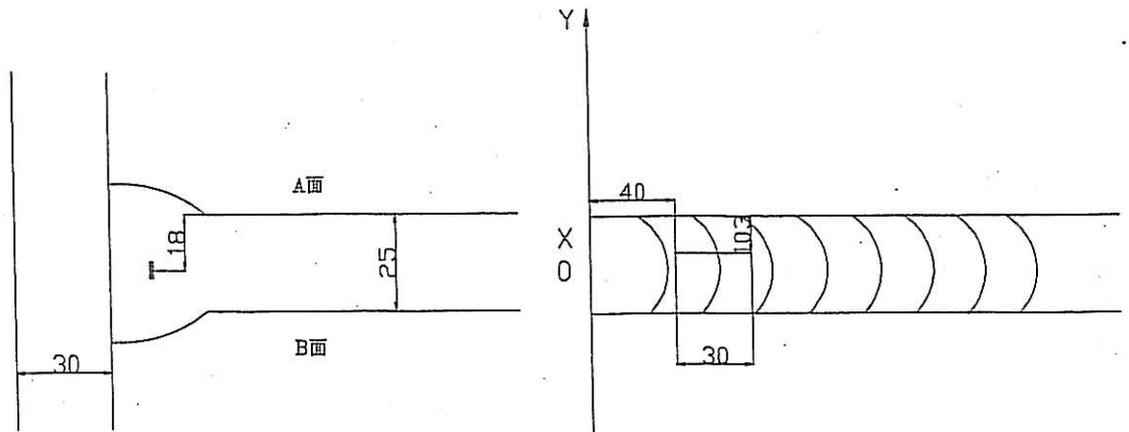
WELD NUMBER: SB006-028-007

Rejected indication found by ultrasonic inspection is less than the maximum allowance aggregate length.

1. Did not clear the weld pass completely in time.

1. Gouge or grind from nearer side from metal edge ($D \leq 0.65T$, "D" is depth of defects, "T" is thickness of metal) to remove all defects;
2. Follow repair WPS for joint preparation, preheat, and weld deposit;
3. Verify with VT no defects remain in the weld joint prior to welding;
4. Grind the repaired area flush with base metal or the adjacent weld;
5. Check the welds according to the working drawings.
