Contract #: 04-0120F4  
 Cty: SF/ALA Rte: 80 PM: 13.2/13.9  
 File #: 69.25B

## QUALITY ASSURANCE -- NON-CONFORMANCE REPORT

**Report No:** NCR-000282

**Reference Description:** Bolt Traceability, Segment 3BE

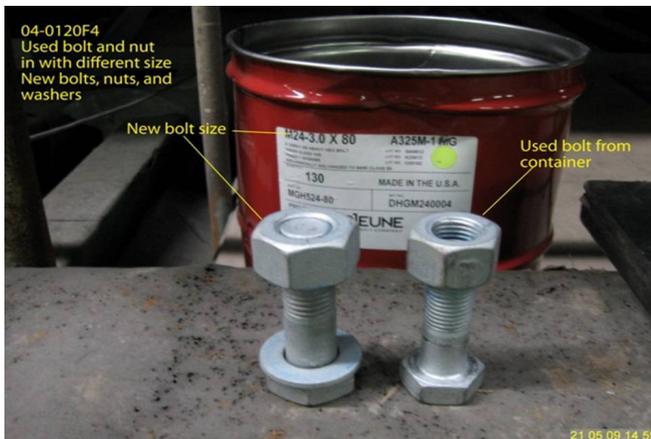
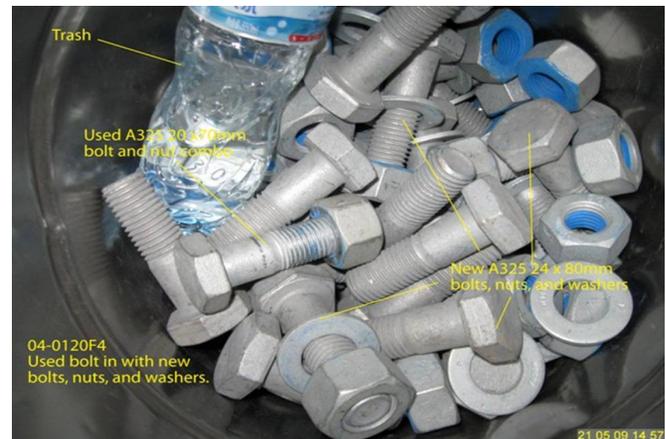
The Contractor failed to segregate used (previously tensioned) fasteners from new fasteners to prevent reuse. Observations of the bolting activities in 3BE revealed one bolt keg marked as size (24 x 80mm) A325 bolts that actually contained both new and used (20 x 70mm) A325 bolts, nuts, and washers.

Standard Specifications and Specifications for Structural Joints Using ASTM A325 bolts, Section 2, Fastener Components, paragraphs:

2.2 Storage of Fastener Components,

2.3.3 Reuse

Please propose a resolution for the identified non-conformance to prevent future occurrences. Means shall be taken to avoid using of used galvanized ASTM A325 bolts.

ZPMC has responded that they will segregate the bolts and provide proper storage.

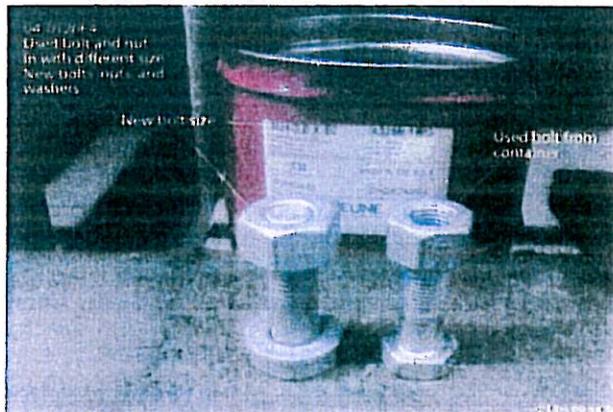
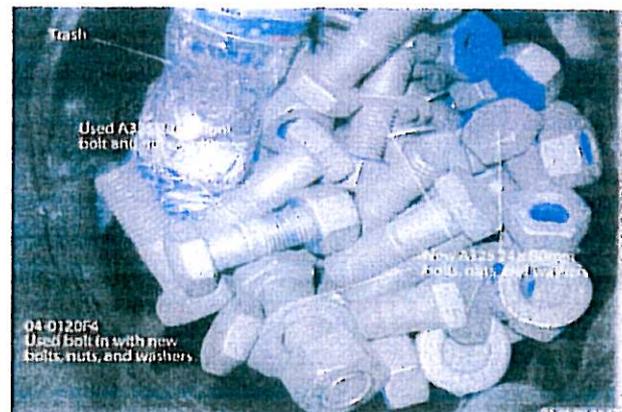
The Contractor failed to segregate used (previously tensioned) fasteners from new fasteners to prevent reuse. Observations of the bolting activities in 3BE revealed one bolt keg marked as size (24 x 80mm) A325 bolts that actually contained both new and used (20 x 70mm) A325 bolts, nuts, and washers.

Standard Specifications and Specifications for Structural Joints Using ASTM A325 bolts, Section 2, Fastener Components, paragraphs:

2.2 Storage of Fastener Components,

2.3.3 Reuse

Please propose a resolution for the identified non-conformance to prevent future occurrences. Means shall be taken to avoid using of used galvanized ASTM A325 bolts.
