Contract #: 04-0120F4Cty: SF/ALA Rte: 80 PM: 13.2/13.9File #: 69.25B**QUALITY ASSURANCE -- NON-CONFORMANCE REPORT****Location:** Changxing Island, Shanghai, P.R. China**Report No:** NCR-000289**Prime Contractor:** American Bridge/Fluor Enterprises, a JV**Date:** 30-May-2009**Submitting Contractor:** Zhenhua Port Machinery Company, Ltd (ZPMC), Changxing Island**NCR #:** ZPMC-0263**Type of problem:****Welding****Concrete****Other****Welding****Curing****Procedural****Bridge No:** 34-0006**Joint fit-up****Coating****Other****Component:** Deck Panel DP048A, Segment 4BE**Procedural****Procedural****Description:****Reference Description:** Tack Weld Removal MT Indications, Segment 4BE**Description of Non-Conformance:**

Project Name: S.F.O.B.B 项目名称: 美国加州海湾大桥		NCR Number: NCR 编号: NCR-B-176 (NCR-289)	
Item: Tack Weld Removal MT Indications 名称描述: 点焊去除后发现裂纹		Item Number: 件号: N/A	Drawing: 图号: N/A
Location: Trail Assembly Yard 4BE 位置: 总拼外场 4BE		Date: 日期: 2009-06-10

项目名称 Project Name:	美国海湾大桥 SFOBB	部件图号 Drawing No.:	OBE4	报告编号 Report No.	B-CWR616
合同号 Contract No.:	04-0120F4	部件名称 Item Name:	Deck plate DP48A on 4BE	NDT 报告编号 Report No. of NDT	N/A
项目编号 Project No.:	ZP06-787

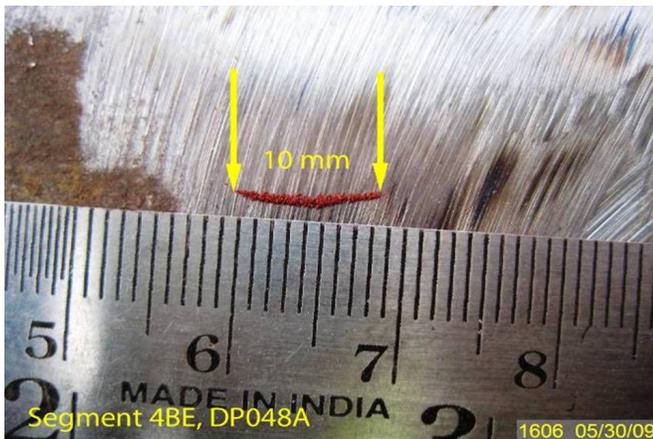
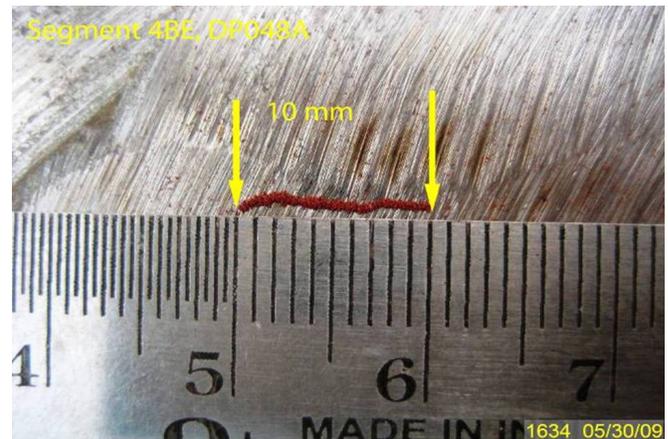
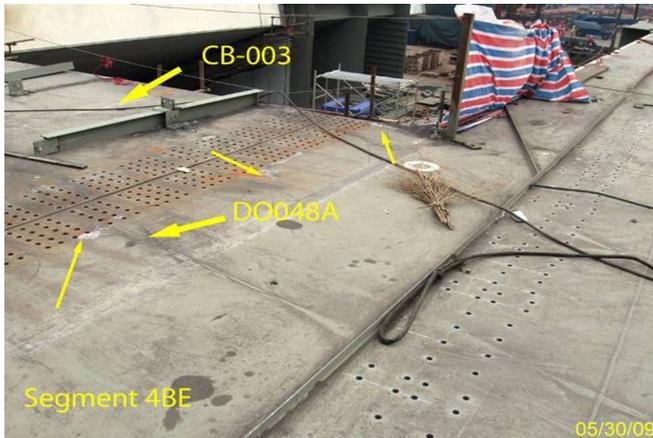
Caltrans Quality Assurance Inspector detected 5 linear indications in the base metal of Deck Panel DP048A in Segment 4BE during random magnetic particle testing (MT) of tack weld removal locations. The tack welds were made to hold the splice plate in place while match drilling the segment deck and crossbeam (CB3) in the trial assembly.

AWS D1.5, 2002 Section 3.3.7.4 - "The removal of tack welds may expose unacceptably hard or cracked HAZs. Such areas on members subject to tension or reversal-of-stress shall be tested by MT (preferably by the yoke method) to assure that no cracks are present."

AWS D1.5, 2002 Section 6.26.2 – "Welds that are subject to MT in addition to visual inspection shall have no cracks"

Reference Resolution: ZPMC has since committed to remove the paint and re-MT all temporary attachment areas in trail assembly. ABF has employed additional MT personnel to re-inspect these same areas.

ABF has notified ZPMC of this NCR. ZPMC has since committed to remove the paint and re-MT all temporary attachment areas in trail assembly. As a further check of verification, ABF has employed additional MT personnel to re-inspect these same areas after ZPMC has completed their own MT.

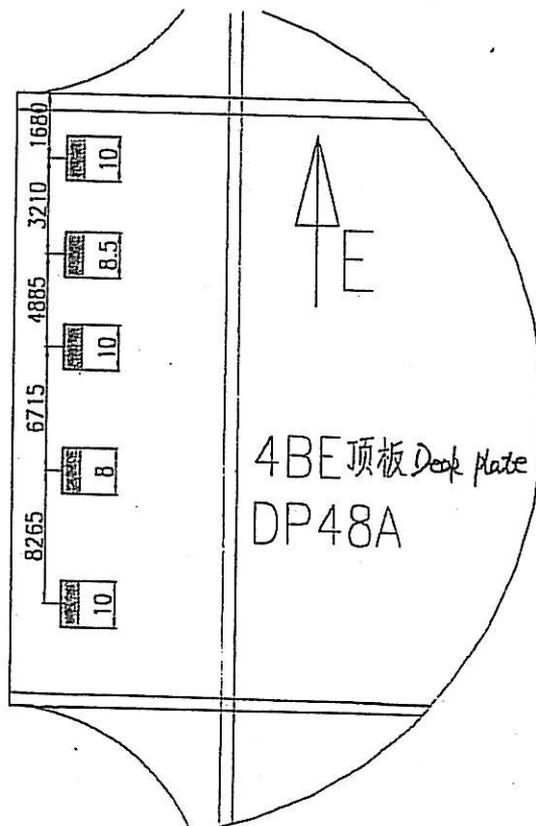
Five cracks were found out after CT performed a casual inspection to the base metal MT on 4BE deck plate DP48A. These cracks were located on the area where the tack welds between box and CB3 connection plate were removed.

The base metal was damaged when removing the lack welds between the box and CB3 connection plate.

1. QC and a Lead CWI shall be present and direct all grinding and welding operations during this repair.
2. QC and a Lead CWI shall have an approved copy of the CWR in hand prior to the repair.
3. QC and a Lead CWI shall direct the repair to ensure the repair is per the disposition requirements.
4. Prepare excavation according to the approved repair WPS;
5. Verify with VT and MT repair area is free of all defects.
6. Preheat and weld according to the relevant repair WPS;
7. Grind the repaired area flush with base metal;
8. Perform 100%VT and MT UT of repair area.

- 对工人进行培训, 提高电焊工和碳刨工技术水平。
 - 加强现场的监控
- 1, Train the welders and grinding operators to improve their technique level.
2, Enhance the monitoring on site.
