Contract #: 04-0120F4Cty: SF/ALA Rte: 80 PM: 13.2/13.9File #: 69.25B**QUALITY ASSURANCE -- NON-CONFORMANCE REPORT****Location:** Changxing Island, Shanghai, P.R. China**Report No:** NCR-000290**Prime Contractor:** American Bridge/Fluor Enterprises, a JV**Date:** 30-May-2009**Submitting Contractor:** Zhenhua Port Machinery Company, Ltd (ZPMC), Changxing Island**NCR #:** ZPMC-0264**Type of problem:**

Bridge No: 34-0006**Component:** Splice Plate X202E, Crossbeam CB3/Segment 4BW**Reference Description:** Base Metal Damage During Tack Weld Removal, Crossbeam CB3/Segment 4BW**Description of Non-Conformance:**

Reference Description: Base Metal Damage During Tack Weld Removal, Crossbeam CB3/Segment 4BW

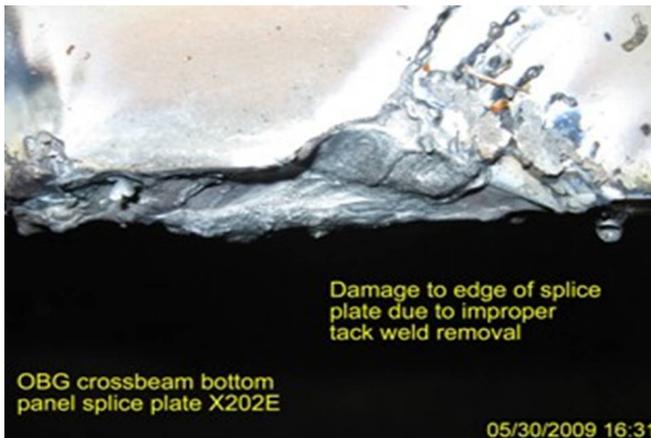
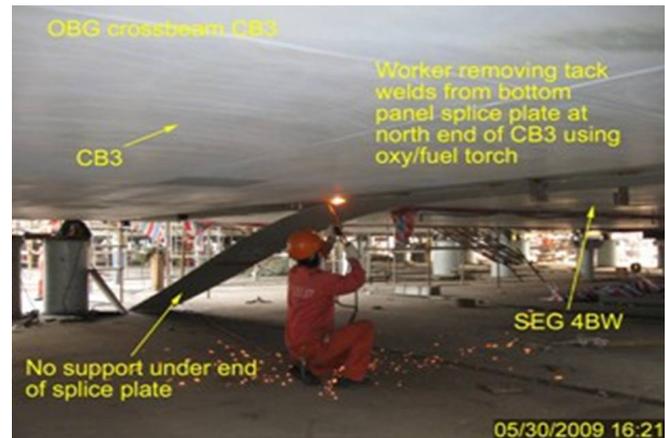
Caltrans Quality Assurance (QA) Inspector observed ZPMC personnel removing temporary tack welds from SPCM Splice Plate X202E. This splice plate was temporarily tack welded to the outside of the bottom panel on the north end of Crossbeam CB3 and OBG Segment 4BW. The worker was using an oxy/fuel torch to remove the tack welds. The edge of the splice plate was damaged at 16 areas where the tack welds were removed.

AWS D1.5 2002 section 3.3.7.3 "Tack welds not incorporated into the final weld shall be removed in such a manner that the base metal is not nicked or undercut. Repair of base metal accidentally removed shall be approved by the Engineer prior to making the repair."

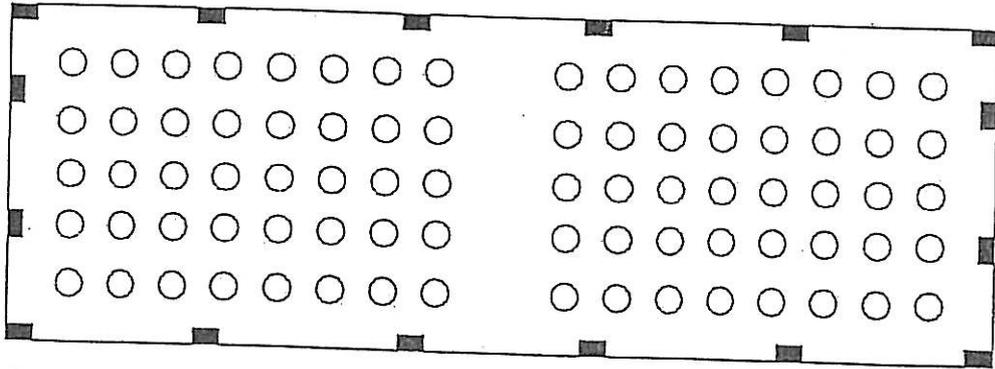
X202D,X202E

CB3连接板X202D,X202E在去除点焊时,有局部母材损伤,最大深度5MM. 见下图:
After inspection CB3 connect X202D and X202E, the base metal was gouged, maximum 5mm in depth, 500mm in length, total 4 parts, see the following draft.

The gouger operated inappropriately during removing tack welds, which led to the base metal damaged.

1. QA CWI Presence.
2. Prepare excavation according to the approved repair WPS.
3. Grind the repair area to a smooth and shiny finish, with tapered ends, to ensure staggered starts and stops.
4. ~~VT and MT the repair area after grinding.~~
5. ~~Preheat and weld according to the relevant repair WPS for SPCM member.~~
6. Grind the repaired area flush with base metal or the adjacent weld.
7. Per AWS D1.5.3.2.2.3, welded repairs to the surfaces and edges of tension and reversal of stress Members shall be subject to ~~UT~~ and MT;
