Contract #: 04-0120F4Cty: SF/ALA Rte: 80 PM: 13.2/13.9File #: 69.25B**QUALITY ASSURANCE -- NON-CONFORMANCE REPORT****Location:** Changxing Island, Shanghai, P.R. China**Report No:** NCR-000295**Prime Contractor:** American Bridge/Fluor Enterprises, a JV**Date:** 03-Jun-2009**Submitting Contractor:** Zhenhua Port Machinery Company, Ltd (ZPMC), Changxing Island**NCR #:** ZPMC-0269**Type of problem:**

Reference Description: Improper Weld Joint Cleaning, Segment 4BE**Description of Non-Conformance:**

Job Name: SAS Superstructure

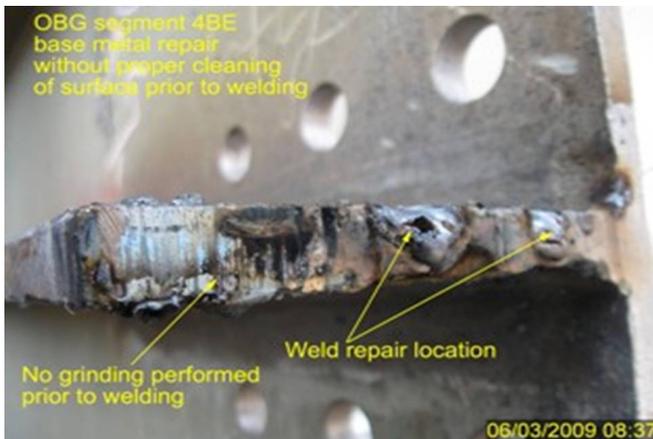
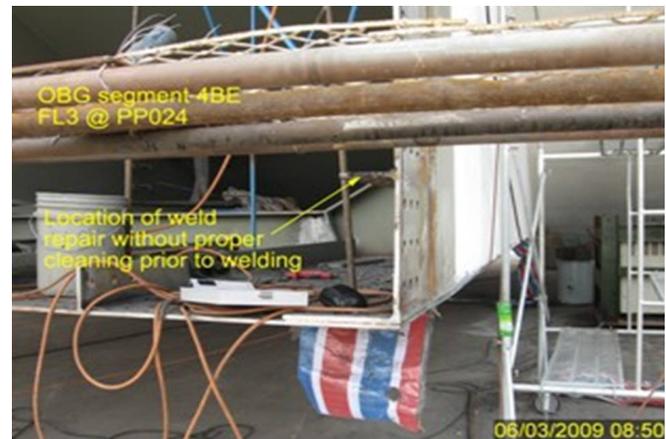
Caltrans Quality Assurance (QA) Inspector observed the Contractor perform base metal edge weld repair without cleaning and removing slag prior to welding. The part was identified as X82V and located on Floor Beam FB018A (FL3, PP026, OBG Segment 4BE).

AWS D1.5 2002 section 3.7.1... "The surface shall be thoroughly cleaned before welding."

The proposed resolution is acceptable. A Critical Weld Repair (CWR) report for the repair is included, and the welder received additional training. Also, the weld in question has been accepted by MT as shown in the attached documents. The Department concurs that Non-Conformance ZPMC-0269 is closed.
