**QUALITY ASSURANCE -- NON-CONFORMANCE REPORT**

**Report No:** NCR-000296

**Component:** OBG Segment Splice 1AE/1BE

**Reference Description:** Welding in Downward Progression, Weld Joint OBE1A-009

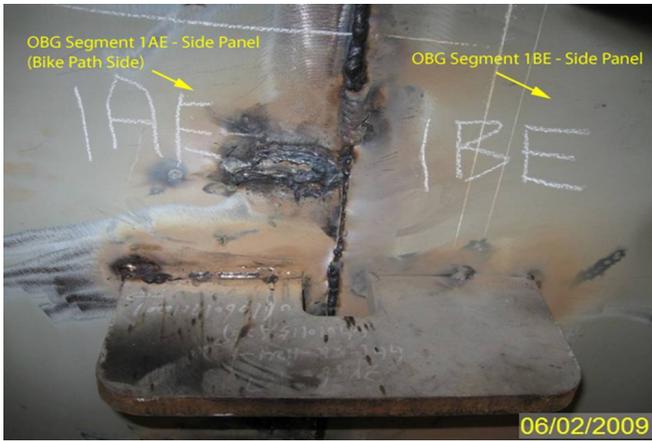
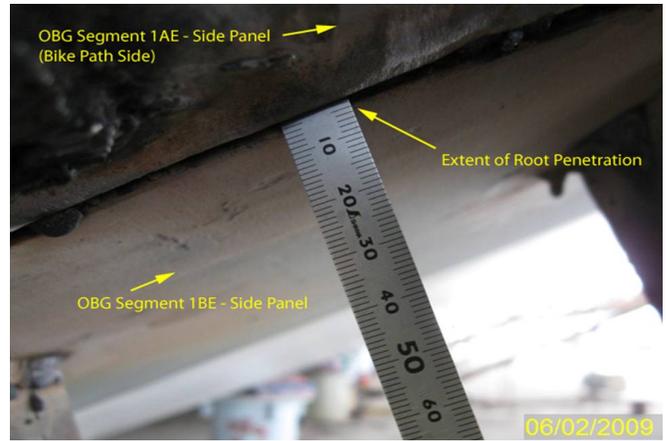
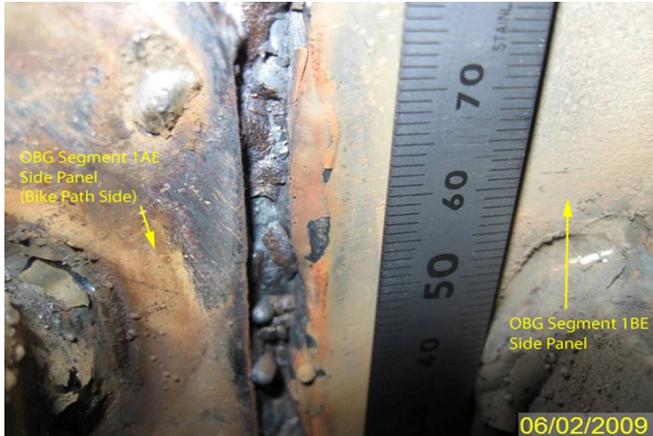
# QUALITY ASSURANCE -- NON-CONFORMANCE REPORT

AWS D1.5 2002, Section 4.14.1.7: "The progression for all passes of vertical position welding shall be upwards, unless a downward progression shall be qualified by tests approved by the Engineer."

The proposed resolution is acceptable. An internal ZPMC NCR was written, and the welder received additional training. Also, the weld in question has been accepted by VT, MT, and UT as shown in the attached documents. The Department concurs that Non-Conformance ZPMC-0270 is closed.
