Contract #: 04-0120F4
 Cty: SF/ALA Rte: 80 PM: 13.2/13.9
 File #: 69.25B

QUALITY ASSURANCE -- NON-CONFORMANCE REPORT

Report No: NCR-000297

Reference Description: Cracked Tack Welds, Segment 8BE

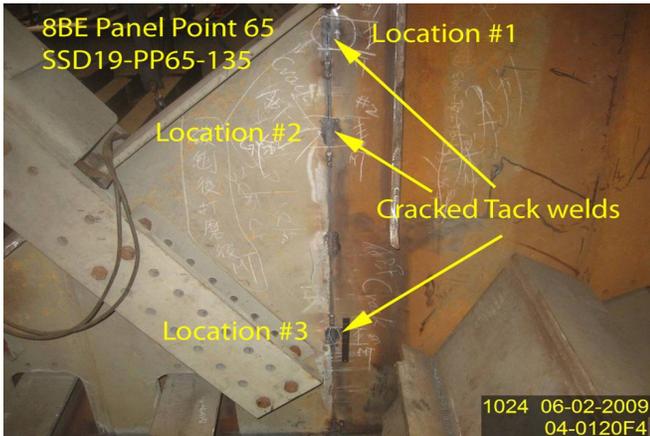
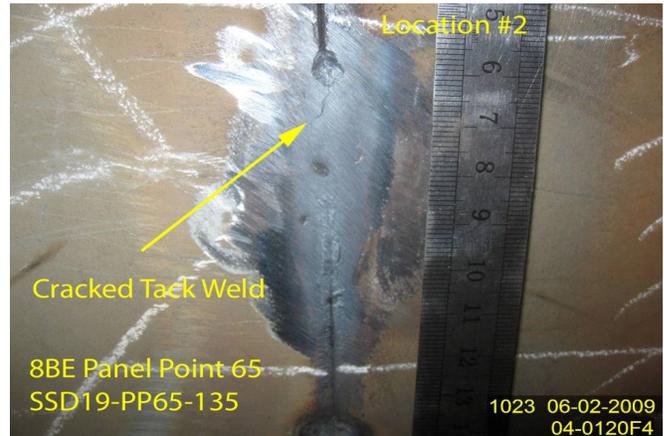
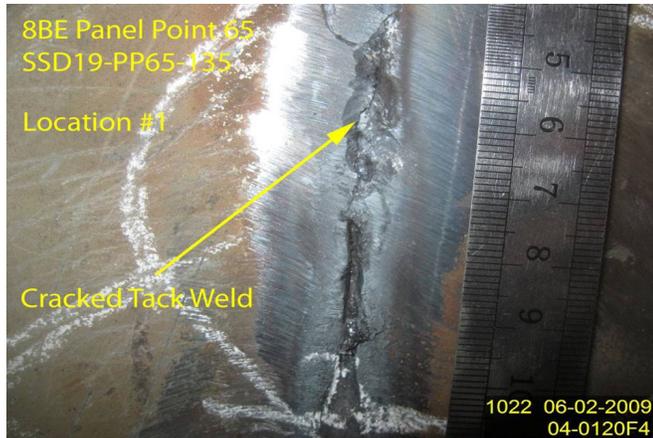
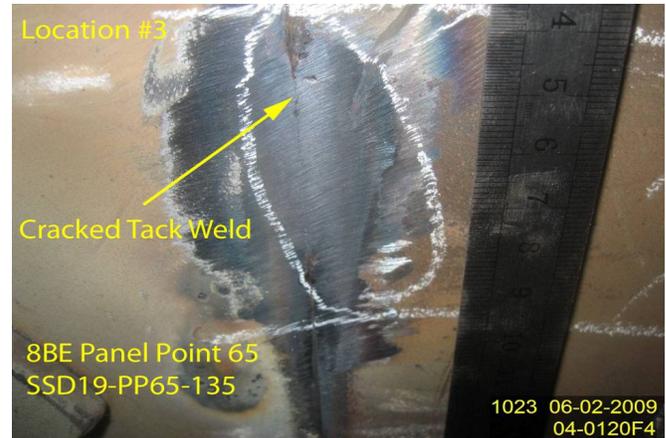
Caltrans Quality Assurance (QA) Inspector observed ZPMC welder Cao Tao (#066163) welding root pass over 3 cracked tack welds on a complete joint penetration (CJP) single bevel groove weld. Tack welds were partially ground and were being incorporated into the final weld. The welder was using the flux cored arc welding (FCAW) process in the 3G (vertical) position on weld joint SSD19-PP65-135 (Segment 8BE, Panel Point 65, FB13A).

AWS D1.5, 2002 Section 3.3.71- "Tack welds shall be subject to the same quality requirements as the final welds."

AWS D1.5, 2002 Section 6.26.1.1- "The weld shall have no cracks."

Please propose a resolution for the identified non-conformance to prevent future occurrences. The weld shall have no cracks.

ZPMC recognizes that welding over cracked tack welds is not acceptable. ZPMC has notified the welder and onsite CWI of this nonconformance. As this weld is a CJP, ZPMC will perform UT to verify a sound weld. Reports will be forwarded at a later date.

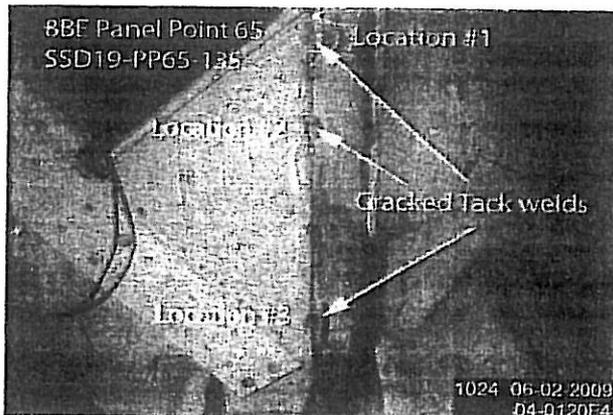
Caltrans Quality Assurance (QA) Inspector observed ZPMC welder Cao Tao (#066163) welding root pass over 3 cracked tack welds on a complete joint penetration (CJP) single bevel groove weld. Tack welds were partially ground and were being incorporated into the final weld. The welder was using the flux cored arc welding (FCAW) process in the 3G (vertical) position on weld joint SSD19-PP65-135 (Segment 8BE, Panel Point 65, FB13A).

AWS D1.5, 2002 Section 3.3.71- "Tack welds shall be subject to the same quality requirements as the final welds."

AWS D1.5, 2002 Section 6.26.1.1- "The weld shall have no cracks."

ZPMC recognizes that welding over cracked tack welds is not acceptable. ZPMC has notified the welder and onsite CWI of this nonconformance. As this weld is a CJP, ZPMC will perform UT to verify a sound weld. Reports will be forwarded at a later date.

Contractor submitted the WRR used during the weld repair procedure as well as the NDT documentation confirming the repair is in conformance with Contract specifications. An internal NCR was also issued.

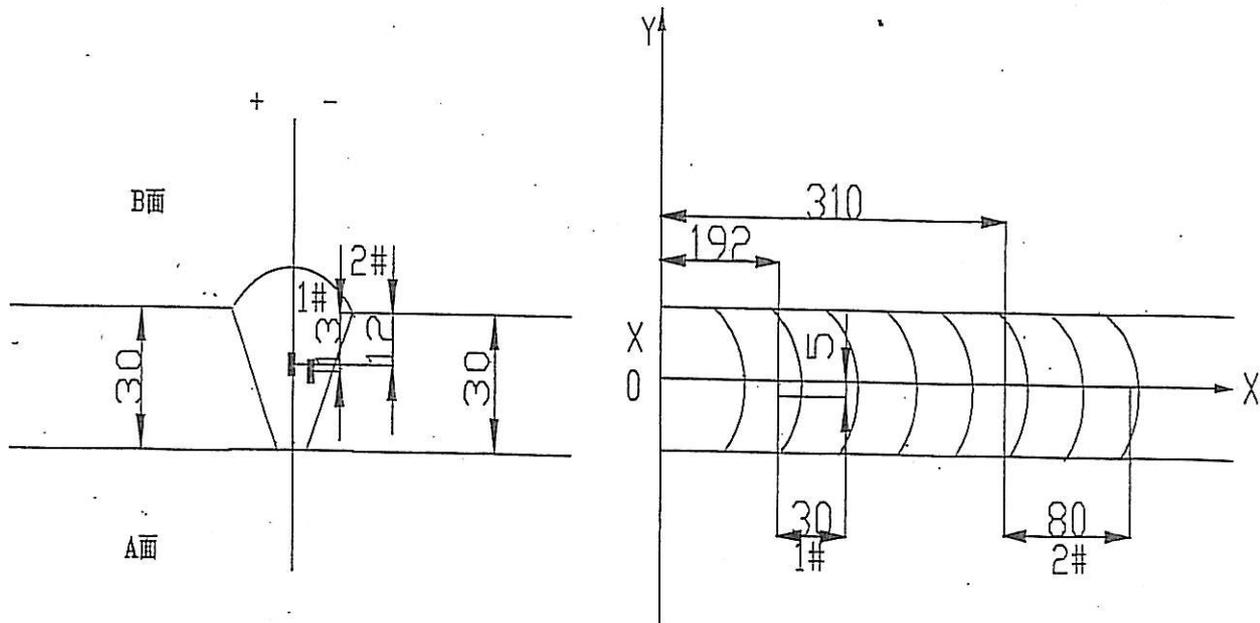
WELD NUMBER: SSD19-PP65-135

Rejected indication found by ultrasonic inspection is less than the maximum allowance, aggregate length.

1. Did not clear the weld pass completely in time.

1. Gouge or grind from nearer side from metal edge ($D \leq 0.65T$, "D" is depth of defects, "T" is thickness of metal) to remove all defects;
2. Follow repair WPS for joint preparation, preheat, and weld deposit;
3. Verify with VT no defects remain in the weld joint prior to welding;
4. Grind the repaired area flush with base metal or the adjacent weld;
5. Check the welds according to the working drawings.

1. Improve monitoring of welding and interpass cleaning.
