Contract #: 04-0120F4Cty: SF/ALA Rte: 80 PM: 13.2/13.9File #: 69.25B**QUALITY ASSURANCE -- NON-CONFORMANCE REPORT****Location:** Changxing Island, Shanghai, P.R. China**Report No:** NCR-000299**Prime Contractor:** American Bridge/Fluor Enterprises, a JV**Date:** 01-Jun-2009**Submitting Contractor:** Zhenhua Port Machinery Company, Ltd (ZPMC), Changxing Island**NCR #:** ZPMC-0273**Type of problem:**

**Reference Description:** Missed UT Indication by QC, Weld Joint FB003-165-104**Description of Non-Conformance:**

**Job Name:** SAS Superstructure

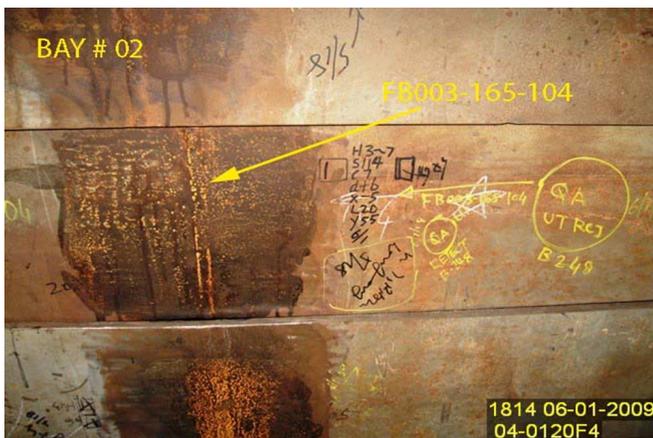
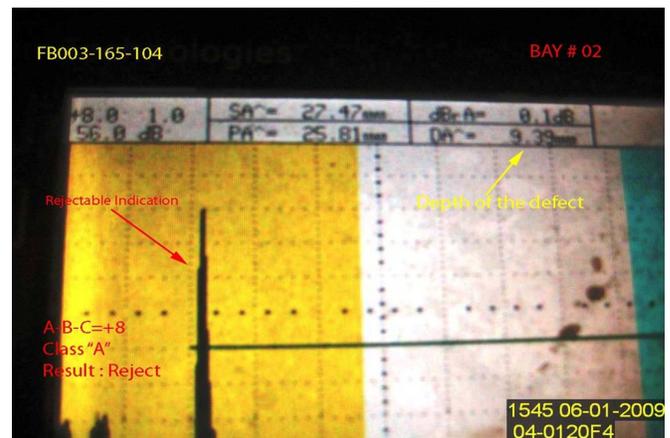
During random 10% verification Ultrasonic Testing (UT) on weld joint FB003-165-104, Caltrans Quality Assurance (QA) Inspector discovered a class "A" non conforming indication measuring approximately 20mm in length. This weld was previously tested and accepted by ZPMC Quality Control (QC) UT technician Han Feng.

AWS D1.5-2002, Section 6, Table 6.3

ABF has notified ZPMC of this nonconformance and instructed the same UT operator to recheck this weld. The UT operator verified the indication was an unacceptable Class "A" indication and has since marked the part for repair. ABF has discussed UT technique issues with ZPMC to prevent further nonconformances. ZPMC will submit repair reports at a later date to close this NCR.

Contractor submitted WRR confirming the repair was made along with NDT records verifying the weld is in conformance with Contract specifications. The NDT Technicians received training from the QCM in regards to the missed indications, and an internal NCR was issued by ZPMC.

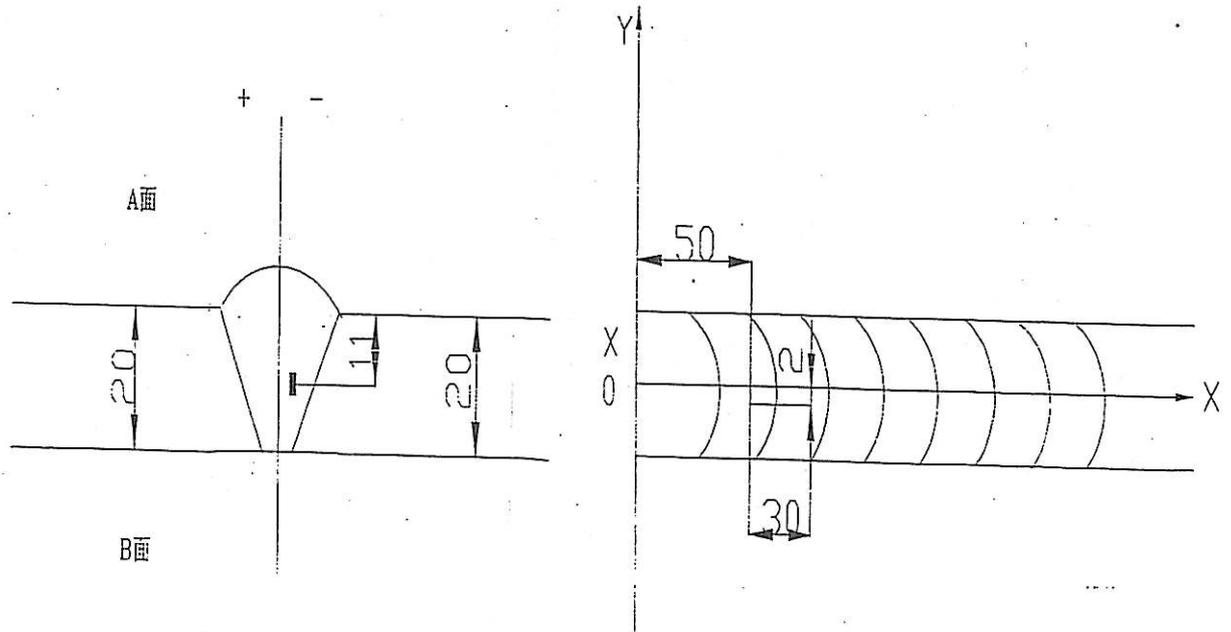
WELD NUMBER: FB003-165-104

DB error caused discontinue defect.

Rejected indication found by ultrasonic inspection is less than the maximum allowance aggregate length.

1. 焊道未及时处理干净。
1. Did not clear the weld pass completely in time.

1. 从缺陷距离端面较近一侧 ( $D \leq 0.65T$ ,  $D$ 为缺陷深度,  $T$ 为板厚) 采用碳刨或打磨的方法去除焊缝缺陷;
  2. 参照返修焊接工艺规程 (WPS) 准备正确的接头型式, 预热和焊接;
  3. 焊前对修补区域进行VT检测保证缺陷完全被消除;
  4. 将修补区域打磨到与母材或邻近焊缝平齐;
  5. 根据批准的车间图纸检查焊缝.
- 
1. Gouge or grind from nearer side from metal edge ( $D \leq 0.65T$ , "D" is depth of defects, "T" is thickness of metal) to remove all defects;
  2. Follow repair WPS for joint preparation, preheat, and weld deposit;
  3. Verify with VT no defects remain in the weld joint prior to welding;
  4. Grind the repaired area flush with base metal or the adjacent weld;
  5. Check the welds according to the working drawings.

1. Improve monitoring of welding and interpass cleaning.
