DIVISION OF ENGINEERING SERVICES

Office of Structural Materials

Quality Assurance and Source Inspection

Contract #: 04-0120F4Cty: SF/ALA Rte: 80 PM: 13.2/13.9File #: 69.25B**QUALITY ASSURANCE -- NON-CONFORMANCE REPORT****Location:** Changxing Island, Shanghai, PRC**Report No:** NCR-000300**Prime Contractor:** American Bridge/Fluor Enterprises, a JV**Date:** 09-Jun-2009**Submitting Contractor:** Zhenhua Port Machinery Company, Ltd (ZPMC), Changxing Island**NCR #:** ZPMC-0274**Type of problem:****Welding****Concrete****Other****Welding****Curing****Procedural****Bridge No:** 34-0006**Joint fit-up****Coating****Other****Component:** North Tower, Lift 4, Skin D**Procedural****Procedural****Description:** Longitudinal Stiffener MT over couplant**Reference Description:** Longitudinal Stiffener MT over couplant**Description of Non-Conformance:**

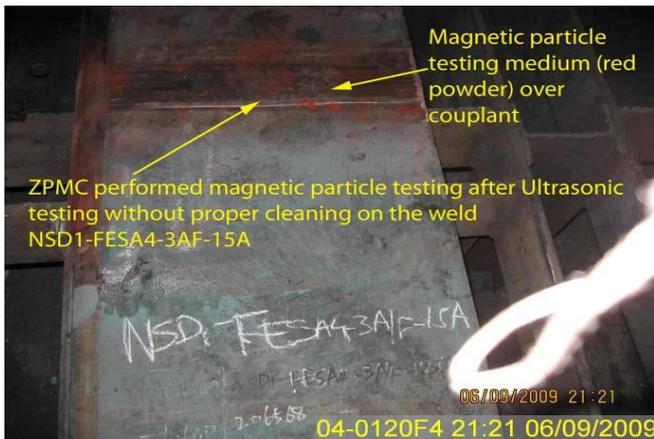
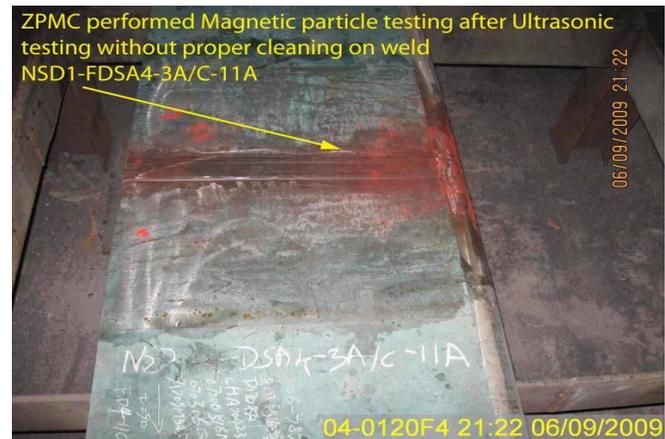
QA observed that ZPMC personnel had performed Magnetic Particle Testing (MT) over a film of residual couplant from prior Ultrasonic Testing (UT) on longitudinal stiffener butt welds SSD1-FCSA4-1A/C-66A, NSD1-FESA4-3A/F-15A and NSD1-FDSA4-3A/C-11A. This layer of couplant prevents magnetic particles from moving freely on the surfaces of the welds.

AWS D1.5-2002, Section 6.7.6.3: "Prior to MT, the surface shall be examined, and any adjacent area within at least 25 mm [1 in.] of the surface to be tested, shall be dry and free of contaminants such as oil, grease, loose rust, loose sand, loose scale, lint, thick paint, welding flux, and weld spatter."

ASTM E709 Section: "Dry particles must not be applied to a damp surface; they will have limited mobility."

ABF QCM has had several discussions with ZPMC MT technicians regarding MT over coatings and MT over contaminants. ABF has instructed ZPMC to clean the weld as required and re-MT. ZPMC will submit MT reports at a later date to close this NCR.

Per Caltrans' comments ZPMC has retested the welds when they were free of any residue and is providing the NDT documentation to show the welds are acceptable. Based on this ZPMC is requesting closure of the NCR.
