Contract #: 04-0120F4Cty: SF/ALA Rte: 80 PM: 13.2/13.9File #: 69.25B**QUALITY ASSURANCE -- NON-CONFORMANCE REPORT****Location:** Changxing Island, Shanghai, PRC**Report No:** NCR-000301**Prime Contractor:** American Bridge/Fluor Enterprises, a JV**Date:** 09-Jun-2009**Submitting Contractor:** Zhenhua Port Machinery Company, Ltd (ZPMC), Changxing Island**NCR #:** ZPMC-0275**Type of problem:**

<b>Welding</b>	<b>Concrete</b>	<b>Other</b>	
<b>Welding</b>	<b>Curing</b>	<b>Procedural</b>	<b>Bridge No:</b> 34-0006
<b>Joint fit-up</b>	<b>Coating</b>	<b>Other</b>	<b>Component:</b> North Tower, Lift 1
<b>Procedural</b>	<b>Procedural</b>	<b>Description:</b>	No preheat on CD interior corner seam weld repair

**Reference Description:** Preheat / North Shaft Lift 1 Skin C & D / Weld Repair Skins C to D Interior Seam

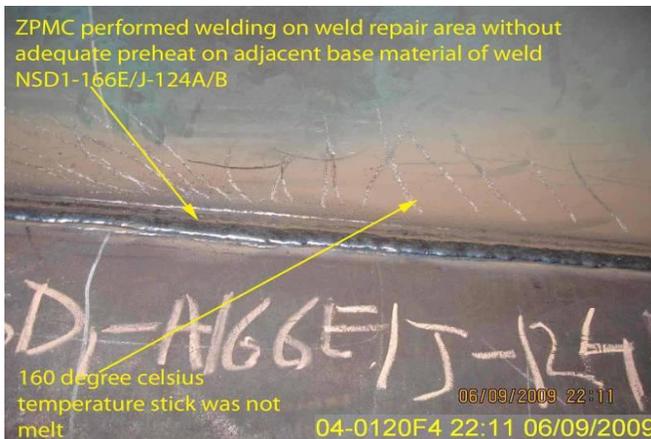
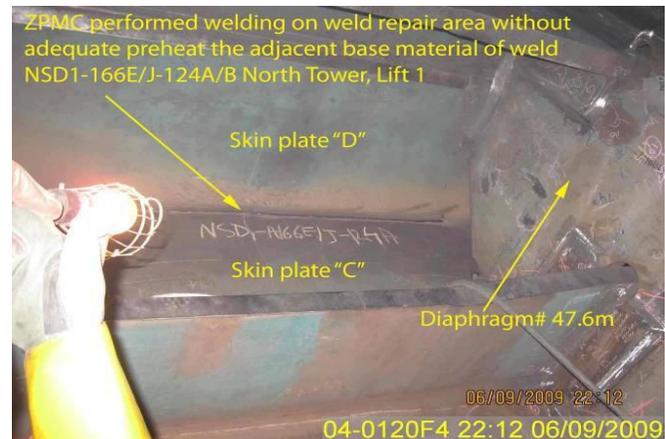
QA observed ZPMC performing weld repairs of North Tower, Lift 1, CD interior corner seam weld NSD1-A166E/J-124A/B without adequate preheat of the adjacent base material. A 160 degree Celsius temperature crayon did not melt when applied to the adjacent base material.

WPS-345-FCAW-2G (2F) requires a minimum base material preheat temperature of 160 degree Celsius.

Recent failures by Quality Control to identify and Production to perform the required preheating of the material have resulted in the issuance of NCR ZPMC-0202, ZPMC-0233, ZPMC-0249, ZPMC-0259, ZPMC-0262 and an additional Incident Report concerning lack of preheating on 03/28/09 (Tower).

Propose a resolution for this systematic non-conformance including documentation that the weld placed is in compliance with the contract requirements. In addition to addressing Production's failure to perform the required preheat of the material, address the failure of Quality Control to identify the inadequate preheat. Provide documentation of the steps/actions taken by Production and Quality Control to prevent future occurrences. Also detail what steps/actions are being taken by ABFJV to address the quality control failures of ABFJV's fabricator/ZPMC.

Submit NDT results indicating a sound weld.

NDT results indicating a sound weld have been submitted and the weld has been green tagged. To prevent recurrence, the Contractor has instructed its inspectors to increase monitoring of preheat temperatures.
