**QUALITY ASSURANCE -- NON-CONFORMANCE REPORT**

**Location:** Changxing Island, Shanghai, P.R. China**Report No:** NCR-000303**Prime Contractor:** American Bridge/Fluor Enterprises, a JV**Date:** 10-Jun-2009**Submitting Contractor:** Zhenhua Port Machinery Company, Ltd (ZPMC), Changxing Island**NCR #:** ZPMC-0277**Type of problem:****Welding****Concrete****Other****Welding****Curing****Procedural****Bridge No:** 34-0006**Joint fit-up****Coating****Other****Component:** OBG Segments 4AE/4BE**Procedural****Procedural****Description:**

**Reference Description:** Heat Straightening Without the Engineer's Approval, Longitudinal Diaphragms at 4AE/4BE Segment Splice

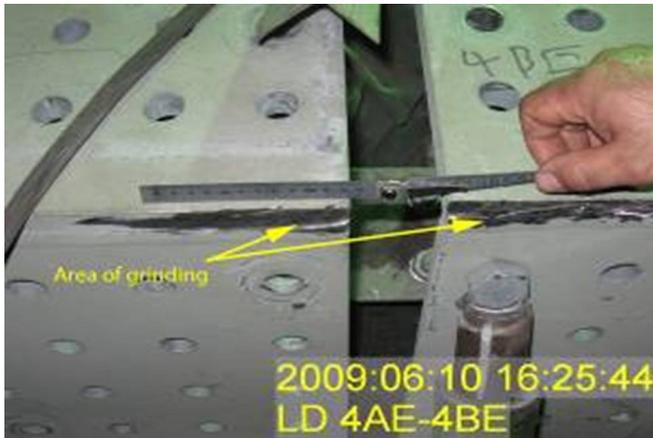
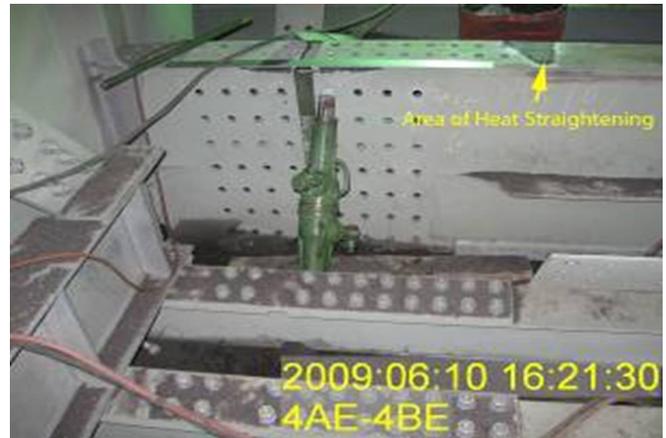
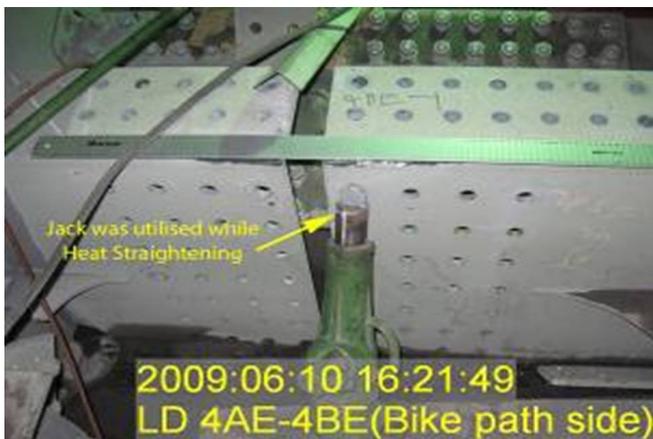
1. The misalignment between Longitudinal Diaphragms LD008-001 (Segment 4AE) and LD018-001 (Segment 4BE) was measured as 12mm. This LD splice was subjected to heat straightening without the Engineer's approval.
2. The heat straightening report utilized at this location was not applicable to the specific work being performed.
3. A mechanical jack was utilized during this process and mechanical jacking was not specified for use on the heat straightening report.
4. Heat straightening was performed without the presence of ZPMC CWI/QC.
5. The base metal edges of the flanges were reduced by grinding to minimize the offset.

AWS D1.5 2002 Section 3.7.3: "Members distorted by welding shall be straightened by mechanical means or by carefully supervised application of a limited amount of localized heat as approved by the Engineer."

With this letter of response, ZPMC requests closure for Caltrans NCR-000303 (ZPMC-0277). We have instructed the sub-contractor that the heat straight must follow the procedure, means that if he want to assistant by machinery then he should add the detail in the HSR and got the approval by engineer prior the corrective action, Otherwise will not be allowed to straight by mechanical method especially the grinding to minimize the offset.

1. Perform MT of heat straightening area, and enhance inspection and train and educate relevant personnel;

2. Remove distortion ~~part~~ connect plate and re-assemble connect plate and it shall inspect alignment of longitudinal diaphragm before assembly longitudinal diaphragm.

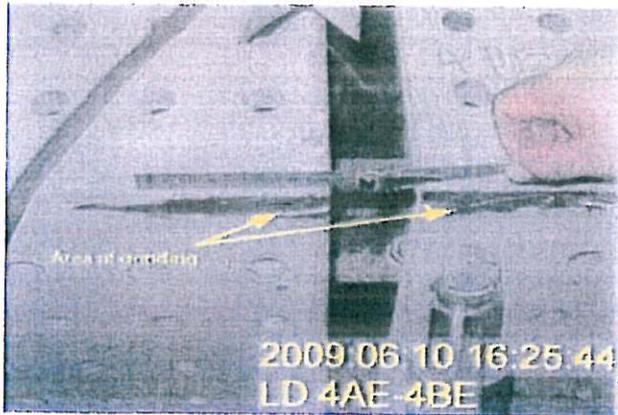
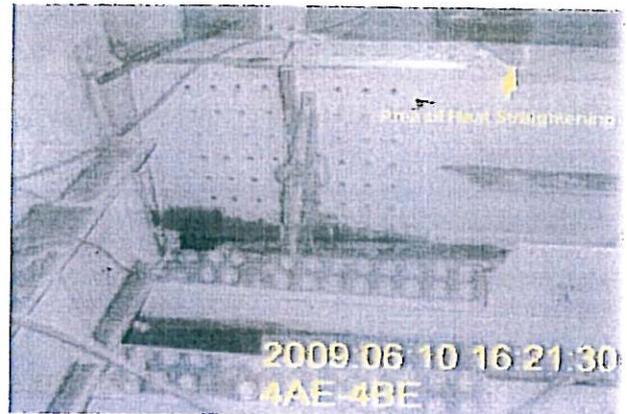
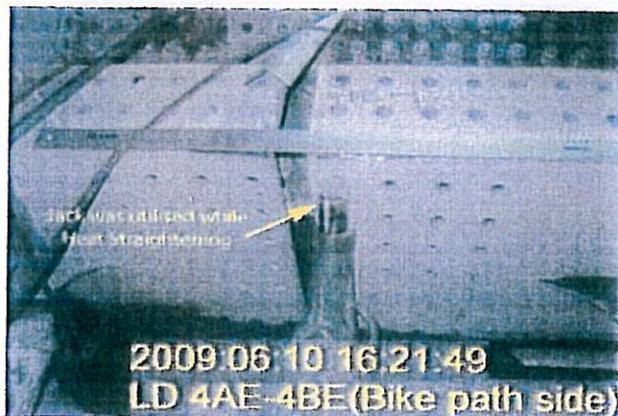
1. The misalignment between Longitudinal Diaphragms LD008-001 (Segment 4AE) and LD018-001 (Segment 4BE) was measured as 12mm. This LD splice was subjected to heat straightening without the Engineer's approval.
2. The heat straightening report utilized at this location was not applicable to the specific work being performed.
3. A mechanical jack was utilized during this process and mechanical jacking was not specified for use on the heat straightening report.
4. Heat straightening was performed without the presence of ZPMC CWI/QC.
5. The base metal edges of the flanges were reduced by grinding to minimize the offset.

Submit approved HSR and perform subsequent NDT.

Contractor submitted HSR as well as VT and MT reports verifying repair was performed in conformance with Contract requirements.

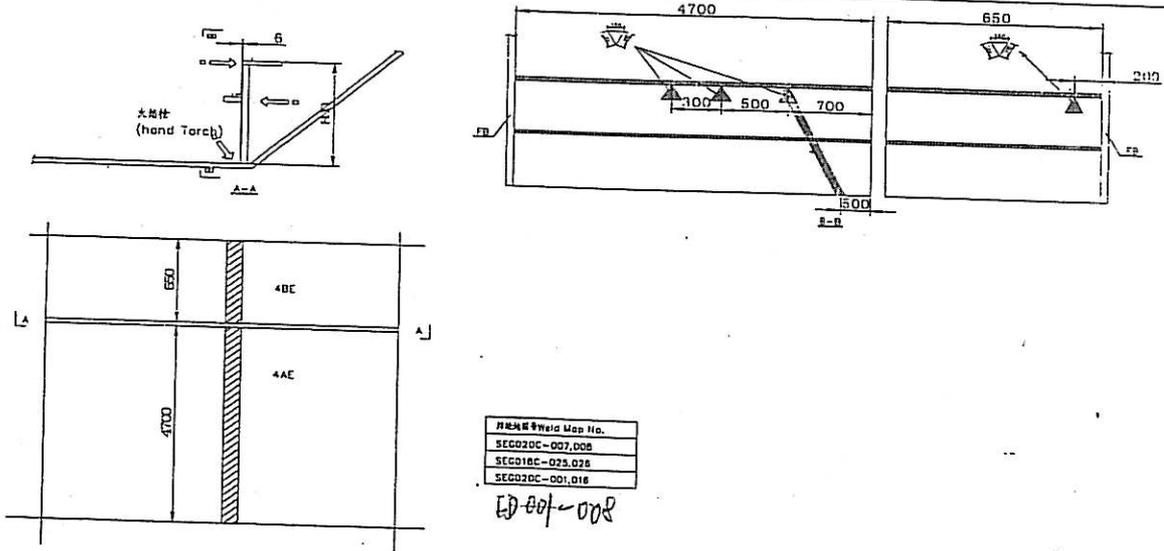
简图 Sketch

Cause原因: Welding distortion 焊接变形  
 Type of Defect缺陷类型: Welding distortion 焊接变形  
 Inspection Method检查方法: Visual 目检

注: 最大变形量约6mm, 最大宽度20~40mm.  
 NOTE: the max deformation is about 6mm, the width is 20~40mm.

缺陷去除方法(Defect Removal Method): Flame Straightening by oxygen acetylene  
 后续NDE(Post-Removal NDE): After finishing heat straightening, the weld of the heat area shall perform NDT according to the approved shop drawing  
 纠正措施(Corrective Action(s)): Control current, voltage and weld speed according to relevant WPS. If necessary anti-deformation or hold down device can be added.  
 实施次数(Number of application): 1~3  
 最高温度(Maximum temperature): <650°C
