QUALITY ASSURANCE -- NON-CONFORMANCE REPORT

Location: Changxing Island, Shanghai, P.R. China **Report No:** NCR-000304
Prime Contractor: American Bridge/Fluor Enterprises, a JV **Date:** 10-Jun-2009
Submitting Contractor: Zhenhua Port Machinery Company, Ltd (ZPMC), Changxing Island **NCR #:** ZPMC-0278

Reference Description: Missed MT Indications by QC, Segment 4BW

Job Name: SAS Superstructure

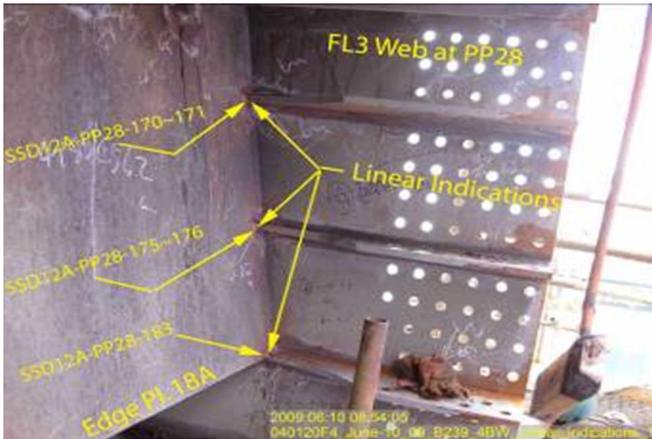
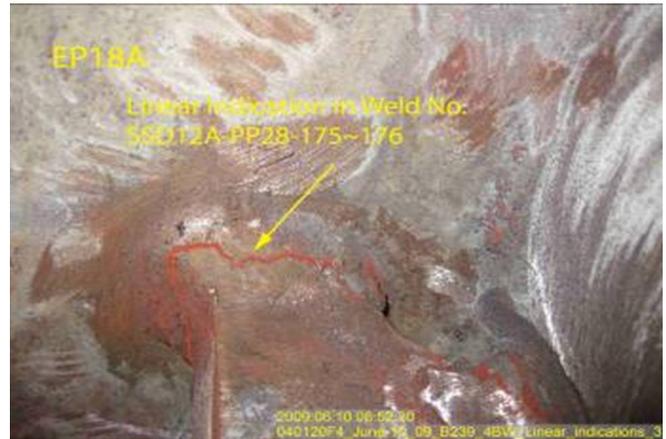
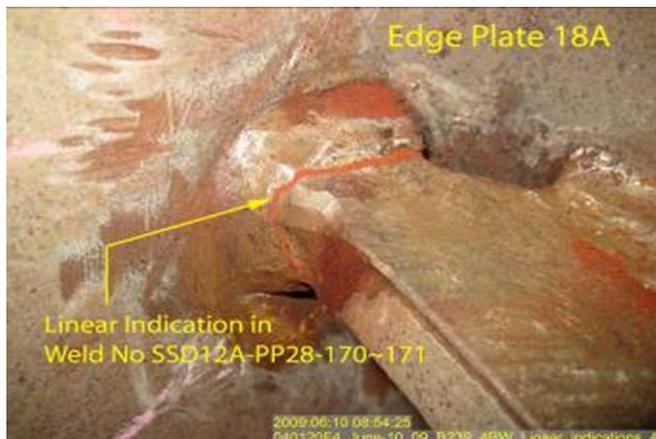
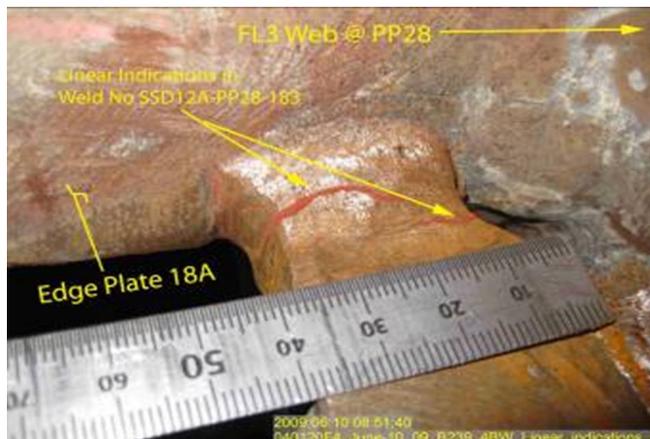
During random verification magnetic particle testing (MT) of the FL3 floor beam horizontal stiffener attachment welds (to Edge Plate 18A), Caltrans Quality Assurance (QA) Inspector discovered a total of four (4) longitudinal linear indications. These indications ranging from 25 to 35mm in length were observed in welds: SSD12A-PP28-170, 171, 175, 176, 183 and SSD10A-PP26-180. These welds have been previously tested and accepted by ZPMC Quality Control (QC) MT and UT technicians.

AWS D1.5 (02) Section 6.26.2 – “Welds that are subject to MT in addition to visual inspection shall have no cracks.”

Propose a resolution for the identified recurring non-conformance which constitutes a systematic problem in quality control with revised procedures to prevent future occurrences. A response for the resolution of this issue is expected within 14 days.

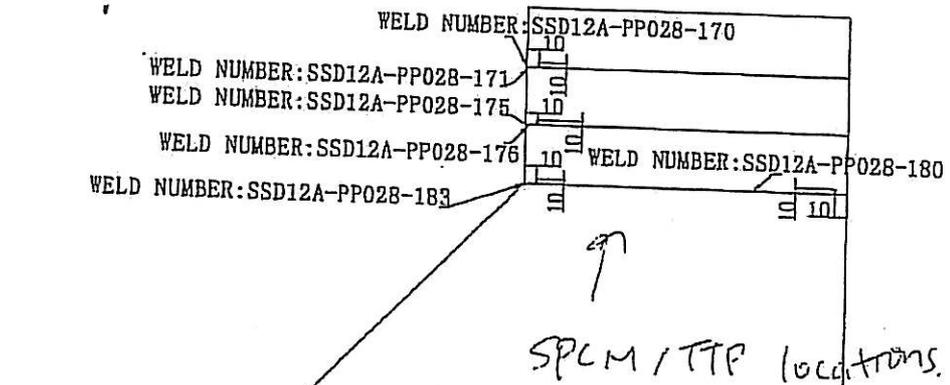
Draft of Welding Discontinuity:

One transverse crack was found by use of MT on each weld(SSD12A-PP028-180、SSD12A-PP028-170、SSD12A-PP028-171、SSD12A-PP028-175、SSD12A-PP028-176、SSD12A-PP028-183). 10mm in length on each weld.

1. 火焰加热时, 水汽没有完全的去掉或者这个区域预热不够;
1. Moisture wasn't completely removed during drying operation (preheating) or the area wasn't preheated sufficiently.

1. Remove the crack by means of grinding.
2. Prepare excavation according to the approved repair WPS.
3. Verify with VT and MT repair areas are crack free.
4. Preheat and weld according to the approved repair WPS.
5. Preheat prior to welding to a minimum temperature of 100°C
6. The preheat area shall be a minimum of 150mm in all directions around the repair area
7. Grind the repaired area flush with base metal or the adjacent weld.
8. Perform VT and MT of the repair areas.

1. QC shall verify sufficient preheat has been applied, to remove moisture, prior to welding.

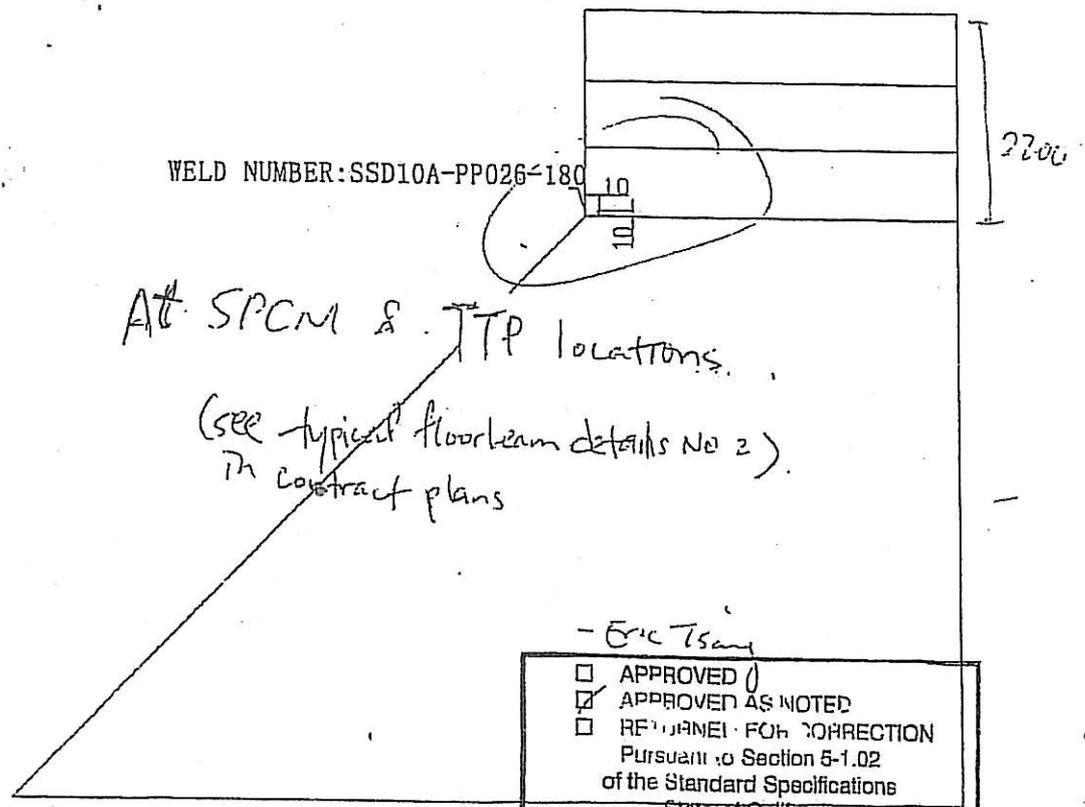
Draft of Welding Discontinuity:

One transverse crack was found by use of MT on weld (SSD10A-PP026-180). L=10mm.

- 1. 火焰加热时, 水汽没有完全的去掉或者这个区域预热不够;
- 1. Moisture wasn't completely removed during drying operation (preheating) or the area wasn't preheated sufficiently.

- 1. Remove the crack by means of grinding.
- 2. Prepare excavation according to the approved repair WPS.
- 3. Verify with VT and MT repair areas are crack free.
- 4. Preheat and weld according to the approved repair WPS.
- 5. Preheat prior to welding to a minimum temperature of 100°C
- 6. The preheat area shall be a minimum of 150mm in all directions around the repair area
- 7. Grind the repaired area flush with base metal or the adjacent weld.
- 8. Perform VT and MT of the repair areas.

1. QC shall verify sufficient preheat has been applied, to remove moisture, prior to welding.
