Contract #: 04-0120F4Cty: SF/ALA Rte: 80 PM: 13.2/13.9File #: 69.25B**QUALITY ASSURANCE -- NON-CONFORMANCE REPORT****Location:** Changxing Island, Shanghai, P.R. China**Report No:** NCR-000306**Prime Contractor:** American Bridge/Fluor Enterprises, a JV**Date:** 10-Jun-2009**Submitting Contractor:** Zhenhua Port Machinery Company, Ltd (ZPMC), Changxing Island**NCR #:** ZPMC-0280**Type of problem:**

Reference Description: Improper Welding/Cleaning, Weld OBW5A-004, 5AW/5BW Segment Splice**Description of Non-Conformance:**

Dear: Mr. Charles Kanapicki
Job Name: SAS Superstructure

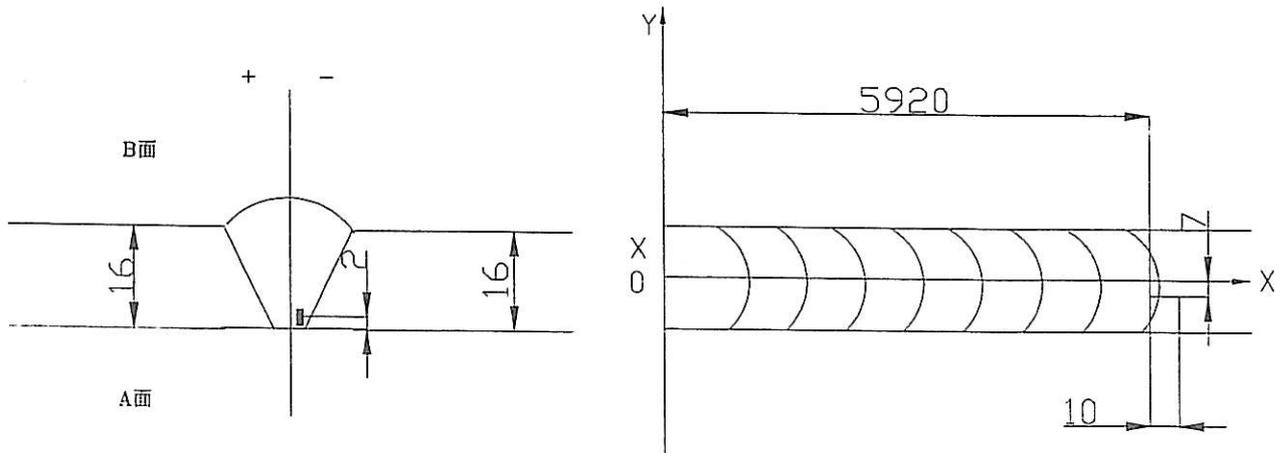
WELD NUMBER: OBW5A-004

Rejected indication found by ultrasonic inspection is less than the maximum allowance aggregate length.

(UT探伤发现的缺陷总长度小于最大允许长度。) OBW5A-004

1、焊道未及时处理干净。

1. Did not clear the weld pass completely in time.

1. 从缺陷距离端面较近一侧 ($D \leq 0.65T$, D为缺陷深度, T为板厚) 采用碳刨或打磨的方法去除焊缝缺陷;
2. 参照返修焊接工艺规程 (WPS) 准备正确的接头型式, 预热和焊接;
3. 焊前对修补区域进行VT检测保证缺陷完全被消除;
4. 将修补区域打磨到与母材或邻近焊缝平齐;
5. 根据批准的车间图纸检查焊缝.

1. Gouge or grind from nearer side from metal edge ($D \leq 0.65T$, "D" is depth of defects, "T" is thickness of metal) to remove all defects;
2. Follow repair WPS for joint preparation, preheat, and weld deposit;
3. Verify with VT no defects remain in the weld joint prior to welding;
4. Grind the repaired area flush with base metal or the adjacent weld;
5. Check the welds according to the working drawings;

1. Improve monitoring of welding and interpass cleaning.
