Contract #: 04-0120F4  
Cty: SF/ALA Rte: 80 PM: 13.2/13.9  
File #: 69.25B

**QUALITY ASSURANCE -- NON-CONFORMANCE REPORT**

**Report No:** NCR-000310

**Reference Description:** Improper Cleaning of Weld Areas Prior to MT, Weld CB202C-001-003, Crossbeam CB5

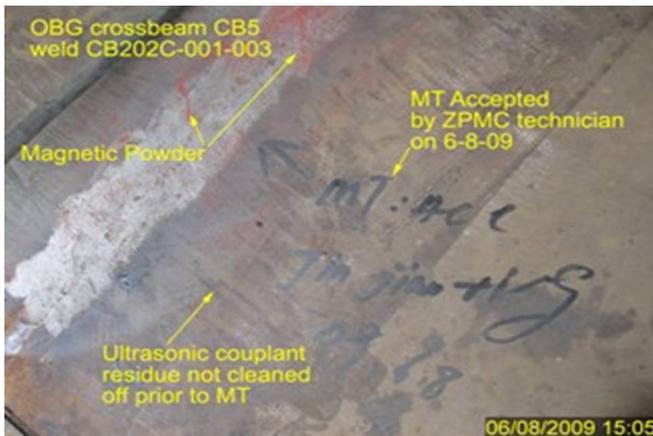
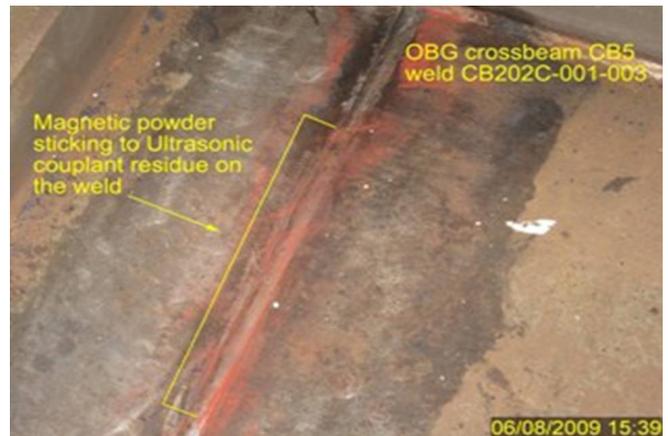
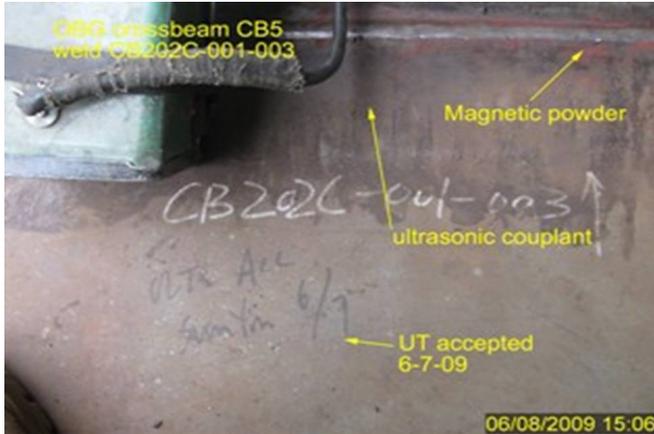
Caltrans Quality Assurance QA) Inspector observed that the Contractor has performed magnetic particle testing (MT) prior to properly cleaning the base metal and weld. The affected weld is identified as CB202C-001-003 (Crossbeam CB5). The weld and adjacent base metal are coated with ultrasonic testing couplant residue.

AWS D1.5 2002 Section 6.7.6.3 "Prior to MT, the surface shall be examined, and any adjacent area within at least 25 mm [i in.] of the surface to be tested, shall be dry and free of contaminants such as oil, grease, loose rust, loose sand, loose scale, lint, thick paint, welding flux, and weld spatter."

**Reference Resolution:** ABF QCM has had several discussions with ZPMC MT technicians regarding MT over coatings and MT over contaminants. ABF has instructed ZPMC to clean the weld as required and re-MT.

ZPMC QA has issued an internal NCR to the QC Department for improper cleaning of the weld prior to NDT. Per the internal NCR the weld was cleaned and NDT was performed again after and found acceptable. Based on this ZPMC requests closure of this NCR.

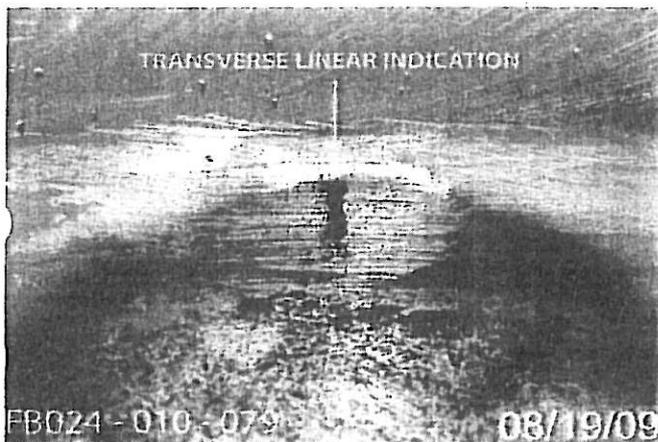
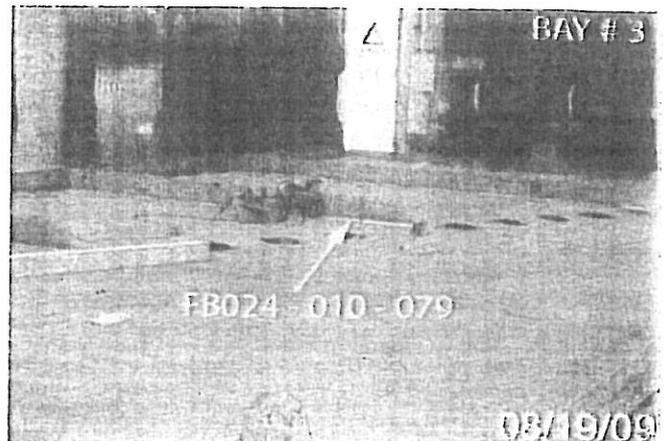
During random verification Magnetic Particle Testing (MT) for the OBG Floor Beam at Bay # 3, this Caltrans Quality Assurance Inspector (QA) observed one (1) transverse linear indication approximately 6mm in length in the weld metal on FB024-010-079. This area has been previously tested and accepted by ZPMC MT Technician.

AWS D1.5 (02) Section 6.26.2 – “Welds that are subject to MT in addition to visual inspection shall have no cracks.

For regarding of NCR-000393(ZPMC-0367), ZPMC arranged grinder and removed the linear indication by a little grinding on site. After repair MT were done to warrant this weld's quality.
