QUALITY ASSURANCE -- NON-CONFORMANCE REPORT

Location: Changxing Island, Shanghai, P.R. China **Report No:** NCR-000311
Prime Contractor: American Bridge/Fluor Enterprises, a JV **Date:** 07-Jun-2009
Submitting Contractor: Zhenhua Port Machinery Company, Ltd (ZPMC), Changxing Island **NCR #:** ZPMC-0285

Reference Description: Missed MT Indications by QC on Base Metal Repairs, CB2/3AE, CB2/3AW Splices

Job Name: SAS Superstructure

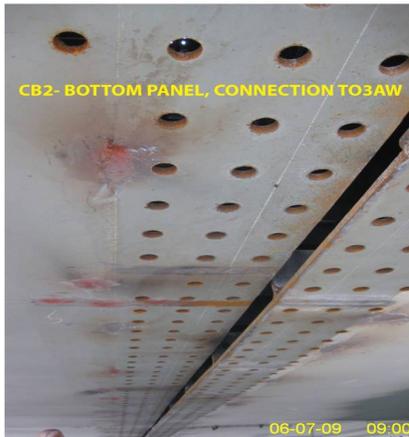
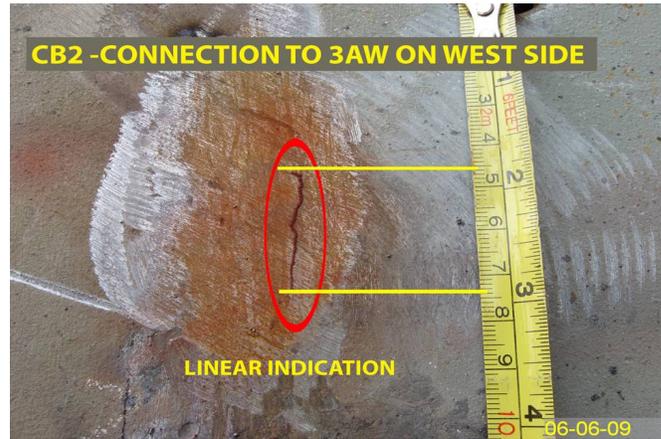
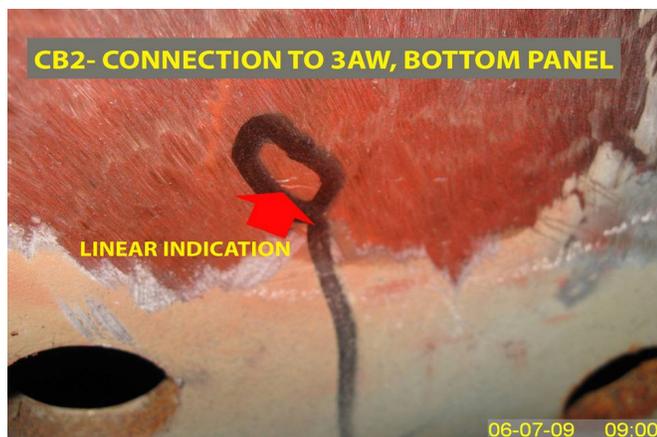
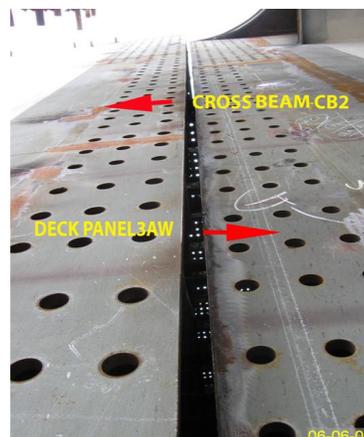
During random magnetic particle testing (MT) of base metal repairs associated with the bolted splice plate connection areas of CB2 to 3AE & 3AW, Caltrans Quality Assurance (QA) Inspector observed linear indications. The base metal repairs were performed to correct damage that resulted from removing the temporary welds holding the splice plates in place while match drilling was completed. These areas were previously tested & accepted by ZPMC Quality Control (QC) MT technicians.

AWS D1.5 (02) Section 6.26.2 – “Welds that are subject to MT in addition to visual inspection shall have no cracks.”

Propose a resolution for the identified recurring non-conformance which constitutes a systematic problem in quality control with revised procedures to prevent future occurrences. A response for the resolution of this issue is expected within 14 days.

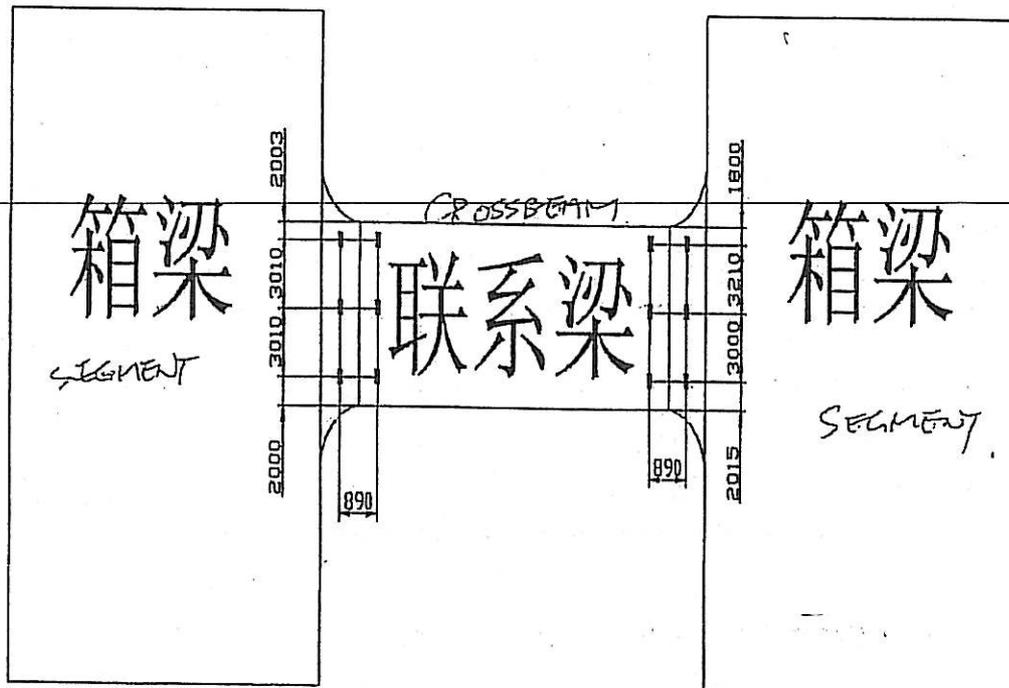
Draft of Welding Discontinuity:

CB2, CB3联系梁在去除连接板与箱梁上点焊时, 发现伤及联系梁和箱梁的母材, 最大深度为3MM, 具体位置见下图:
After removing CB2 and CB3 strut plate tack weld, the base metal was gouged, maximum 3mm, the detail see the following draft.

Remark: blank point was base metal gouged area.

The worker operated error during removing tack welds caused base metal gouged.

1. Prepare excavation according to the approved repair WPS.
2. Grind the gouged area to a smooth and shiny finish, with tapered ends, to ensure staggered starts and stops.
3. VT and MT the repair area.
4. Preheat and weld according to the relevant repair WPS.
5. Grind the repaired area flush with base metal or the adjacent weld.
6. Perform VT and MT over 100% of the repair area.

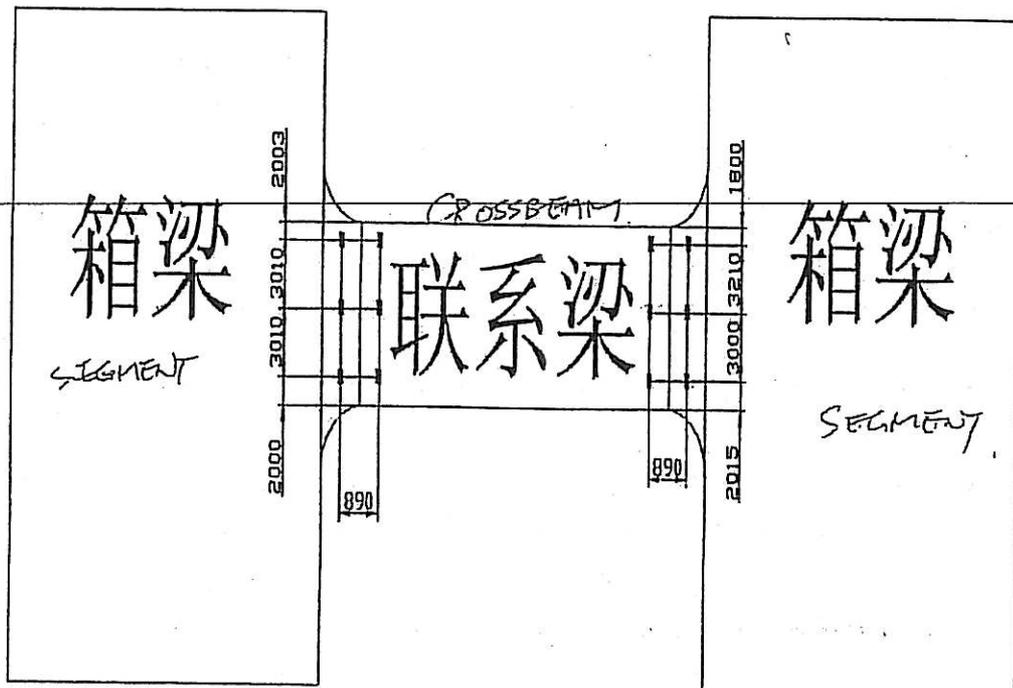
Draft of Welding Discontinuity:

Remark: blank point was base metal gouged area.

The worker operated error during removing tack welds caused base metal gouged.

1. Prepare excavation according to the approved repair WPS.
2. Grind the gouged area to a smooth and shiny finish, with tapered ends, to ensure staggered starts and stops.
3. VT and MT the repair area.
4. Preheat and weld according to the relevant repair WPS.
5. Grind the repaired area flush with base metal or the adjacent weld.
6. Perform VT and MT over 100% of the repair area.
